# SAFETY RECALL BULLETIN

SUBJECT:			No:	SR-17-008
INCLATOR CAFETY RECALL CAMPAICN				December 2017
				MODEL: 2016 - 2017 i-MiEV
CIRCULATE TO:	[X] GENERAL MANAGER	[X] PARTS MANAGER		[X]TECHNICIAN
[X] SERVICE ADVISOR	[X] SERVICE MANAGER	[X] WARRANTY PROCES	SOR	[X]SALES MANAGER

This campaign bulletin instructs dealers to replace the passenger side frontal air bag inflator with one from a different supplier. Dealers must return the subject air bag inflator per the instructions in the **Parts Information** section of this procedure.

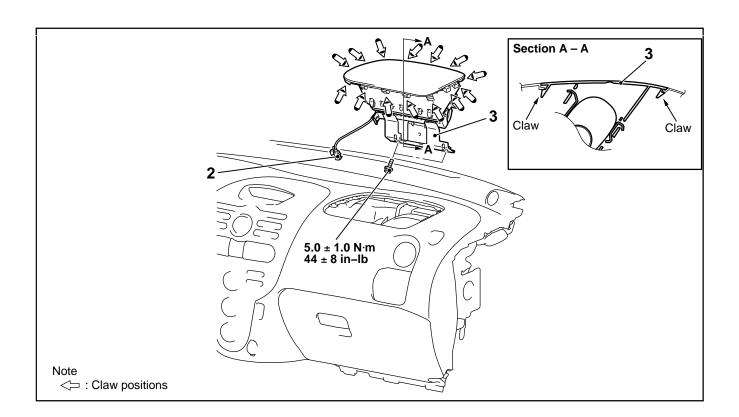
8. Unbolt the air bag module from the metal dash brace.

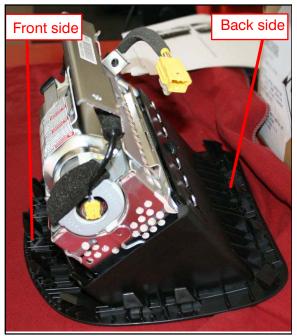
- Place the air bag module on a clean work bench covered with a new, clean, static—free cloth/sheet with the air bag module cover facing down.
- 11. Identify the air bag module and air bag module cover.
- 12. Light surface rust may be present on the inflator surface. This is normal and does not affect the functionality of the inflator.

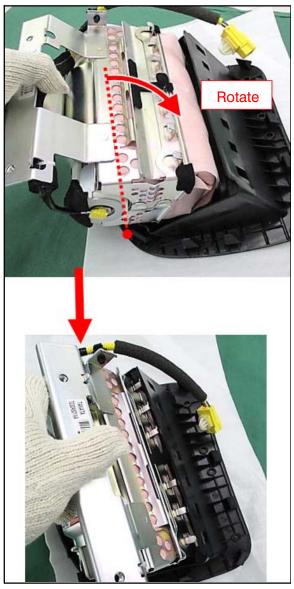
4. Confirm that the air bag module is correctly hooked into place.

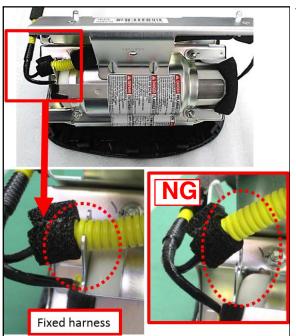
6. Confirm that the air bag module is correctly hooked into place.

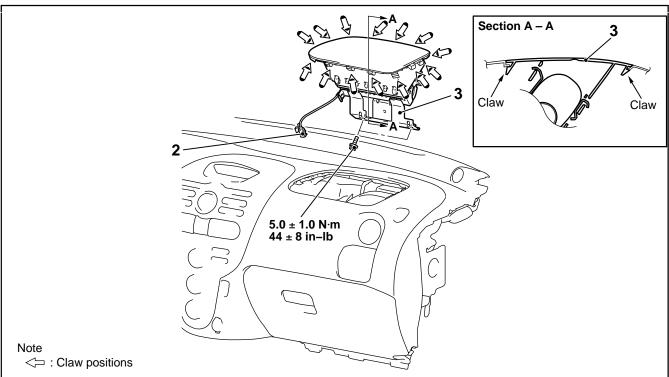
1. Reinstall the air bag module and cover into the vehicle.

2. Bolt the air bag module to the metal dash brace to  $44\pm8$  in–lb (5.0  $\pm$  1.0 Nm).
