Revised June 2018

Dealer Service Instructions for:

Safety Recall T79 / NHTSA 17V-821 Brake Transmission Shift Interlock

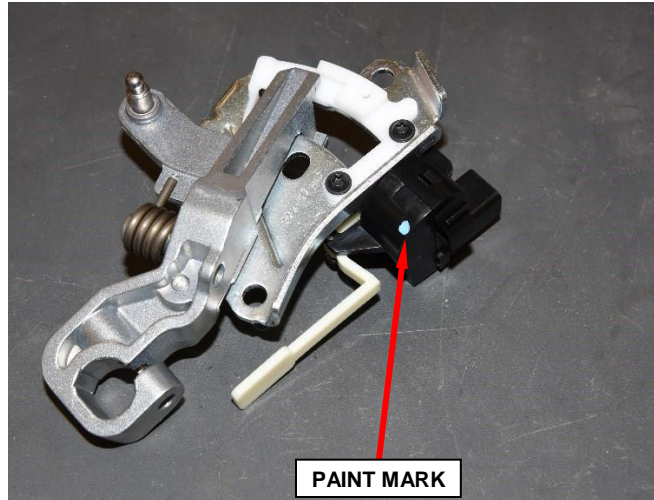
Figure 14 – Gearshift Bracket / BTSI Assembly Paint Mark Verification

- 24. Discard the old gearshift bracket / BTSI assembly.
- 25. Verify the **new** gearshift bracket / BTSI assembly to be used has a paint mark on the BTSI solenoid (Figure 14).
