Revised April 2018

Dealer Service Instructions for:

# Safety Recall T79 / NHTSA 17V-821 Brake Transmission Shift Interlock

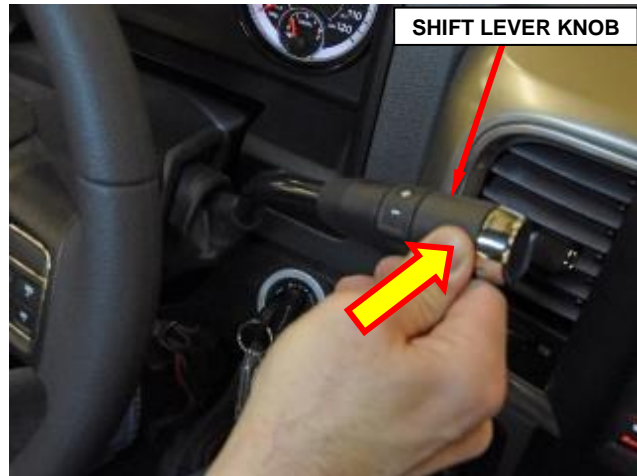
**Figure 1 – Push Lightly On Shift Lever Knob Toward Instrument Panel To Feel BTSI Solenoid Pin Movement**

5. Place your hand on the shift lever knob and push lightly on the shift lever toward the instrument panel. This will allow you to feel a click sensation from BTSI solenoid pin movement when the brake pedal is applied and released (Figure 1).
