Dealer Service Instructions for:

# Safety Recall T79 / NHTSA 17V-821 Brake Transmission Shift Interlock

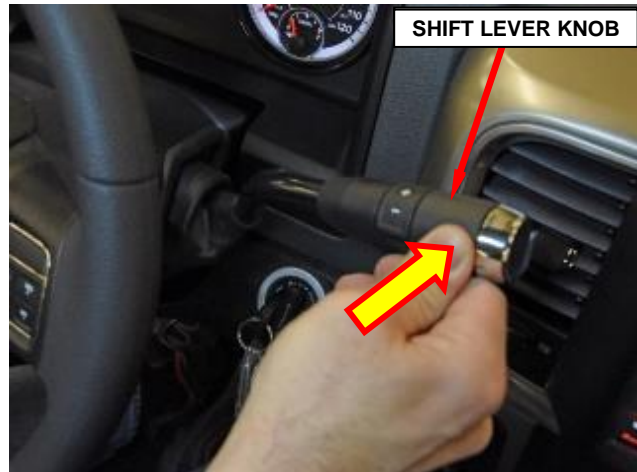
**Figure 1 – Push Lightly On Shift Lever Knob Toward Instrument Panel To Feel BTSI Solenoid Pin Movement**

5. Place your hand on the shift lever knob and push lightly on the shift lever toward the instrument panel. This will allow you to feel a click sensation from BTSI solenoid pin movement when the brake pedal is applied and released (Figure 1).

9. After five seconds of holding the brake pedal down, release the brake pedal while both listening and feeling for the click of the BTSI pin movement. The sound and feel of the BTSI pin movement should occur immediately within 0-2 seconds upon release of the brake pedal.

➤ If the BTSI pin could be heard and felt moving within 0-2 seconds, then the BTSI inspection process is complete and the gearshift bracket / BTSI assembly does not need to be replaced. Place the ignition switch in the “OFF” position then proceed to **Section C. Reprogram Body Control Module (BCM)**.

➤ If the BTSI pin could **not** be heard and felt moving within 0-2 seconds, then continue with **Step 10**.
