Revised August 2018

Dealer Service Instructions for:

# Safety Recall T79 / NHTSA 17V-821

## Brake Transmission Shift Interlock

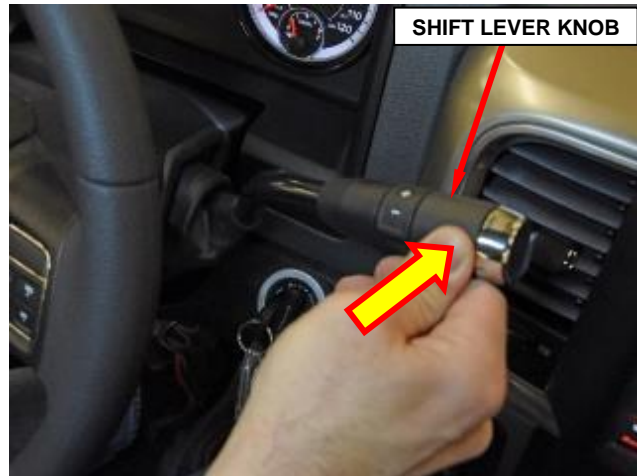
**Figure 1 – Push Lightly On Shift Lever Knob Toward Instrument Panel To Feel BTSI Solenoid Pin Movement**

5. Place your hand on the shift lever knob and push lightly on the shift lever toward the instrument panel. This will allow you to feel a click sensation from BTSI solenoid pin movement when the brake pedal is applied and released (Figure 1).

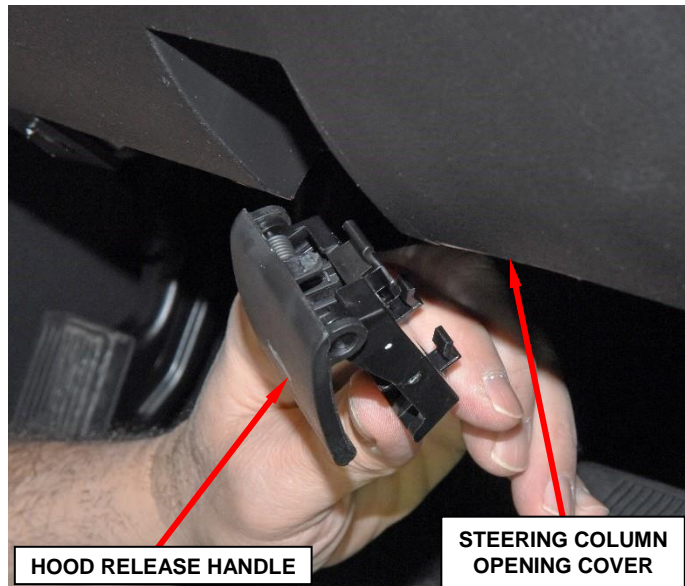
**Figure 2 – Hood Release Handle**

1. Open the vehicle hood
2. Disconnect the negative battery cable terminal from the battery(s).
3. Using a trim stick C-4755 or equivalent, disengage the retainer clip that secures the hood release handle to the steering column opening cover, and remove the hood release handle from the cover (Figure 2).

45. Position the hood release handle onto the steering column opening cover and fully engage the retainer clip that secures the hood release handle to the steering column opening cover (Figure 2).

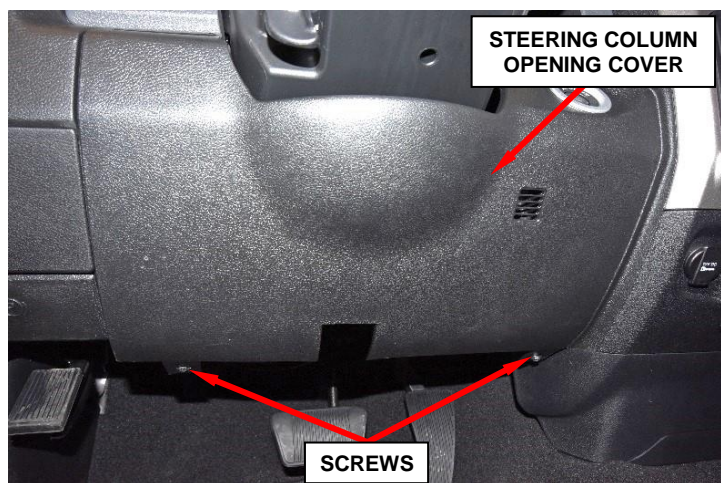
**Figure 3 – Steering Column Opening Cover**

4. Remove and save the two screws that secure the bottom of the steering column opening cover to the instrument panel (Figure 3).
5. Using a trim stick C-4775 or equivalent, release the eight spring clips that attach the steering column opening cover to the instrument panel (Figure 3)

43. Attach the steering column opening cover to the instrument panel with the eight spring clips (Figure 3).
  44. Install the two screws that secure the steering column opening cover to the instrument panel. Tighten the screws to 3.6 N·m (32 in. lbs.) (Figure 3).

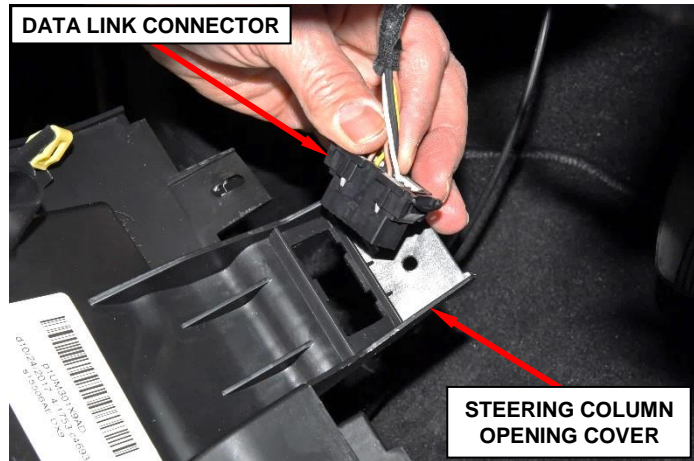
**Figure 4 – Data Link Connector**

6. Remove the data link connector from the steering column opening cover by pressing in the tabs and pushing the connector through the opening on the back side of the cover (Figure 4).

41. **If equipped:** Connect the electrical connectors for any electrical devices to the steering column opening cover.
  42. Install the data link connector to the steering column opening cover by pushing the connector through the opening on the back side of the cover and fully engaging the lock tabs of the connector (Figure 4).

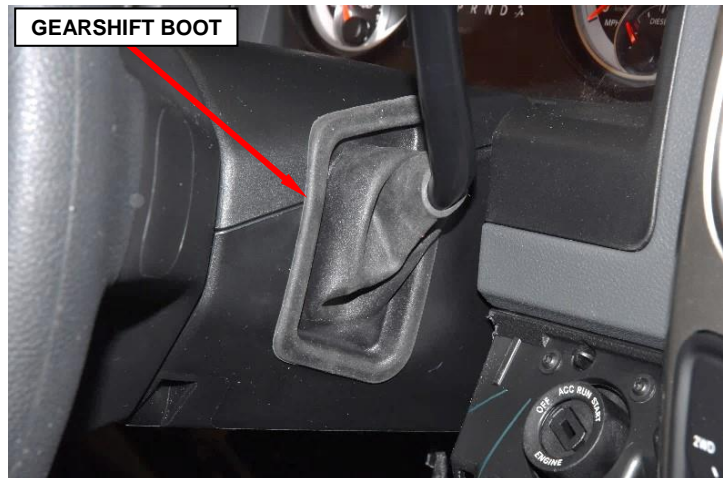
**Figure 5 – Gearshift Boot**

9. Using a trim stick, disengage the gearshift boot from the steering column shrouds (Figure 5).

40. Attach the shift boot to the upper and lower steering column shrouds (Figure 5).

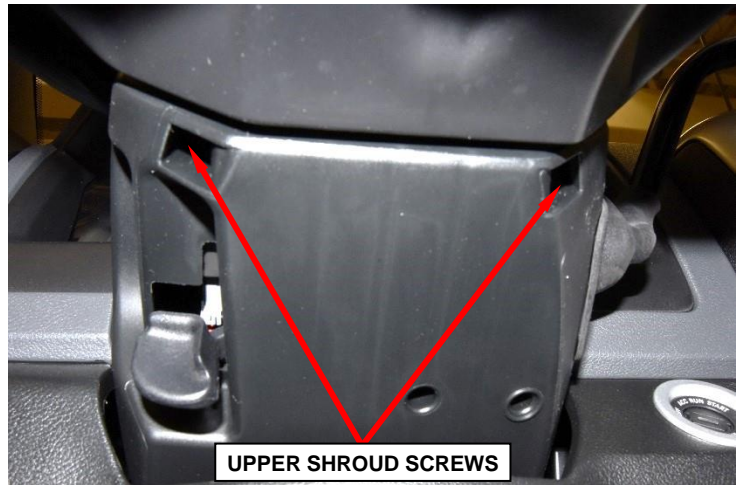
**Figure 6 – Upper Shroud Screws**

10. Remove and save the two T20 star-head screws that attach the upper steering column shroud to the lower steering column shroud. The screws are located on the underside of the lower steering column shroud (Figure 6).

39. Install the two T20 star-head screws that attach the lower steering column shroud to the upper shroud. Tighten the screws to 1.3 N·m (12 in. lbs.) (Figure 6).

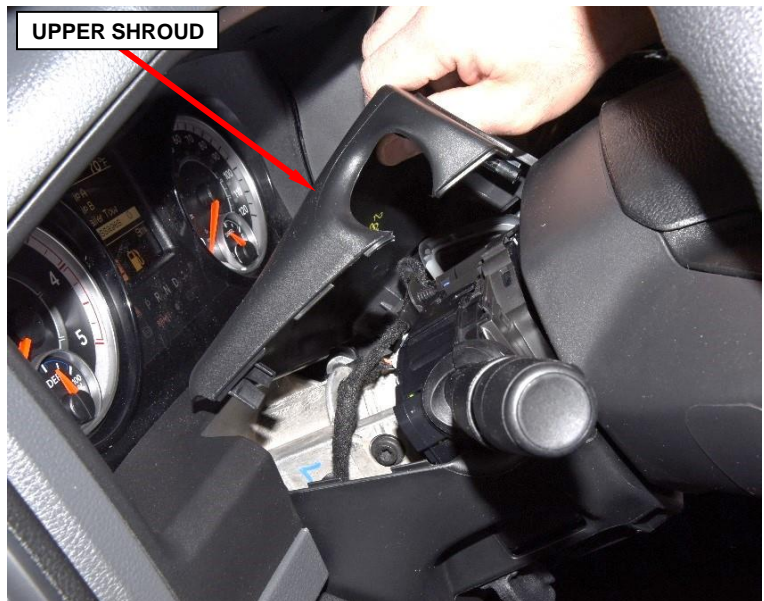
**Figure 7 – Steering Column Upper Shroud**

11. Remove and save the upper steering column shroud by pushing gently inward and upward on both sides of the upper shroud just above the joint line to the lower shroud to release the snap features that secure the shrouds together (Figure 7).

37. Install the T20 star-head screw that retains the lower shroud to the steering column. Tighten the screw to 2.3 N·m (20 in. lbs.) (Figure 8).
38. Attach the upper steering column shroud by pushing gently inward on both sides of the upper shroud just above the joint line to the lower shroud and attach to the lower shroud using the snap features (Figure 7).

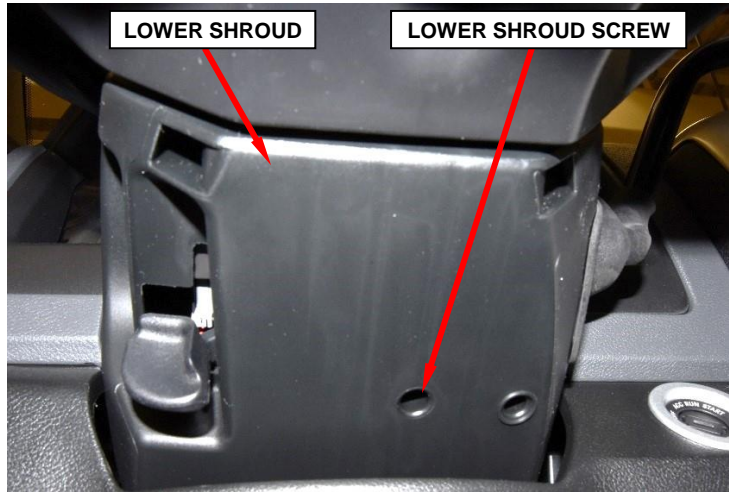
**Figure 8 – Steering Column Lower Shroud**

12. Remove and save the T20 star-head screw that retains the lower shroud to the steering column (Figure 8).

13. Carefully move the lower shroud to clear the steering column tilt lever then remove and save the lower shroud. (Figure 8).

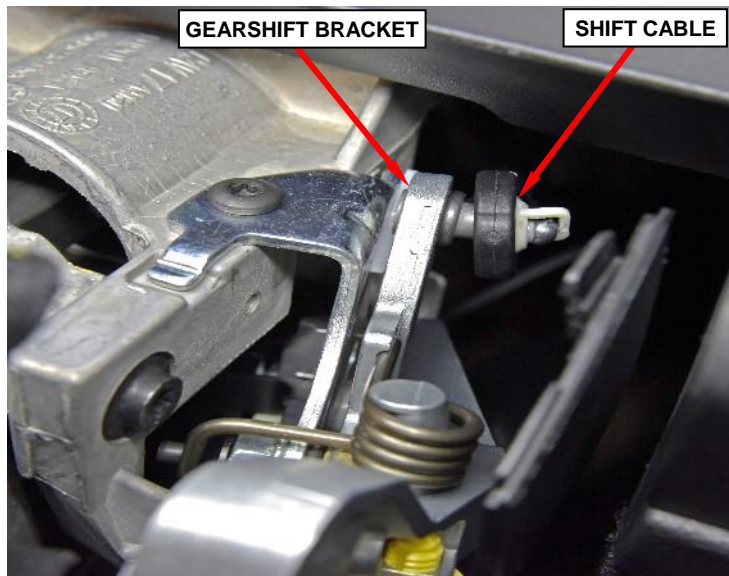
**Figure 9 – Shift Cable**

14. Disconnect the shift cable from the gearshift bracket (Figure 9).

35. Connect the shift cable to the gearshift bracket (Figure 9).
36. Carefully position the lower shroud over the steering column tilt lever and onto the steering column (Figure 8).

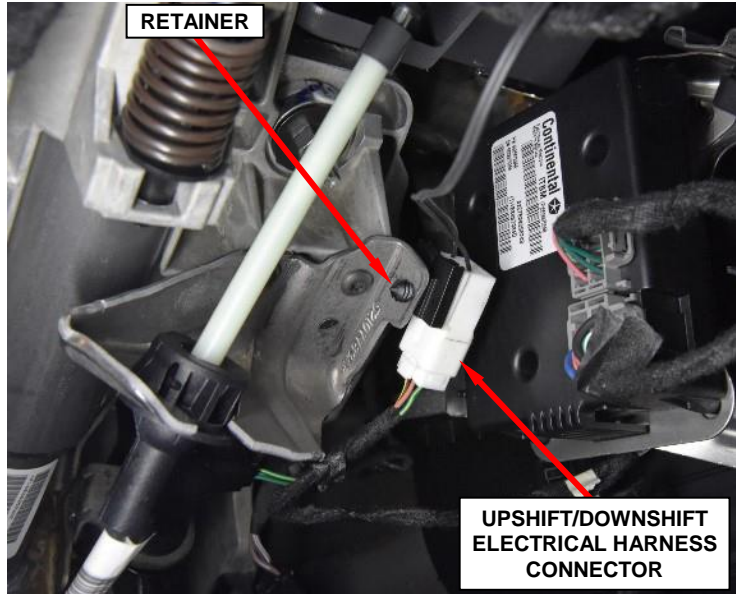
**Figure 10 – Upshift/Downshift Electrical Harness**

15. Disconnect the upshift/downshift electrical harness connector (Figure 10).

16. Release the upshift/downshift electrical harness connector retainer (Figure 10).

32. Connect the BTSI electrical harness connector (Figure 11).
33. Install the upshift/downshift electrical harness connector retainer (Figure 10).
34. Connect the upshift/downshift electrical harness connector (Figure 10).

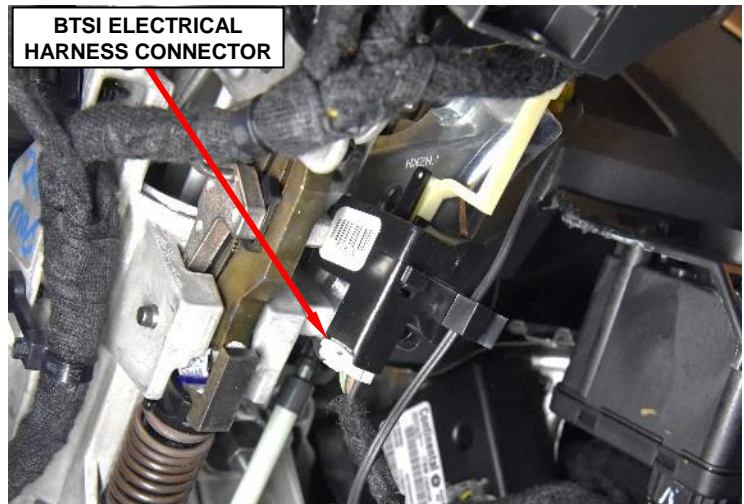
**Figure 11 – BTSI Electrical Harness**

17. Disconnect the BTSI electrical harness connector (Figure 11).

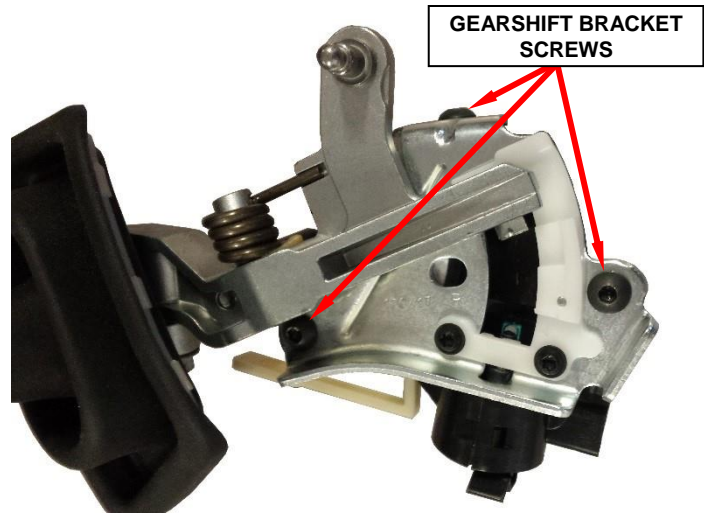
**Figure 12 – Gearshift Bracket / BTSI Assembly Screws**

18. Remove and save the three T27 star-head screws securing the gearshift bracket / BTSI assembly to the steering column (Figure 12).

31. Install the three T27 star-head screws securing the gearshift bracket / BTSI assembly to the steering column. Tighten the screws to 10 N·m (89 in. lbs.) (Figure 12).

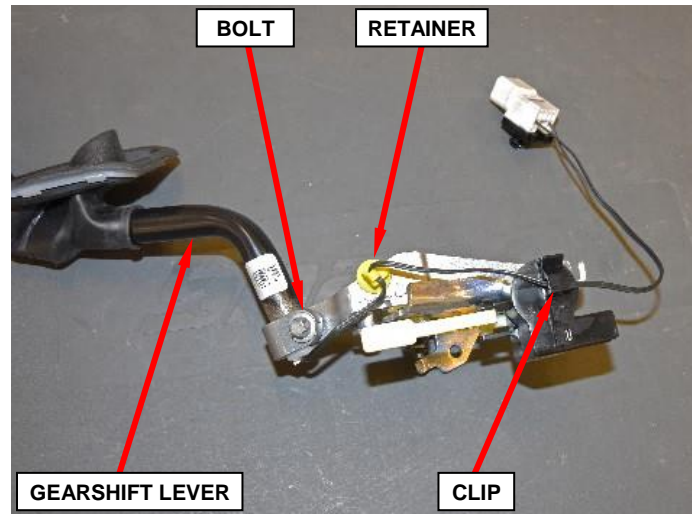
**Figure 13 – Gearshift Lever**

19. Remove the gearshift bracket / BTSI assembly with shift lever from the steering column then transfer to bench (Figure 13).

20. Remove the upshift/downshift electrical harness from the retaining clip (Figure 13).

21. Release the upshift/downshift electrical harness retainer from the gearshift bracket / BTSI assembly (Figure 13).

22. Remove and save the E10 star-head pinch bolt securing the shift lever to the gearshift bracket / BTSI assembly (Figure 13).

23. Remove and save the gearshift lever from the gearshift bracket / BTSI assembly (Figure 13).

27. Install the E10 star-head pinch bolt securing the shift lever to the gearshift bracket / BTSI assembly. Tighten the pinch bolt to 11 N·m (97 in. lbs.) (Figure 13). Ensure shift lever is properly seated and not loose after tightening.
28. Attach the upshift/downshift electrical harness retainer to the gearshift bracket / BTSI assembly (Figure 13).
29. Install the upshift/downshift electrical harness to the retaining clip (Figure 13).

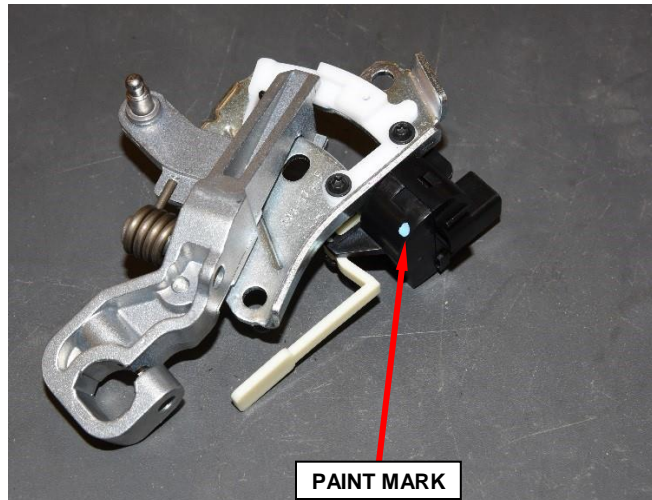
**Figure 14 – Gearshift Bracket / BTSI Assembly Paint Mark Verification**

24. Discard the old gearshift bracket / BTSI assembly.
25. Verify the **new** gearshift bracket / BTSI assembly to be used has a paint mark on the BTSI solenoid (Figure 14).
26. Install the gearshift lever to the **new** gearshift bracket / BTSI assembly and ensure the gearshift lever is fully inserted into the gearshift bracket (Figure 15).

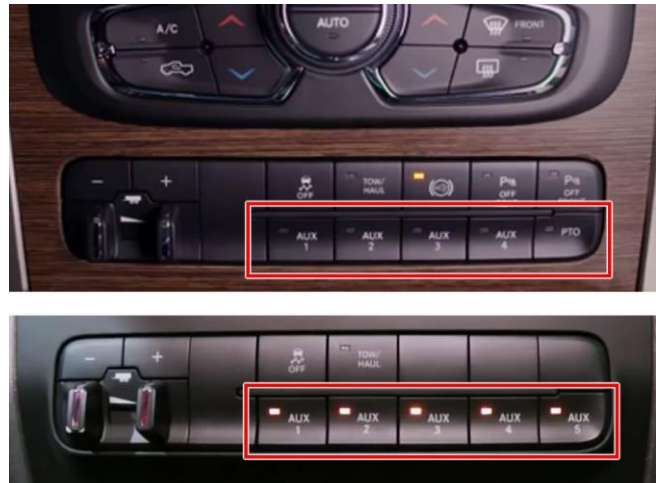
**Figure 16 – Auxiliary Switches**

**NOTE:** If the vehicle is equipped with instrument panel mounted auxiliary switches located below the HVAC controls (AUX 1 through AUX 5 or PTO), the customer preferred switch settings may be erased during reprogramming of the BCM. It is advisable to record the customer preferred auxiliary switch settings prior to BCM reprogramming so that the customer preferred switch settings are not lost during the BCM reprogramming process.
