Revision II August 2018

Dealer Service Instructions for:

# Safety Recall T79 / NHTSA 17V-821 Brake Transmission Shift Interlock

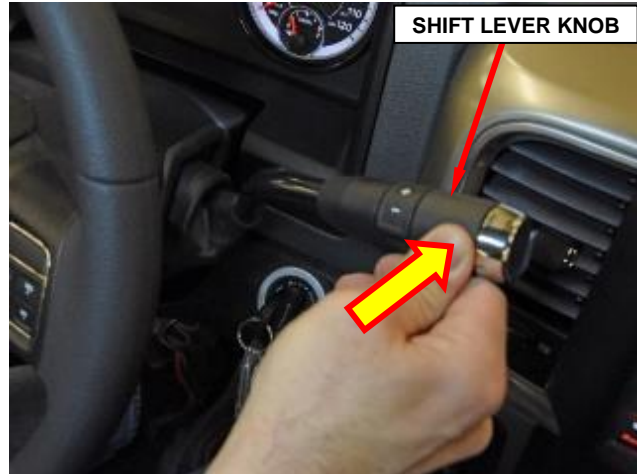
**Figure 1 – Push Lightly On Shift Lever Knob Toward Instrument Panel To Feel BTSI Solenoid Pin Movement**

5. Place your hand on the shift lever knob and push lightly on the shift lever toward the instrument panel. This will allow you to feel a click sensation from BTSI solenoid pin movement when the brake pedal is applied and released (Figure 1).

9. After five seconds of holding the brake pedal down, release the brake pedal while both listening and feeling for the click of the BTSI pin movement. The sound and feel of the BTSI pin movement should occur immediately within 0-2 seconds upon release of the brake pedal.

➤ If the BTSI pin could be heard and felt moving within 0-2 seconds, then the BTSI inspection process is complete and the gearshift bracket / BTSI assembly does not need to be replaced. Place the ignition switch in the “OFF” position then proceed to **Section C. Reprogram Body Control Module (BCM)**.

➤ If the BTSI pin could **not** be heard and felt moving within 0-2 seconds, then continue with **Step 10**.
