Dealer Service Instructions for:

Safety Recall T79 / NHTSA 17V-821 Brake Transmission Shift Interlock

2009 - 2017	(DS)	RAM 1500 Pickup
2010 - 2017	(DJ)	RAM 2500 Pickup
2010 - 2017	(D2)	RAM 3500 Pickup
2011 - 2017	(DD)	RAM 3500 Chassis Cab
2016 - 2017	(DF)	RAM 3500 10K GVWR Chassis Cab
2011 - 2017	(DP)	RAM 4500/5500 Chassis Cab

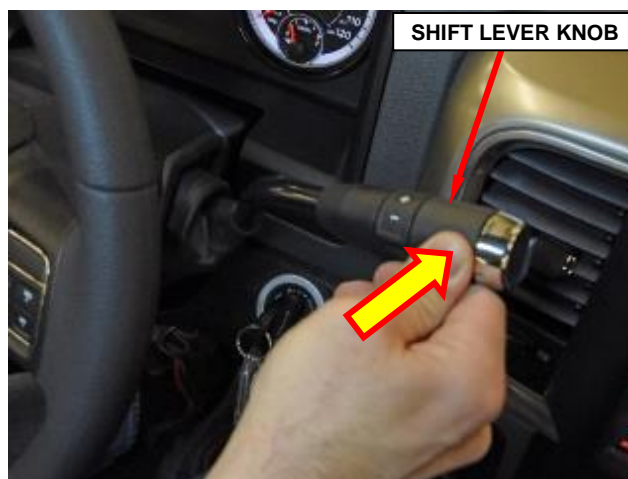
Figure 1 – Push Lightly On Shift Lever Knob Toward Instrument Panel To Feel BTSI Solenoid Pin Movement

5. Place your hand on the shift lever knob and push lightly on the shift lever toward the instrument panel. This will allow you to feel a click sensation from BTSI solenoid pin movement when the brake pedal is applied and released (Figure 1).

6. Listen for a click sound from the BTSI solenoid pin movement while also feeling for the corresponding click sensation in the shift lever when the brake is applied and released.

9. After five seconds of holding the brake pedal down, release the brake pedal while both listening and feeling for the click of the BTSI pin movement. The sound and feel of the BTSI pin movement should occur immediately within 0-2 seconds upon release of the brake pedal.

- If the BTSI pin could be heard and felt moving within 0-2 seconds, then the BTSI inspection process is complete and the gearshift bracket / BTSI assembly does not need to be replaced. Place the ignition switch in the “OFF” position then proceed to **Section C. Reprogram Body Control Module (BCM)**.

- If the BTSI pin could **not** be heard and felt moving within 0-2 seconds, then continue with **Step 10**.
