Revised March 2018

Dealer Service Instructions for:

## **Safety Recall T79 / NHTSA 17V-821 Brake Transmission Shift Interlock**

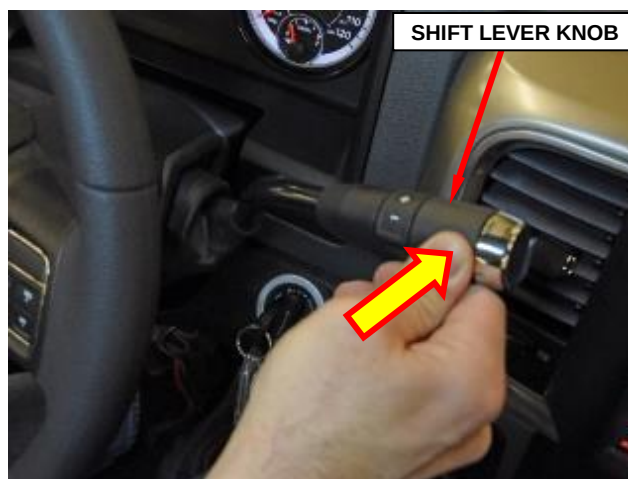
**Figure 1 – Push Lightly On Shift Lever Knob Toward Instrument Panel To Feel BTSI Solenoid Pin Movement**

5. Place your hand on the shift lever knob and push lightly on the shift lever toward the instrument panel. This will allow you to feel a click sensation from BTSI solenoid pin movement when the brake pedal is applied and released (Figure 1).

6. Listen for a click sound from the BTSI solenoid pin movement while also feeling for the corresponding click sensation in the shift lever when the brake is applied and released.
