Compliance Recall Code: 69T7

Subject	Head Curtain Airbags	
Release Date	January 05, 2018	
Affected Vehicles	U.S.A. : Certain 2018 MY Audi A5 Coupe	
	Check Campaigns/Actions screen in Elsa on the day of repair to verify that a VIN qualifies for repair under this action. Elsa is the <u>only</u> valid campaign inquiry & verification source.	
	✓ Campaign status must show "open."	
	✓ If Elsa shows other open action(s), inform your customer so that the work can also be completed at the same time the vehicle is in the workshop for this campaign.	
Problem Description	A head curtain airbag may not unfold properly from the A-pillar during deployment. In a crash where the head curtain airbag deploys, this may result in reduced airbag protection and could increase the risk of injury to vehicle occupants. This makes the head curtain airbags noncompliant with Federal Motor Vehicle Safety Standard No. 226 – Ejection Mitigation.	
Corrective Action	Remove excess fabric from the head curtain airbags, along with the paper sleeve on the upper part of the A-pillar.

Subject: Compliance Recall 69T7 – Head Curtain Airbags Certain 2018 Model Year Audi A5 Coupe

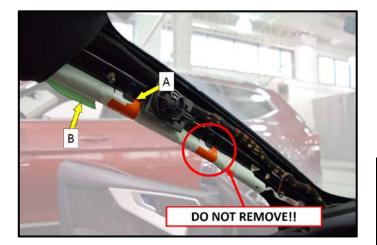
- Check for presence of tape <A> and excess material .
 - If tape <A> and excess material are <u>not</u> present, proceed to Section C.
 - If tape <A> and /or excess material
 are present, proceed to the next step.

• Remove and discard clip <A> and tape from the head curtain airbag.

- Do not cut the airbag material when removing tape .
- All of the tape must be removed from the head curtain airbag.

- The tape is perforated and should be able to be removed without using any tools.
- If the tape cannot be torn, used curved tip scissors to cut off the tape.
- Pull the headliner down slightly and place a clean folded shop rag <circle> between the roof and the headliner as shown.
- Pull the head curtain airbag material out slightly <arrow>.
