Product Safety Recall

17009 Front Passenger Air Bag Inflator

Reference Number: N162017009

Release Date: December 2017

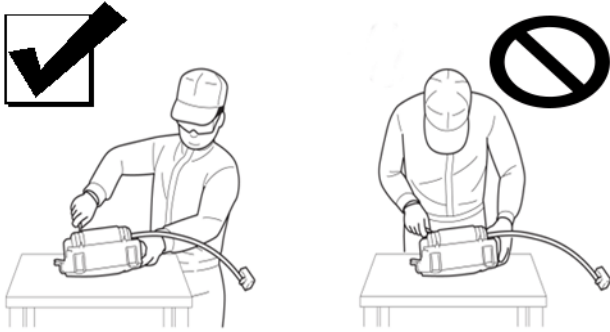
4751076

Warning: Confirm the stopper plate to inflator fitment is correct. *DO NOT* pinch the harness between the inflator and the stopper plate.

Warning: When working with the airbag module, avoid standing directly in front of the parts

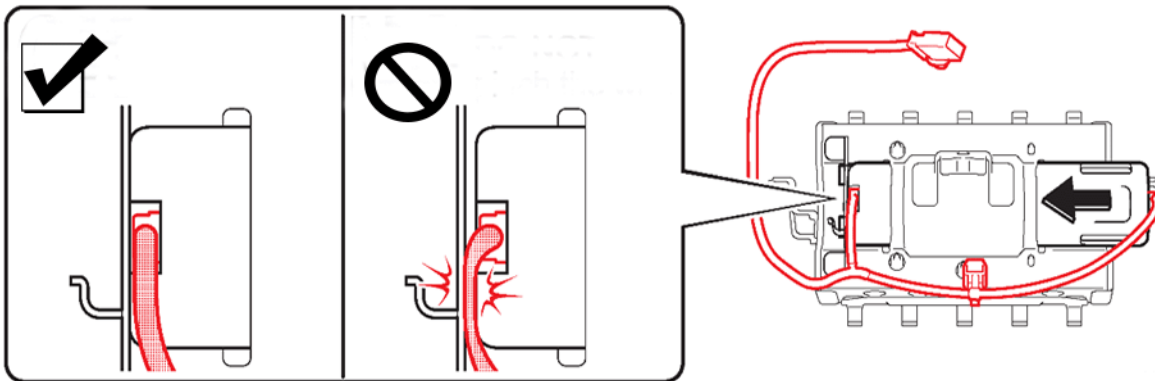
4751080

Important: Make sure that the inflator is oriented correctly as shown in the illustration, not upside down. If the passenger airbag inflator is upside down, it will not be able to be fully inserted.

6. Insert the inflator fully with the correct orientation as shown. DO NOT pinch the wire.

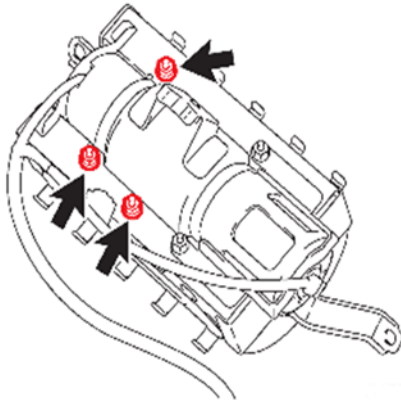
4751083

Important: If any gap exists, the aligned flats may move apart, resulting in failure in normal deployment of the airbag.

8. Remove the 3 remaining old self-locking nuts and install temporarily 3 NEW self-locking nuts by hand. Store the removed self-locking nuts in a replacement part box or the like.
9. Push the inflator and plate towards the position determining plate to eliminate any gap.

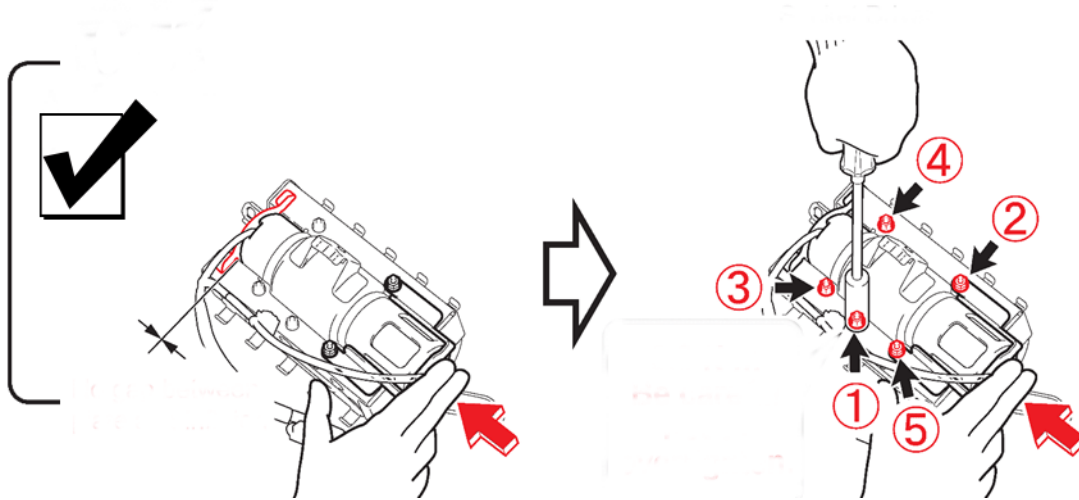
4751085

Important: The tightening torque is low (3.9 N·m). Use of an air ratchet wrench or tightening strongly with a T-handle wrench or a ratchet handle may cause deformation of the stud bolt.

10. Tighten 5 nuts evenly in several increments in the order shown above using a socket driver while pushing the inflator and plate. (You will encounter some resistance during tightening because these nuts are self-locking nuts.). Torque: 3.9 N*m (40 kgf*cm, 35 in.*lbf).
11. Install the harness clip to the center stud after all 5 nuts have been torqued.
