Product Safety Recall

17009 Front Passenger Air Bag Inflator

Reference Number: N162017009

Release Date: January 2018

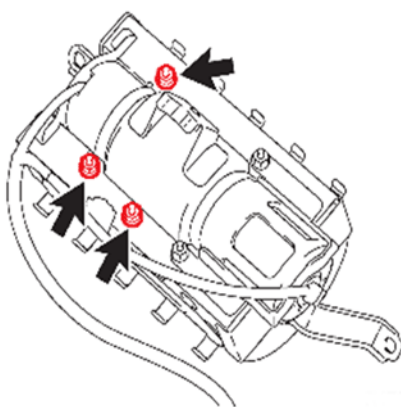
4751083

Important: If any gap exists, the aligned flats may move apart, resulting in failure in normal deployment of the airbag.

8. Remove the 3 remaining old self-locking nuts and install temporarily 3 **NEW** self-locking nuts by hand. Store the removed self-locking nuts in a replacement part box or the like.
9. Push the inflator and plate towards the position determining plate to eliminate any gap.

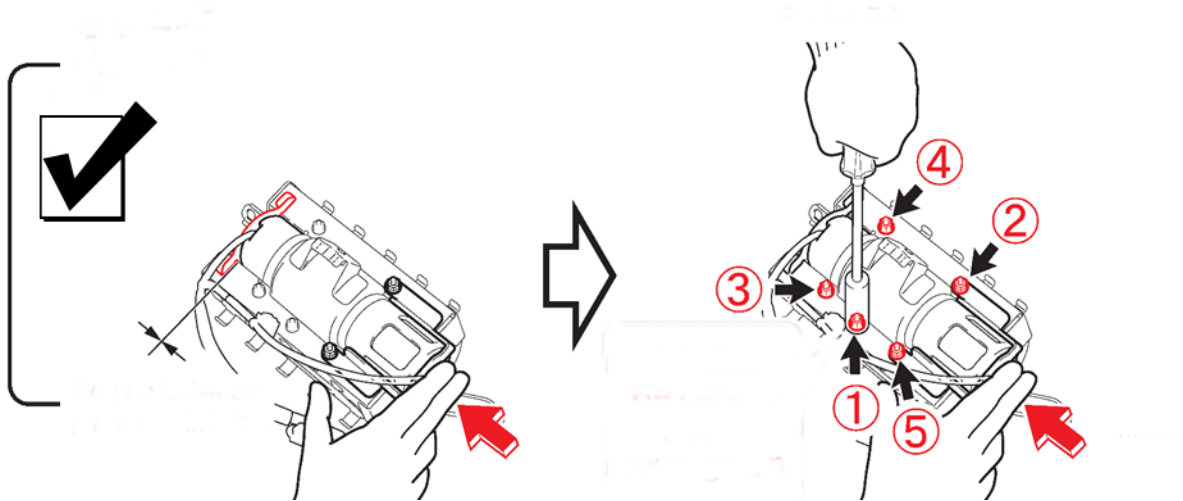
4751085

Important: The tightening torque is low (3.9 N·m). Use of an air ratchet wrench or tightening strongly with a T-handle wrench or a ratchet handle may cause deformation of the stud bolt.

10. Tighten 5 nuts evenly in several increments in the order shown above using a socket driver while pushing the inflator and plate. (You will encounter some resistance during tightening because these nuts are self-locking nuts.). Torque: 3.9 N·m (40 kgf·cm, 35 in.·lbf).
11. Install the harness clip to the center stud after all 5 nuts have been torqued.
