Product Safety Recall

17036 Passenger Presence System

Reference Number: N162080281

Release Date: March 2018

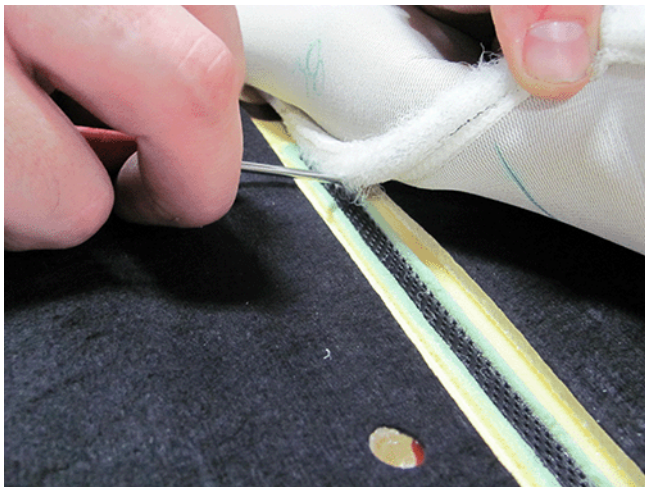
Note: Use a small flat blade screw driver to separate the seat cover hook and loop fastener strips from the seat foam fasteners. Do not pull the two components apart, the seat cushion may be damaged. If the cover fastener strips pull out of foam, the seat cover will not attach to seat properly, replace the cushion pad with a new cushion.

- Turn Ignition to the “OFF” position. Remove the passenger seat cushion trim cover. Refer to *Seat Cushion Trim Cover and Pad Replacement* in SI.
