17085 Electric Power Steering Connector Cable Seal Not Seated

Reference Number: N162075010 Release Date: February 2017

Condition	General Motors has decided that a defect, which relates to motor vehicle safety, exists in certain 2017				
	model year Buick LaCrosse vehicles. Some of these vehicles have a condition in which the cable seal				
	on one or both of the electric power steering (EPS) connectors may not be properly seated. If the seal				
	is not properly seated on a connector, water could enter and corrode the connector, or create a high				
	resistance condition capable of melting the connector, potentially resulting in a loss of EPS. If power				
	steering assist is lost, manual steering functionality is retained but would require an increased steering				
	effort, particularly at lower speeds, increasing the risk of a crash.				
Correction	Verify the seals are fully seated and secure the seal to the affected connectors.

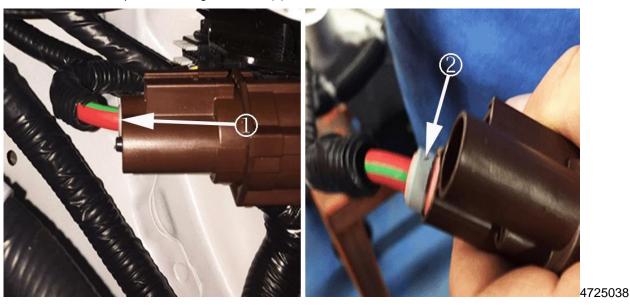
2. Locate the electronic power steering connector (1).

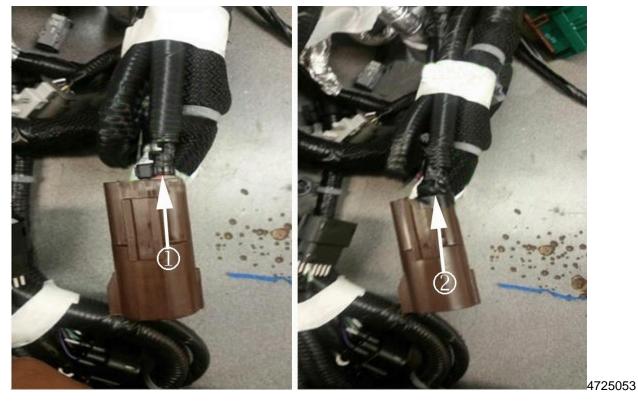
- 3. Verify the wire seal is fully seated (1).
 - If the wire seal is fully seated, proceed to the next step.
 - If the wire seal is NOT fully seated (2), re-seat the wire seal with a trim tool and proceed to the next step.

- 4. Install a tie strap (1) around the wire at the base of the connector to hold the seal in the connector.
- 5. Wrap the wire and tie strap in vinyl electrical tape (2).
- 6. Remove fender covers and close hood.
- 7. Raise and support the vehicle. Refer to Lifting and Jacking the Vehicle in SI.

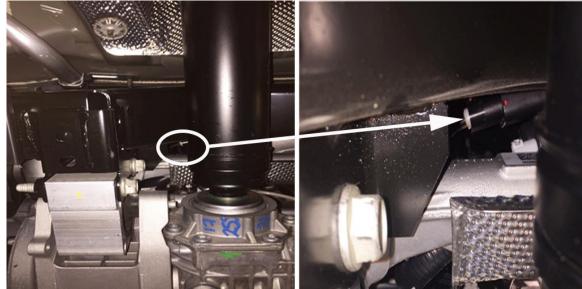
4725063

AWD

8. Locate the K43 power steering control module X1 connector.

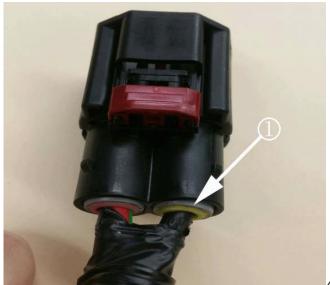
4725069

- 9. Verify the yellow wire seal is fully seated (1).
 - If the yellow wire seal is fully seated, proceed to the next step.
