Product Safety Recall

17085 Electric Power Steering Connector Cable Seal Not Seated

Reference Number: N162075010

Release Date: March 2017

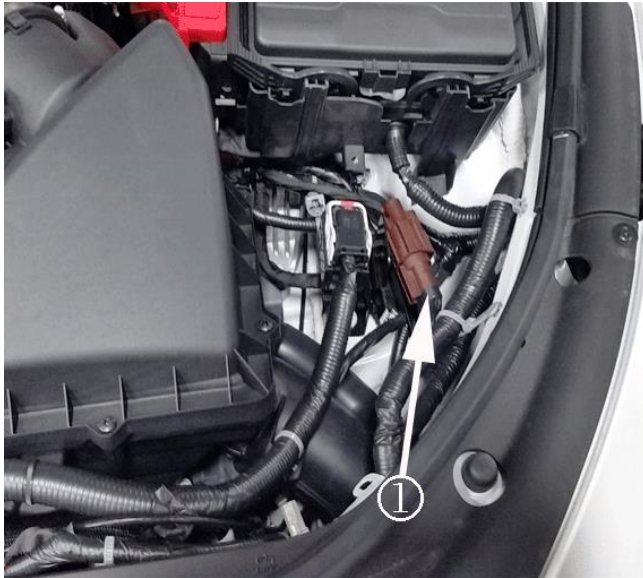
4725030

2. Locate the electronic power steering connector (1).

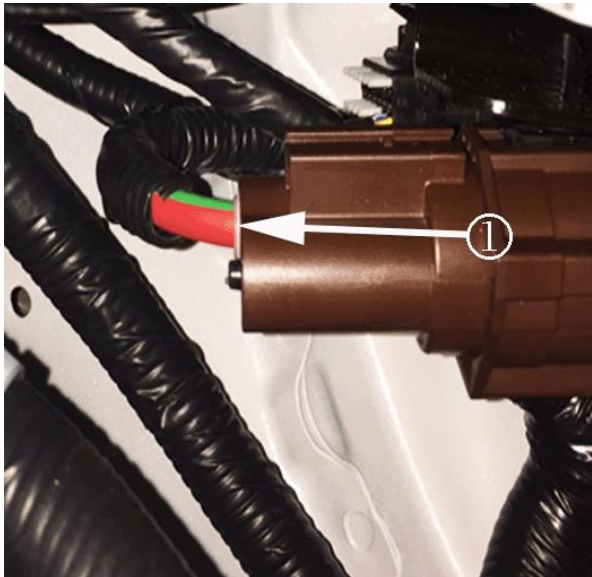
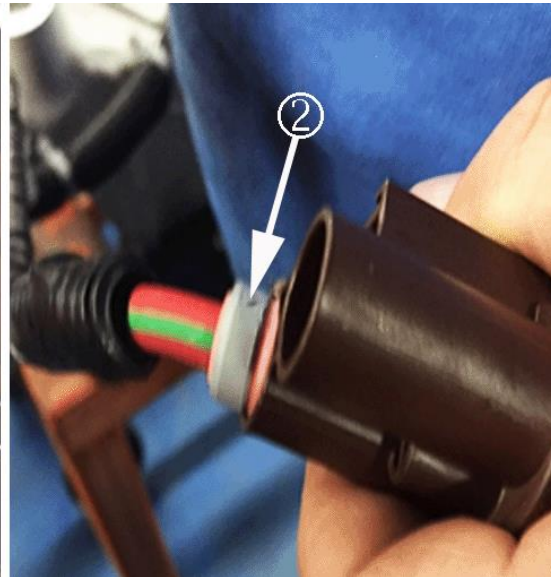
4725038

3. Verify the wire seal is fully seated (1).
 - If the wire seal is fully seated, proceed to the next step.
 - If the wire seal is NOT fully seated (2), re-seat the wire seal with a trim tool and proceed to the next step.

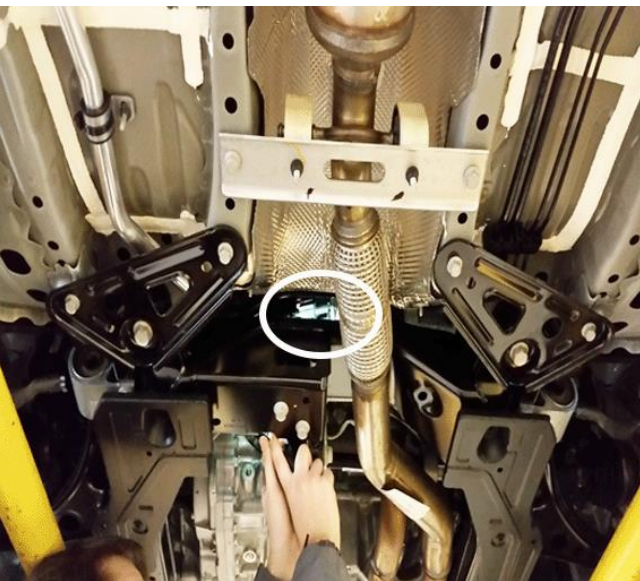
4725056

8. Locate the K43 power steering control module X1 connector.

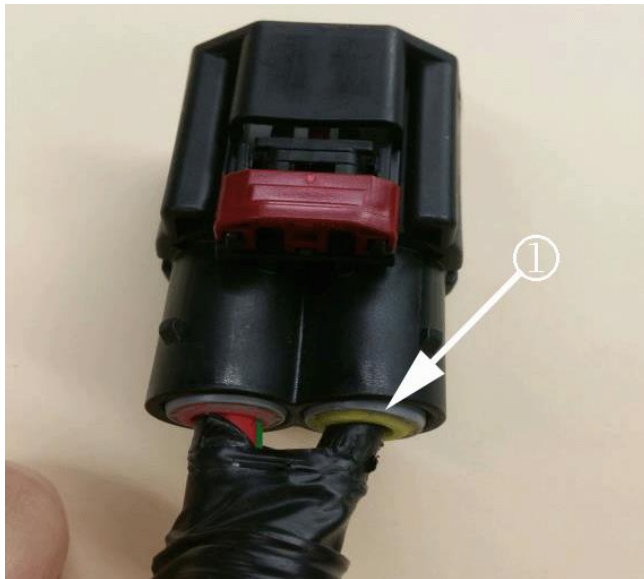
4725069

9. Verify the yellow wire seal is fully seated (1).
 - If the yellow wire seal is fully seated, proceed to the next step.

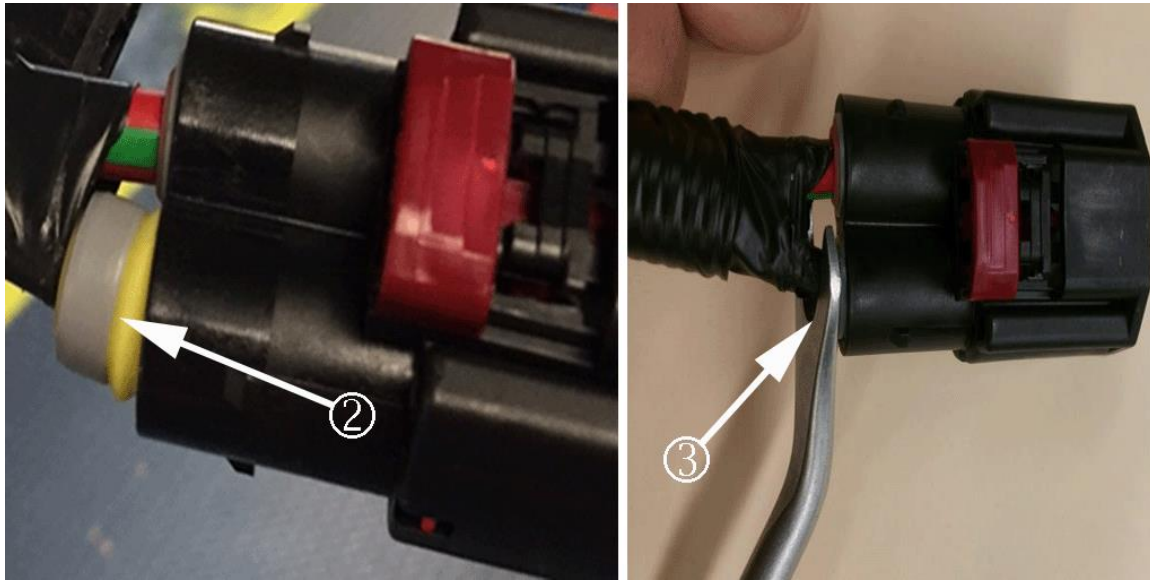
4725079

Note: A tie strap is NOT required for this connector.

- If the yellow wire seal is NOT fully seated (2), re-seat the yellow wire seal using a long trim tool (3) and proceed to the next step.
