# Product Safety Recall

## 17167 Loss of Power Steering Assist

**Reference Number:** A172093260

**Release Date:** August 2020  
**Revision:** 02

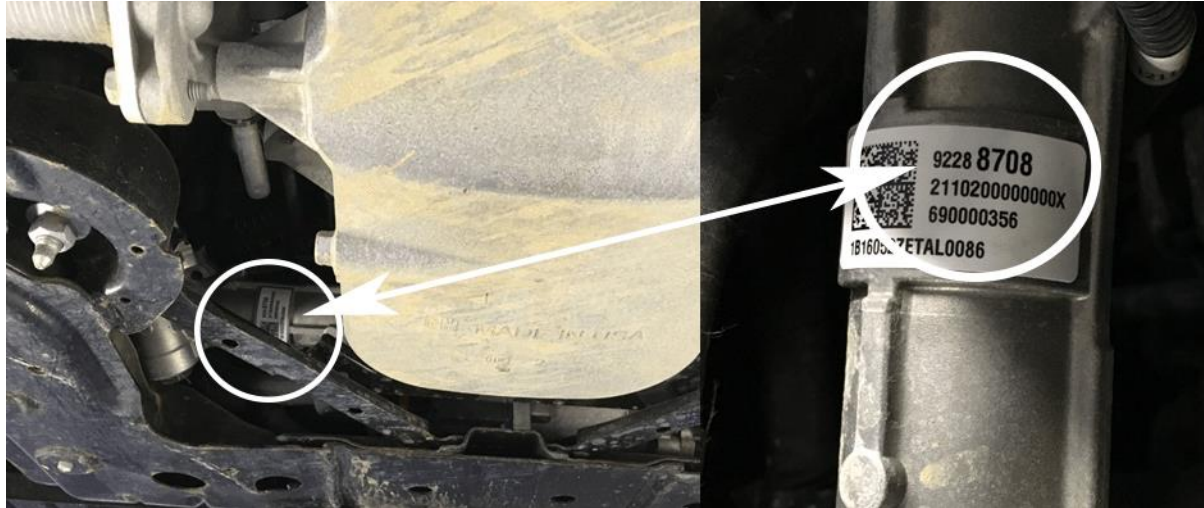
4780576

| <b>Condition</b> | General Motors has decided that a defect which relates to motor vehicle safety, exists in certain 2014-2016 model year Chevrolet Caprice Police Pursuit Vehicles (PPVs). These vehicles were associated with previous recall 16V160 (22010). Pursuant to that recall, and in order to remedy corrosion in the steering gear control units that could potentially lead to a loss of Electronic Power Steering (“EPS”) assistance while driving or idling, these vehicles were repaired with steering gear control units that had epoxy applied to critical areas on the steering gear control unit. Despite successful testing, the remedy failed to improve EPS failure rates in the impacted vehicles. If power steering is lost, manual steering functionality is retained but would require an increased steering effort, particularly at lower speeds, increasing the risk of a crash. |

1. Raise the vehicle and remove the front bumper fascia extension. Refer to *Front Bumper Fascia Extension Replacement* in SI.
2. Inspect the part number on the electric belt drive rack and pinion steering gear:
  - If the vehicle steering gear part number IS NOT 92289255, 92289251, or 92288914, replace the steering gear assembly. Proceed to step 3.
  - If the vehicle has steering gear part number 92289255, 92289251, or 92288914 already installed, **record the part number of the currently installed gear in your warranty claim.** Reinstall the front bumper fascia extension. Refer to *Front Bumper Fascia Extension Replacement* in SI.
3. Remove the Electric Belt Drive Rack and Pinion Steering Gear. Refer to *Electric Belt Drive Rack and Pinion Steering Gear Replacement* in SI.

**Note:** Use Loctite 272 on the front lower control arm nut and bolt when reinstalling.

4. Install the Electric Belt Drive Rack and Pinion Steering Gear. Refer to *Electric Belt Drive Rack and Pinion Steering Gear Replacement* in SI.
