Product Safety Recall

17168 Rear Suspension Adjust Link

Reference Number: N172095130

Release Date: May 2017

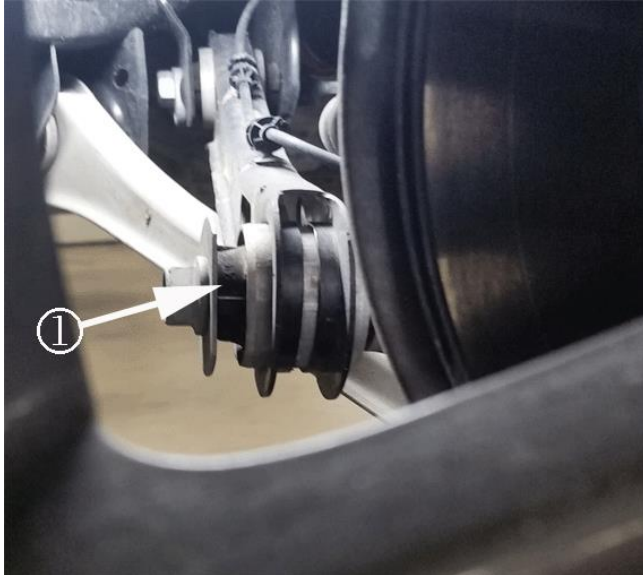
4779575

Driver side shown. Passenger side similar.

Note: The bushing may be visible through the spokes of the wheel. It is NOT necessary to remove the wheel to inspect the bushing. An inspection mirror may be used to inspect the bushing if it is not visible through the spokes of the wheel.

2. Inspect the bushing (1) on the rear suspension adjust link at the left and right rear knuckles.

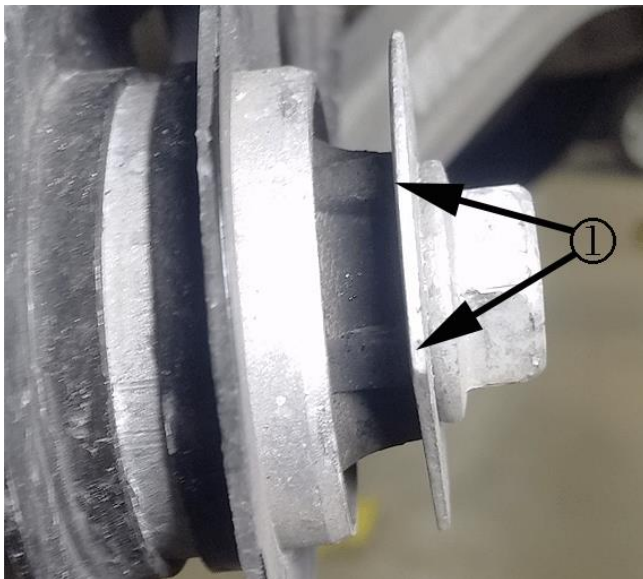
4779580

Note: The nubs may be in different clocking positions and it is necessary to inspect around the entire bushing.

3. Count the number of nubs (1) on the bushing.
 - If the bushing on the adjust link at the rear knuckle has 3 nubs, no further action is required.
 - If the bushing on the adjust link at the rear knuckle has 2 nubs, proceed to the next step.

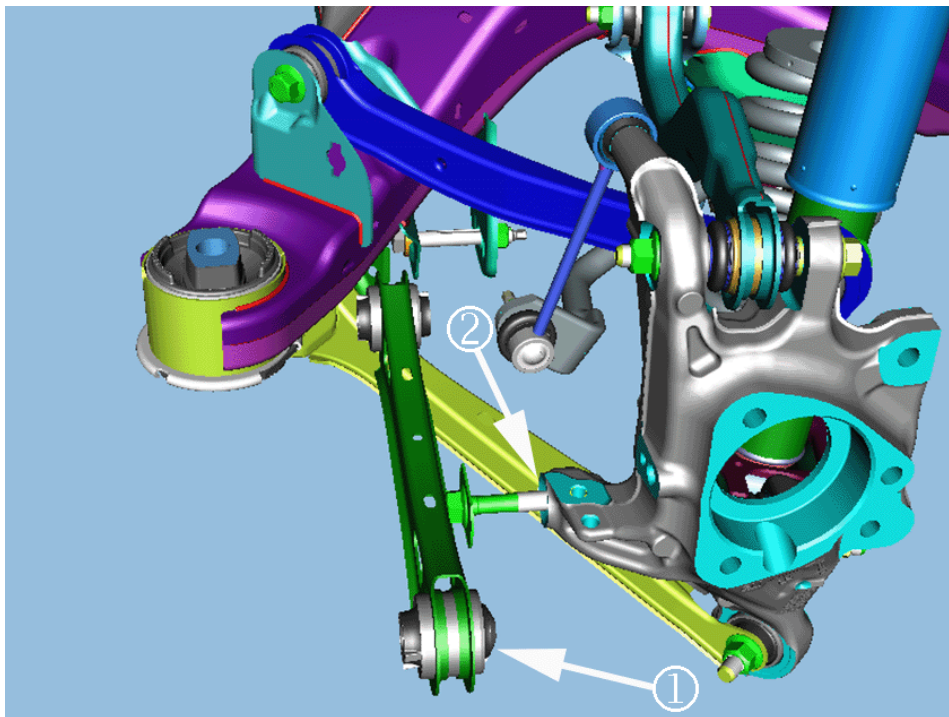
4779589

Caution: This vehicle is equipped with torque-to-yield or single use fasteners. Install a NEW torque-to-yield or single use fastener when installing this component. Failure to replace the torque-to-yield or single use fastener could cause damage to the vehicle or component.

Note: The rear suspension adjust link inner bolt can be reused. The rear suspension adjust link outer bolt MUST be replaced.

5. Reinstall the rear suspension adjust link ensuring the conical bushing (1) is mated with the rear knuckle (2). Refer to *Adjust Link Replacement* in SI.
6. Repeat steps 4 and 5 for other side of vehicle, if required.
7. Lower the vehicle. Refer to *Lifting and Jacking the Vehicle* in SI.
