17199 Front Passenger Airbag Deployment

Reference Number: N172097790 Release Date: August 2017

Revision: 01

Condition	General Motors has decided that certain 2016 - 2017 Chevrolet Spark vehicles may not comply with			
	Federal Motor Vehicle Safety Standard ("FMVSS") 208, and Canada Motor Vehicle Safety Standard			
	("CMVSS") 208 "Occupant Crash Protection." During air bag compliance testing using unbelted, out of			
	position 3-year-old and 6-year-old test dummies in the front passenger seating position, the dummy			
	mentation recorded axial neck force from the air bag's deployment greater than permitted by			
	FMVSS/CMVSS (TSD) 208 S22.4.2, S21.5.5, and S23.5.5.			
Correction	tion Dealers will replace the passenger air bag module with a new air bag module containing an air bag with			
	an additional, folded in flap intended to guide the trajectory of the air bag and reduce axial neck force			
	during deployment.

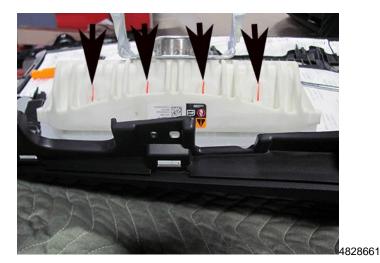
- Visually inspect all eight locking tabs, ensure the tabs are fully engaged.
- All eight tabs on the chute should be free to move after installation. If the tab is not free to move (binding) the tab needs to be fully seated.

- Using a red paint pen, mark each of the eight tabs as they are being verified for full engagement.
- Separate the instrument panel upper trim panel and airbag instrument panel module for deployment and disposal. Refer to Airbag Instrument Panel Module Replacement in SI.
