Product Safety Recall

17287 Frontal Airbag and Pretensioner Non Deploy

Reference Number: N172105680

Release Date: July 2017

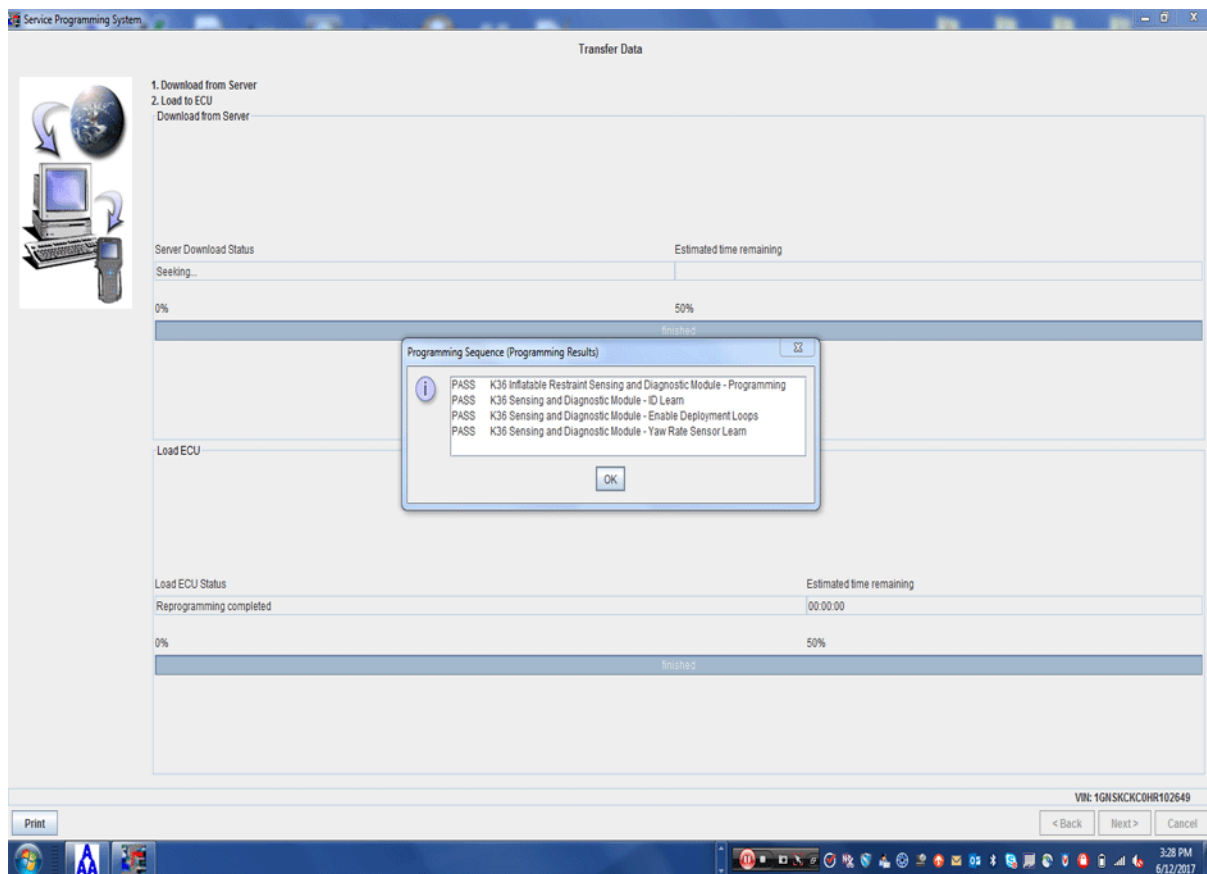
Important: The screen above should show all “PASS” or “SKIPPED” and/or PASS” if the programming event is successful. If ANY of the results show “FAILED”, proceed to “Unable to Program SDM” section.

2.1. To avoid warranty transaction rejections, the SPS Warranty Claim Code must be entered and Programming Result Screenshot attached to the GWM system when submitting this transaction.

Submit a screenshot of the “Programming Sequence (Programming Results)” including the VIN (lower right corner) in the screenshot as shown above along with the SPS Warranty Claim Code when submitting this transaction.
