K270/K370 Front Axle Sway Bar Links

Title	17KWE: K270/K370 Front Axle Sway Bar Links
Search Words	
Bulletin No.	17KWE
What's New Abstract	Safety Recall – The front axle sway bar links may be assembled incorrectly. Inspect for missing or incorrectly installed washers and install them correctly as needed.
Supplier	Kenworth
Description	The front axle sway bar links may be assembled incorrectly on certain vehicles.
Release Date	
Introduction	<p>Customer letters will be sent stating that parts will be available November 13.</p> <p>Kenworth Truck Company has decided that a defect, which relates to motor vehicle safety, exists in certain model year 2009-2018 K270 and K370 vehicles manufactured from January 14, 2009 through August 21, 2017. These vehicles may have a front axle sway bar link assembled incorrectly. A missing or incorrectly assembled hardened washer used to attach the front axle sway bar link to the frame rail can result in the sway bar link becoming detached from the frame rail.</p>

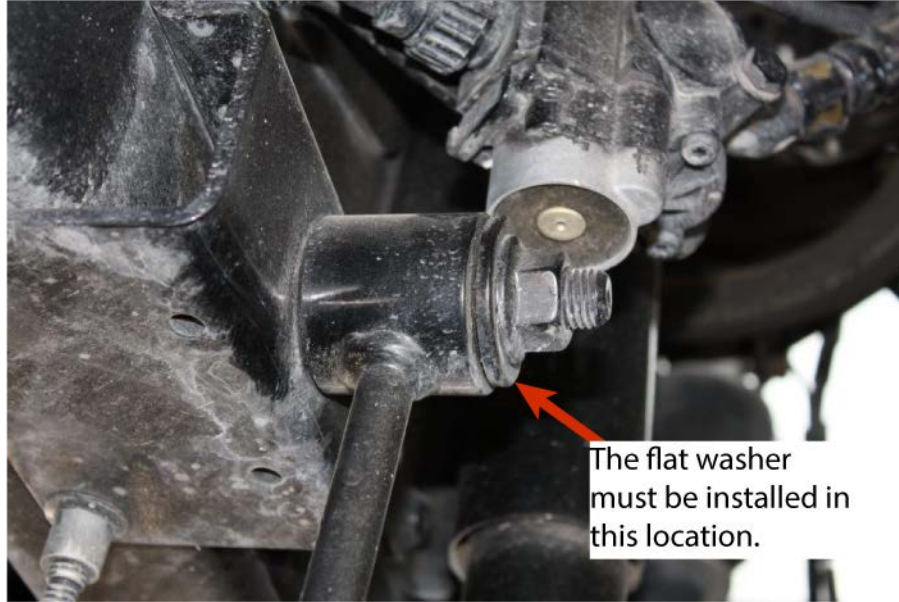
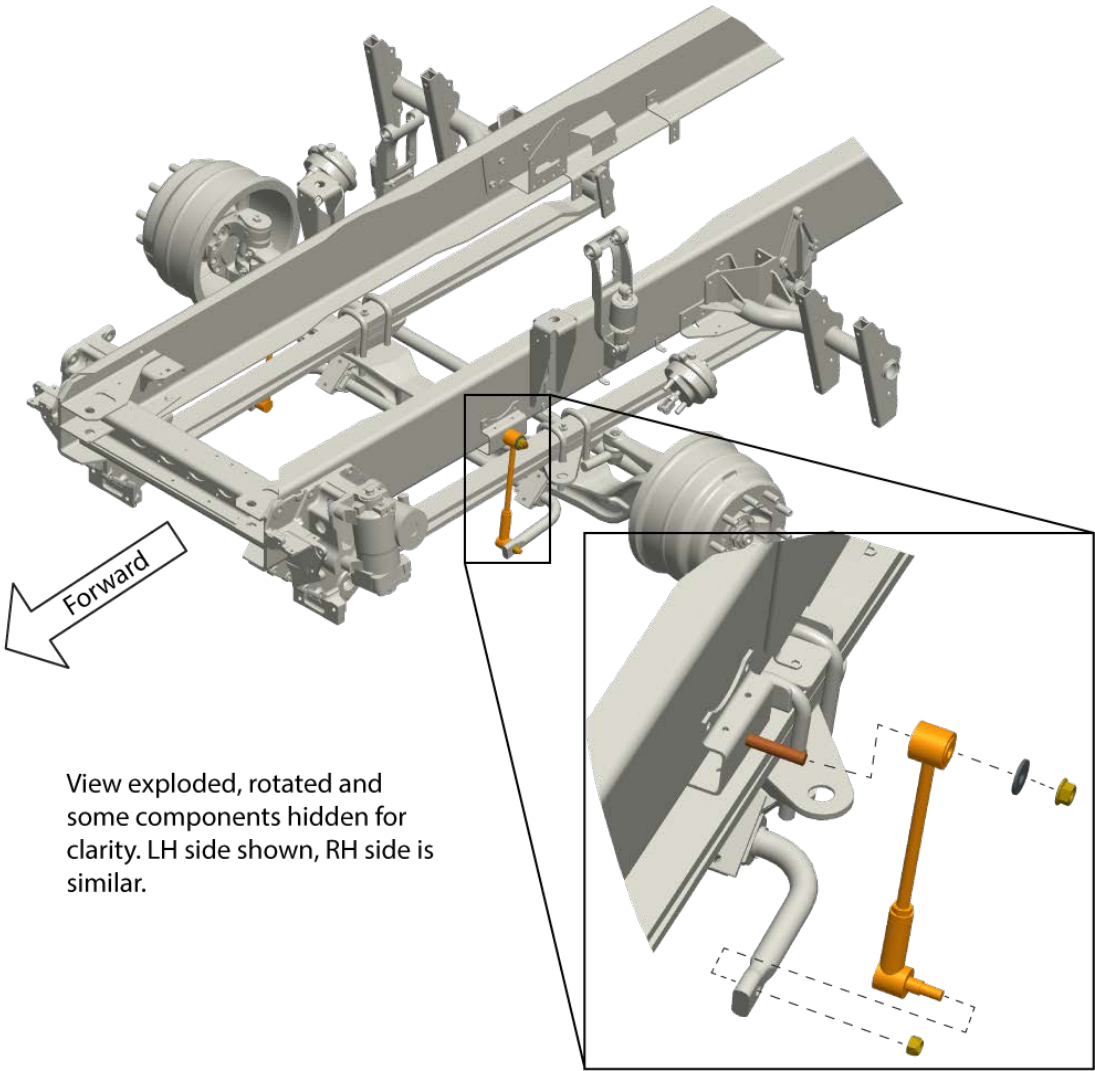
1. Inspect the upper sway bar link attachment on each side of the vehicle and confirm that the hardened flat washers are installed as shown in the images below.
2. Move the flat washer to the correct location, if needed.
3. If the hardened flat washer is missing, install the hardened flat washer in the correct location.

<p>View exploded, rotated and some components hidden for clarity. LH side shown, RH side is similar.</p>
<p>Shipping</p>	
<p>Freight</p>	
<p>Contact</p>	
<p>Attachments</p>	<p>Dealer\Chassis List Customer Letter</p>
