Product Safety Recall

17387 Driver Airbag Abnormal Deployment

Reference Number: N172103640

Release Date: October 2017
Revision: 01

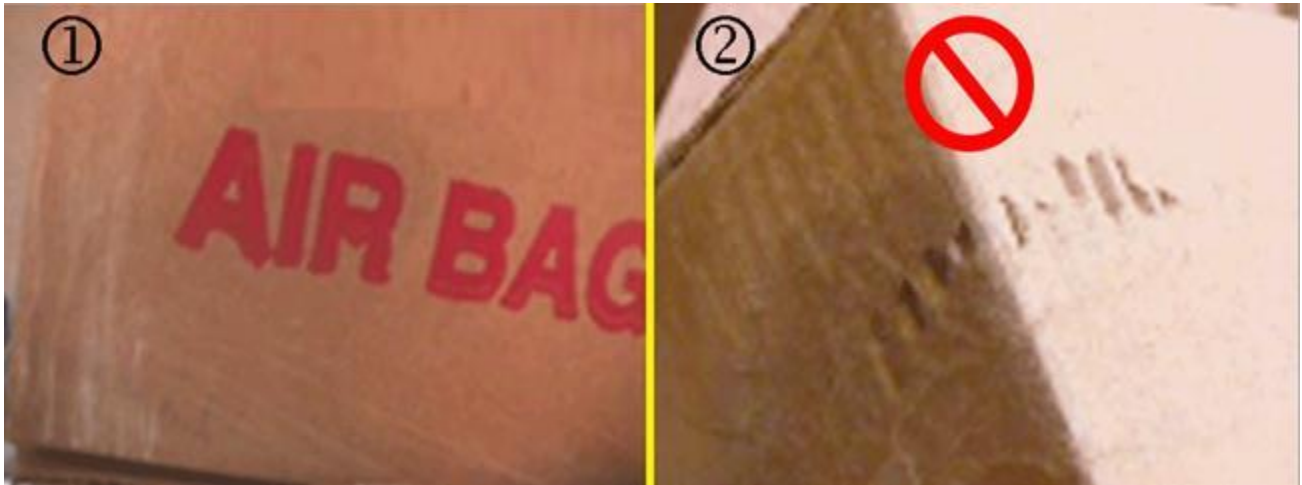
3961561

- **Abrasions:** Abrasions result from sliding the package against a rough surface (e.g. concrete floors). Major abrasions (2) are NOT acceptable. Note the flutes are visible.

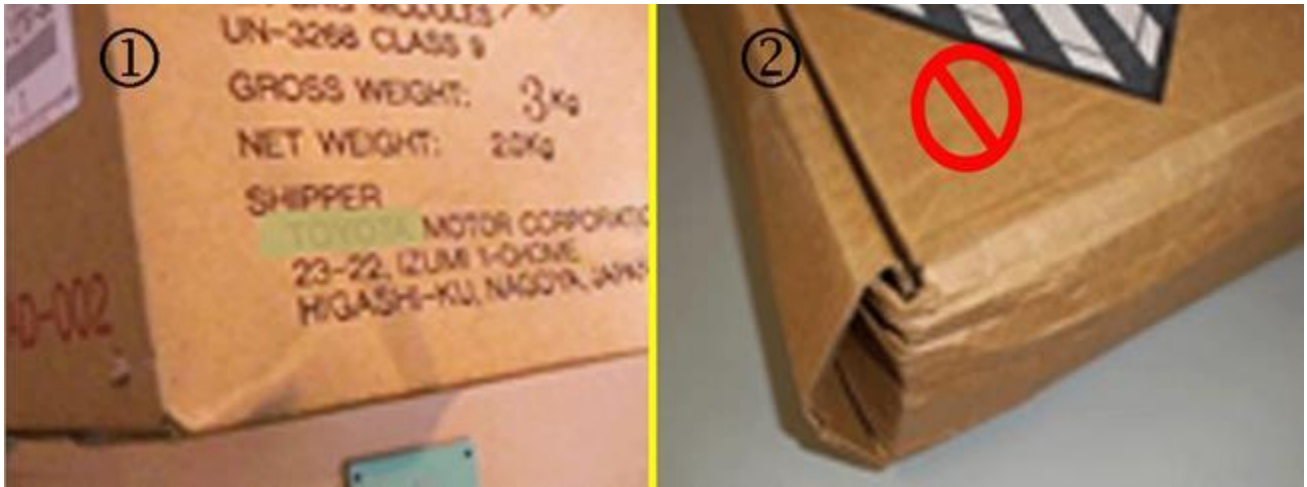
3961563

- **Compressions:** Compressions result from superimposed weights (e.g. stacked too high) or from dropping the packages. Small dimples (1) are acceptable.

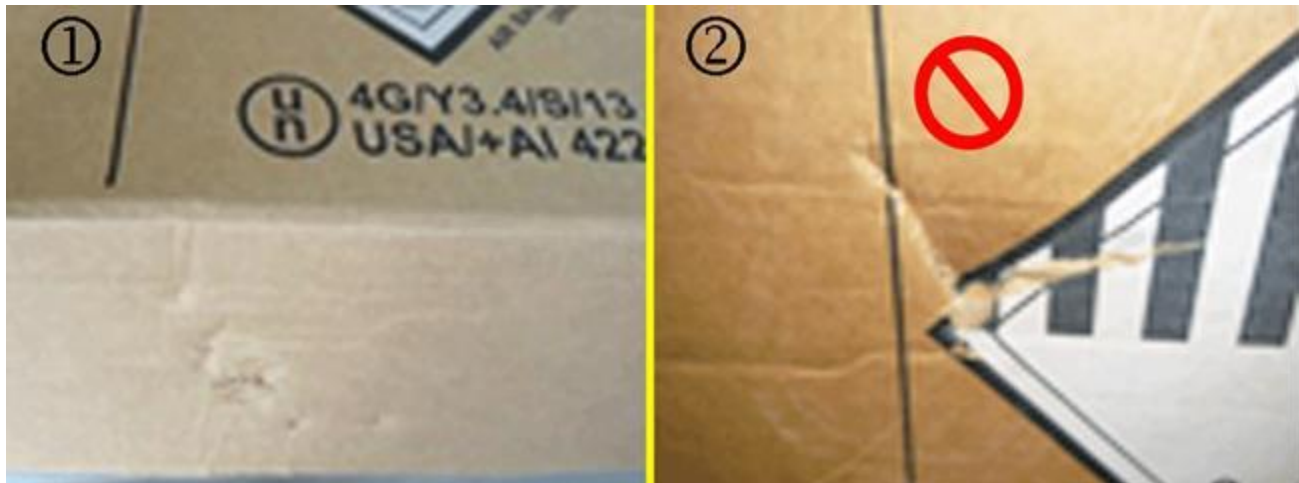
3961564

- **Dents:** Minor dents (1) occur through normal handling and picking (e.g. pulling from bin locations) and are acceptable. Major dents (2) result from impacts with others objects (e.g. pallet impacts).

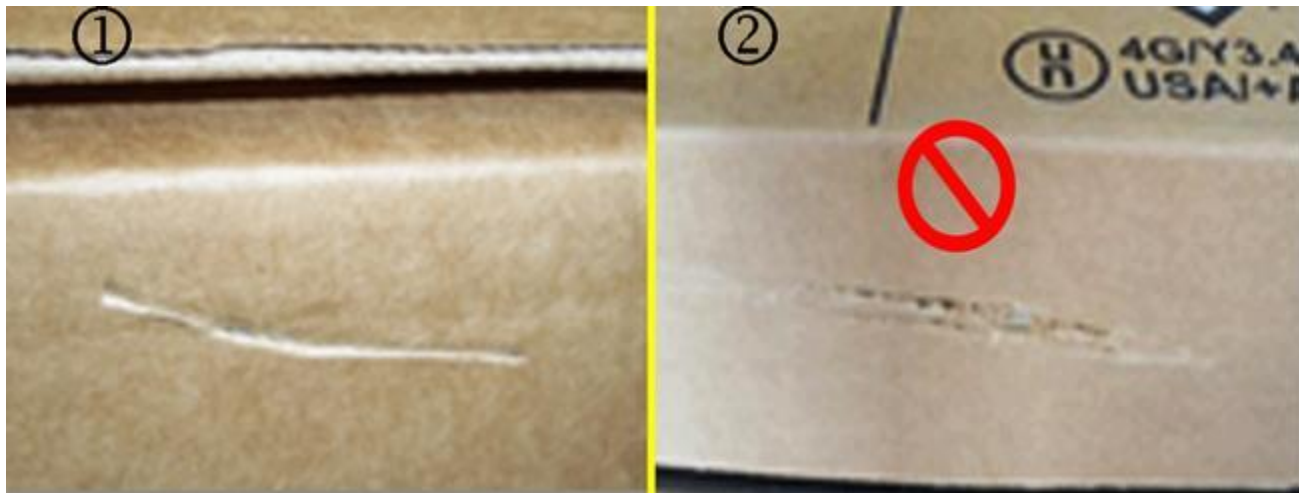
3961565

- **Incisions:** Minor incisions (1) are acceptable. Major incisions (2) (e.g. pallet box cut open with **utility** knife) are NOT acceptable.

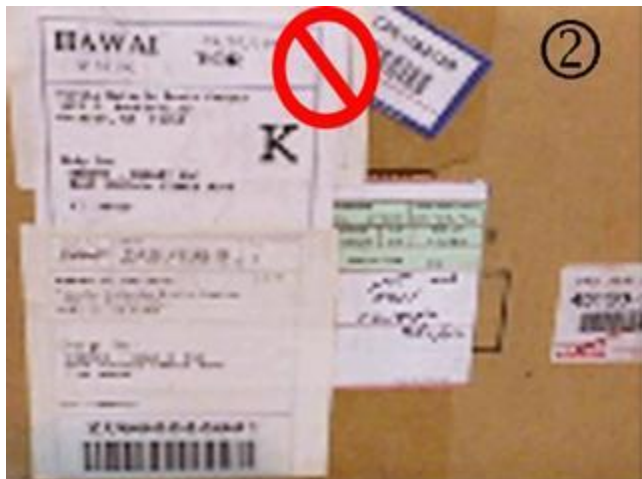
3961566

- **Labeling:** Packages with excessive labeling are NOT acceptable, particularly if the labels obscure other required marks and labels.

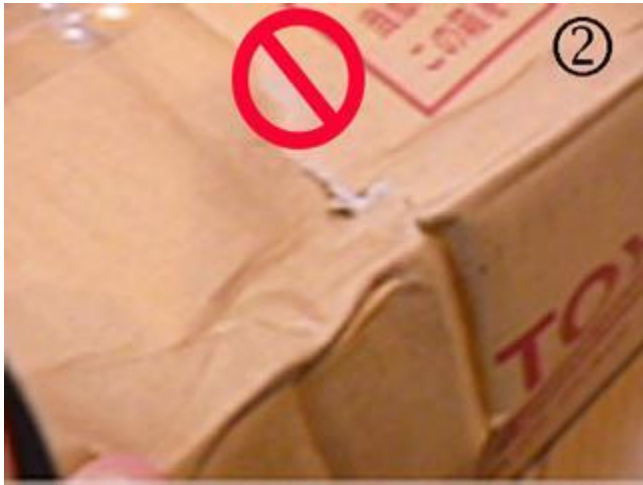
3961567

- **Other Damages:** Multiple damages, such as those shown above, may affect the integrity of the packages, and are NOT acceptable. Others that are not as severe may be acceptable. If questionable, repackage the material.

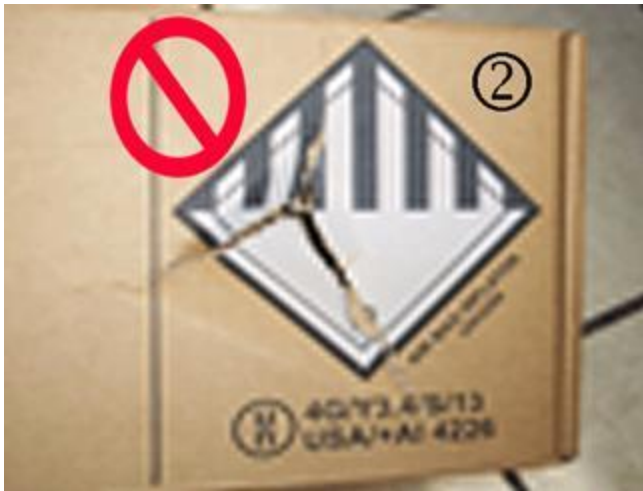
3961568

- **Punctures:** Any punctures, even minor ones, are NOT acceptable.

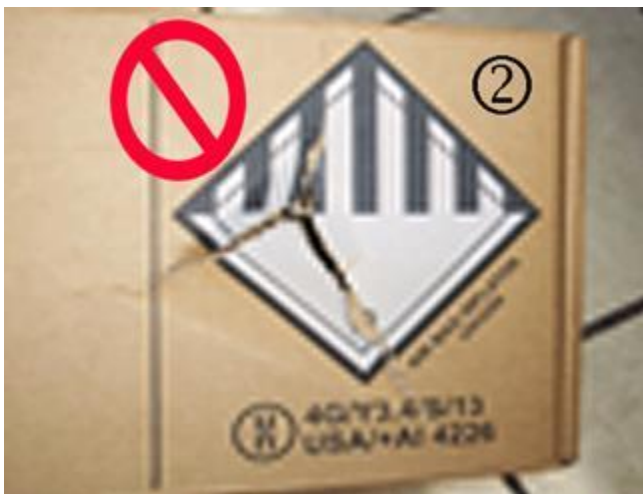
3961568

- **Tears:** Minor tears will not generally affect the structural integrity of the packaging and are considered to be normal "wear and tear", however, large tears or rips are NOT acceptable.

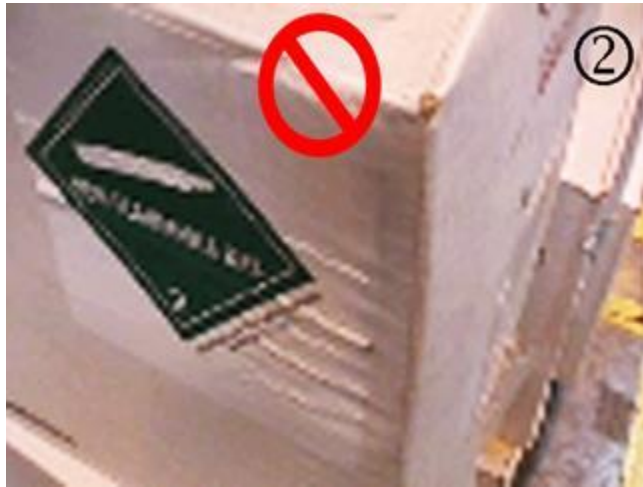
3961569

- **Water Damages:** Water Damages, such as the example shown above, are NOT acceptable. Water damages will affect the structural integrity of the packaging. These packages should be repacked in appropriate specification packages.
