Product Safety Recall

17399 Fuel Tank Expansion Into Driveline

Reference Number: N172105000

Release Date: March 2018

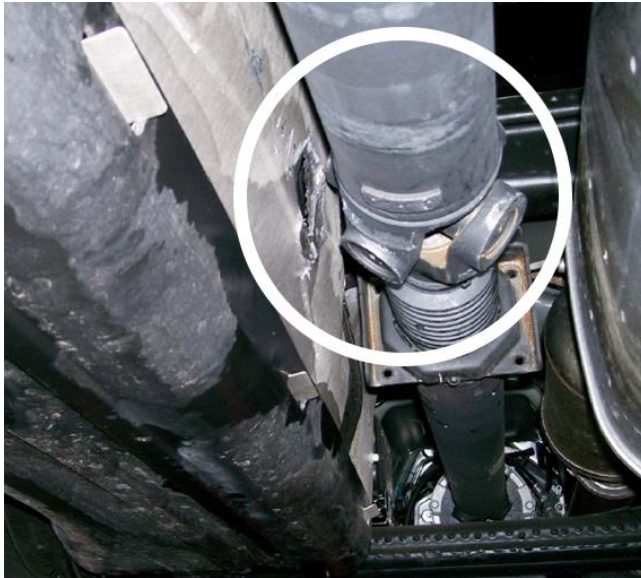
4916360

2. Inspect the front fuel tank shield for contact with the propeller shaft universal joint, as shown above.
 - If there is evidence of the propeller shaft universal joint contacting the shield, proceed to the next step.

- If there has not been any contact, proceed directly to step 7.
3. Remove the fuel tank shield. Refer to *Fuel Tank Shield Replacement* in SI.
4. Inspect the front fuel tank for evidence of the propeller shaft universal joint contact.

- If there is NO evidence of the propeller shaft universal joint contacting the front fuel tank, proceed to the next step.
 - If there is evidence of the propeller shaft universal joint contacting the front fuel tank, replace the front fuel tank. Refer to *Fuel Tank Replacement (Cab/Chassis – Front)*.

5. Replace the front fuel tank fuel level sensor. Refer to *Fuel Level Sensor Replacement (25/35 Series)*.
6. Replace the fuel tank shield. Refer to *Fuel Tank Shield Replacement* in SI.
