Product Safety Recall

17399 Fuel Tank Expansion Into Driveline

Reference Number: N172105000

Release Date: December 2017
Revision: 00

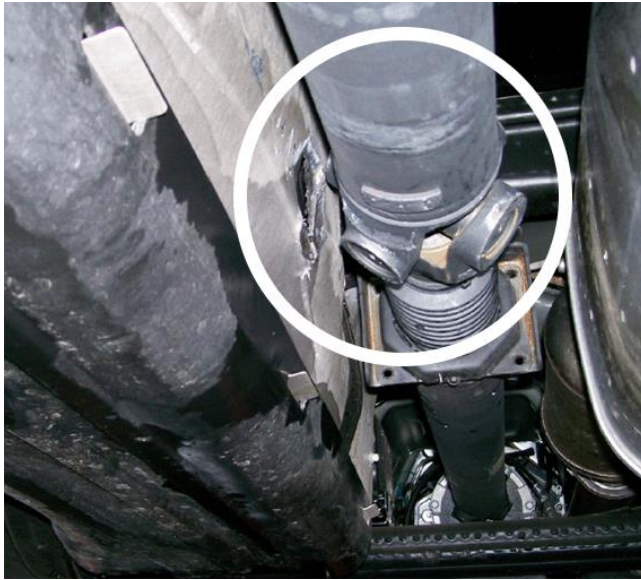
4916360

2. Inspect the front fuel tank shield for contact with the propeller shaft universal joint, as shown above.
 - If there is evidence of the propeller shaft universal joint contacting the shield, proceed to the next step

- If there has not been any contact, proceed directly to step 7.
3. Remove the fuel tank shield. Refer to *Fuel Tank Shield Replacement* in SI.
4. Inspect the front fuel tank for evidence of the propeller shaft universal joint contact.

- If there is NOT evidence of the propeller shaft universal joint contacting the front fuel tank, proceed to the next step.
 - If there is evidence of the propeller shaft universal joint contacting the front fuel tank, replace the front fuel tank. Refer to *Fuel Tank Replacement (Cab/Chassis – Front)*.

5. Replace the front fuel tank fuel level sensor. Refer to *Fuel Level Sensor Replacement (25/35 Series)*.
6. Replace the fuel tank shield. Refer to *Fuel Tank Shield Replacement* in SI.
