Product Safety Recall

17399 Fuel Tank Expansion Into Driveline

Reference Number: N172105000

Revision: 01

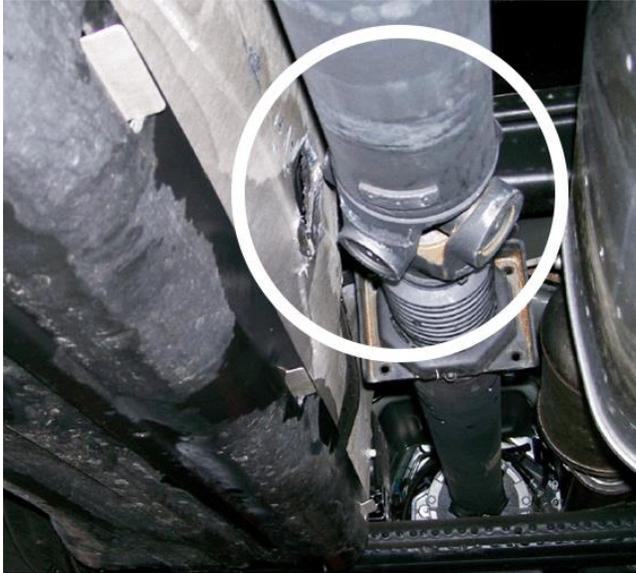
4916360

2. Inspect the front fuel tank shield for contact with the propeller shaft universal joint, as shown above.
 - If there is evidence of the propeller shaft universal joint contacting the shield, proceed to the next step.

- If there has not been any contact, proceed directly to step 7.
3. Remove the fuel tank shield. Refer to *Fuel Tank Shield Replacement* in SI.
4. Inspect the front fuel tank for evidence of the propeller shaft universal joint contact.

- If there is NOT evidence of the propeller shaft universal joint contacting the front fuel tank, proceed to the next step.
 - If there is evidence of the propeller shaft universal joint contacting the front fuel tank, replace the front fuel tank. Refer to *Fuel Tank Replacement (Cab/Chassis – Front)*.
