CONDITION OF CONCERN

On the driver seat of certain 2010-2011 Mazda3 and 2011 Mazda2 vehicles, the seat height adjustment lifter link may be cracked due to insufficient strength of the lifter link or the lifter link push nuts may be separated. If the vehicle continues to be used in this condition, the seat may exhibit an abnormal noise or rattling. In the worst case, the lifter link may be broken or detached from the seat frame, causing the seat to be inclined and the driver may not be able to maintain an appropriate driving position, increasing the risk of a crash.

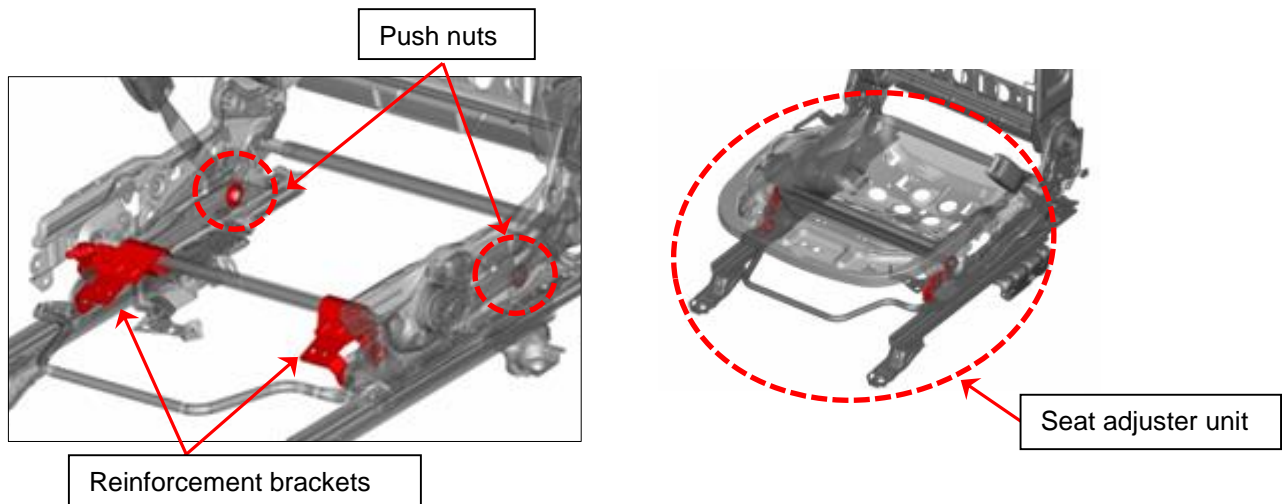
If any crack or damage exists in the lifter link, the seat adjuster unit needs to be replaced with a modified one. The inspection and repair must be performed on all subject vehicles at no charge to the vehicle owners.

Dealers are instructed to inspect the front lifter links for any crack or damage, and if no crack or damage exists in the lifter links, install reinforcement brackets on the lifter links, and increase the number of push nuts for the rear seat lifter links to two per lifter link.
