THOR MOTOR COACH AM EQUIPMENT WINDSHIELD WIPER INSPECTION/REPAIR INSTRUCTIONS
(Rev 6/21/17)
APPLIES TO: TUSCANY MY 2013-2018, TUSCANY XTE MY 2013-2017, ARIA MY 2018

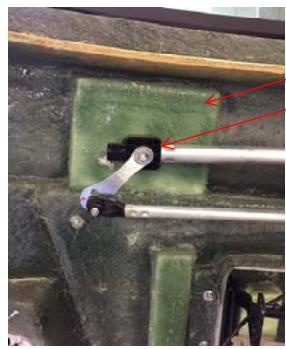
BACKER
WIPER STRINGER PLATE

6.) If pivot shaft alignment does not show any signs of binding with the pivot shaft hole in the front cap, verify that the wiper stringer plate sits flush against the backer laminated into the inside of the front cap. If there is a gap between the face of the stringer plate and the laminated backer, remove system and sand backer with 80 grit sandpaper so that system will sit flush.
