CONDITION OF CONCERN

Recall Campaign 1117E

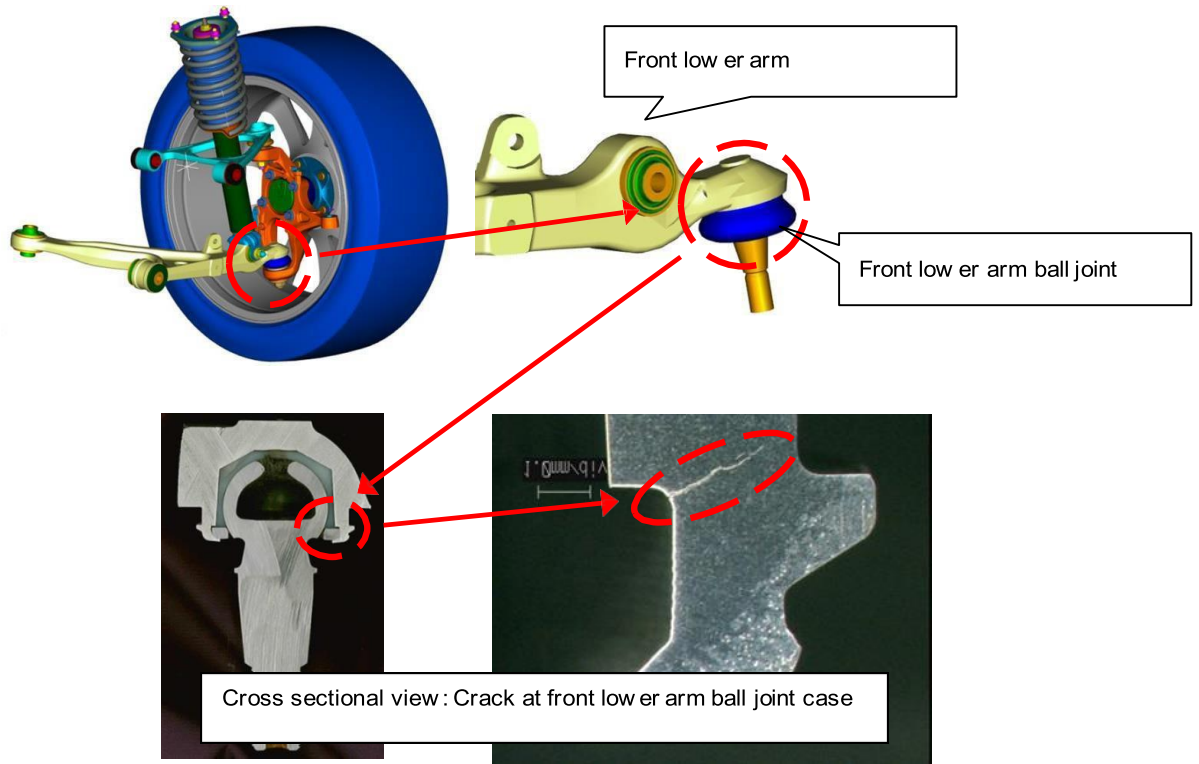
On certain RX-8 vehicles, the front lower arm ball joint case may have a crack due to inappropriate process at production stage. In the worst case, the ball joint case may break and detach from the ball joint if a large load is applied during driving, causing a loss of steering control and increasing the risk of a crash.

Dealers are instructed to replace the front lower arms (both left and right) with modified ones.
