CONDITION OF CONCERN

PARTS AND WARRANTY INFORMATION
Recall Campaign 1117E

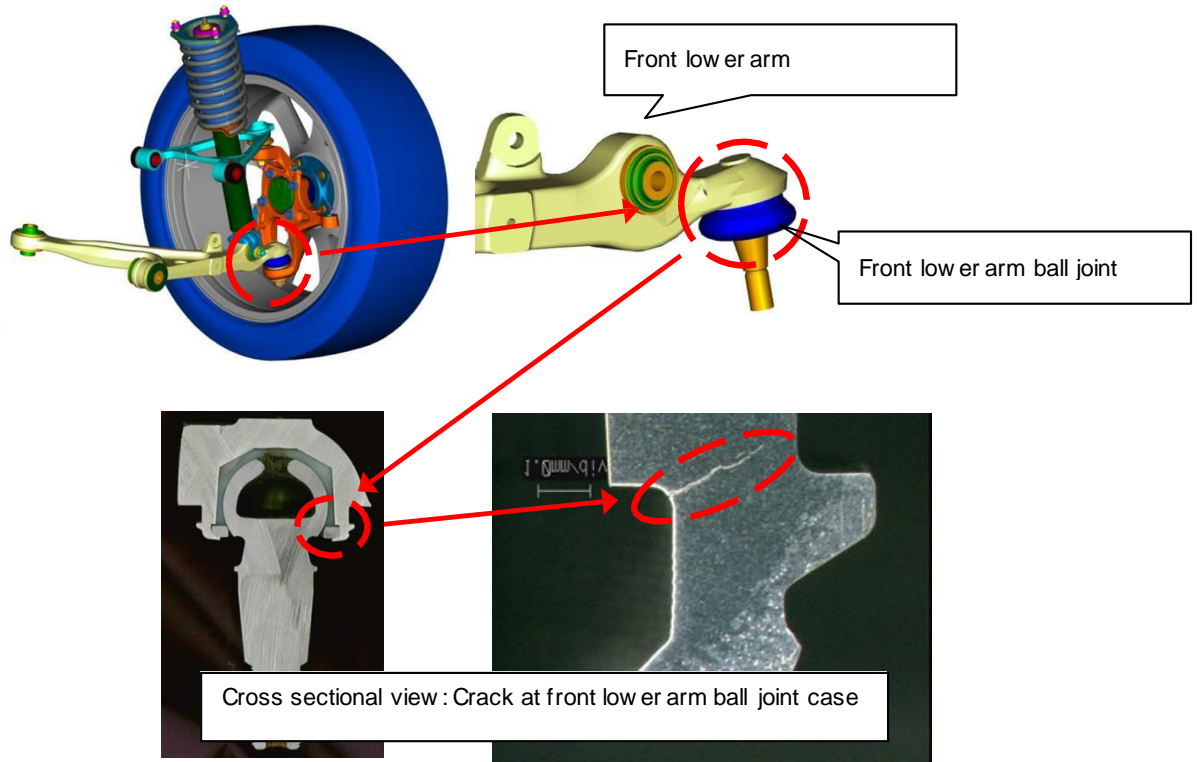
On certain RX-8 vehicles, the front lower arm ball joint case may have a crack due to inappropriate process at production stage. In the worst case, the ball joint case may break and detach from the ball joint if a large load is applied during driving, causing a loss of steering control and increasing the risk of a crash.

Dealers are instructed to replace the front lower arms (both left and right) with modified ones.
