CONDITION OF CONCERN

SUBJECT VEHICLES

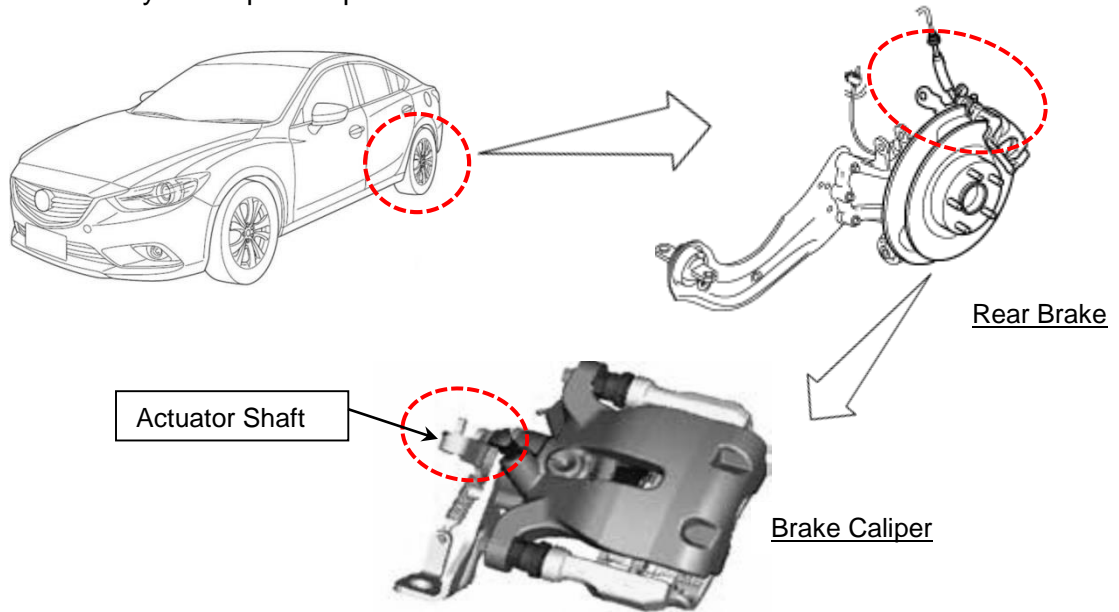
On the mechanical (cable) type parking brake, water may enter the brake caliper due to inappropriate sealing performance of the rear brake caliper protective boot, in cold temperatures. As a result, the parking brake actuator shaft, which is a component of the rear brake caliper, may rust. If the vehicle continues to be used with this condition, the rust may progress, increasing the sliding resistance of the actuator shaft. In extreme cases, the rusted actuator shaft may stick in the brake caliper body, resulting in the rear brakes dragging while driving and a decreased parking brake holding force. This could result in unexpected movement of the vehicle if parked on a slope, increasing the risk of a collision. The braking performance by brake pedal operation is not affected.

Dealers are instructed to check first if the vehicle is equipped with the subject rear brake calipers or not. If the subject brake caliper(s) is(are) installed, inspect the parking brake actuator shaft(s) inside the brake caliper(s) for any rust on the specific area. If the actuator shaft(s) is(are) found to be rusted on the specific area, replace the brake caliper(s) with modified one(s). If no rust is found on the specific area of the actuator shaft(s), replace the protective boot(s) with modified one(s). The inspection and repair must be performed on all subject vehicles at no charge to the vehicle owners.
