CONDITION OF CONCERN

SUBJECT VEHICLES

| Model | VIN Range | Build Date Range |
|---|---|---|
| 2016 Mazda6 | JM1 GJ1*5* G1 400009 – 463163 | From November 24, 2014 through December 9, 2015 |

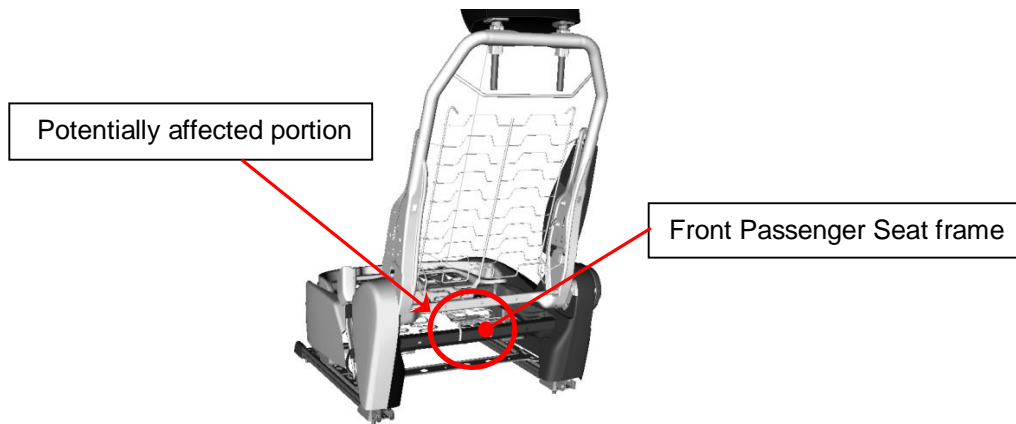
On the front passenger seat, it is possible that excessive weld spatter might adhere on the seat frame during the manufacturing process. If there is excessive weld spatter on the seat frame and the passenger seat is occupied, the occupant classification sensor (OCS) wire harness may contact the weld spatter and become damaged over time. Eventually, the harness damage could cause a short-circuit. If a short-circuit occurs, multiple warning/indicator lights in the instrument cluster may illuminate and some vehicles may experience loss of power steering assist and deactivation of the air bags. This could increase a risk of crash and risk of injury in the event of a crash.

Dealers are instructed to inspect the front passenger seat frame and attach a protective felt pad when necessary. If the wire harness is damaged, repair the damaged portion using insulating tape. The inspection and repair must be performed on all subject vehicles at no charge to the vehicle owners.
