Tie Rod Arm Taper Inspection Procedure

Steer Axle Models Affected:

Re: Dana, Inc. Recall ID# 17E041

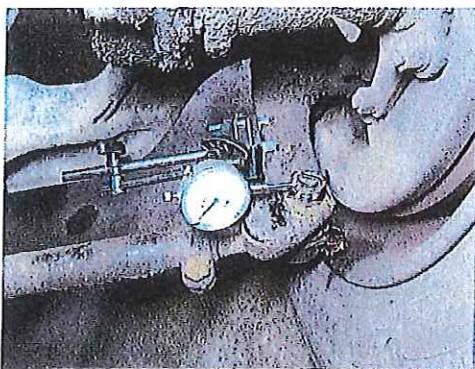
Dial Indicator Mounting Position

1. Block the forward and rear of at least one of the drive axle tires so the vehicle cannot move during this procedure.
2. With a flexible, magnetic base dial indicator, mount the base of the indicator on the tie rod arm so that the indicator tip can be centered on the threads of the stud just above the nut.

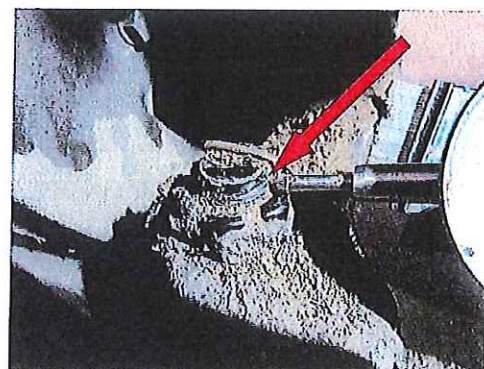
Dial Indicator Tip Must be Placed on The Stud

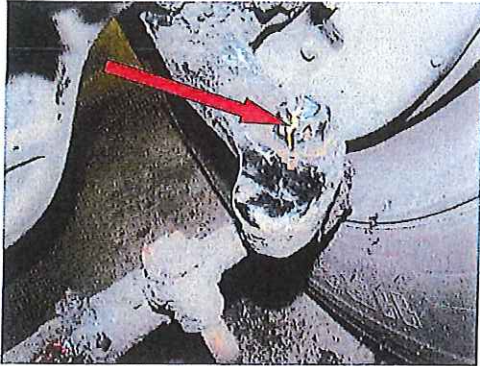
Paint Mark to Identify Nut Rotation

- The next step is to remove the cotter pins and check for proper nut torque. Put a paint mark across one side of the nut and top of the stud. With a DIAL torque wrench and a 1 ¼" socket, torque the nut in a clockwise (tighten) direction until the nut just starts to rotate or you reach 130 ft. lbs. **Important: Do not exceed 170 ft. lbs.** Record your findings on the spreadsheet.

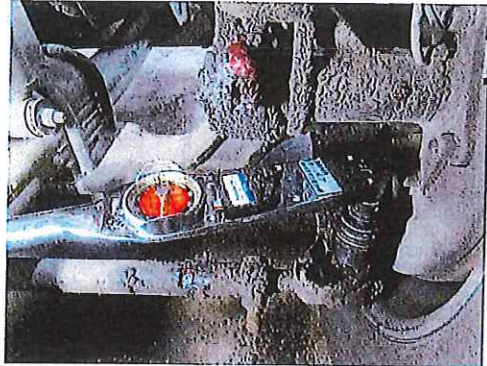
Check Nut Torque – Do Not Exceed 170 ft. lbs.

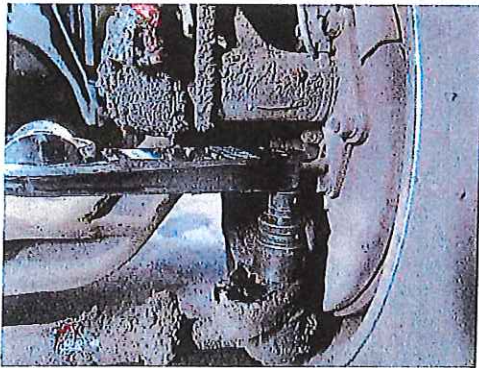
Retorque to 130 ft. lbs.

- If you found rotation of the nut before you reached 130 ft. lbs., we can now torque the nut to 130 ft. lbs. Using the paint mark, record the amount of movement to the nut. Example: Use the paint mark as the 12:00 position, if the nut rotates ¼ turn to reach 130 ft. lbs., document the nut rotated as the 3:00 position.

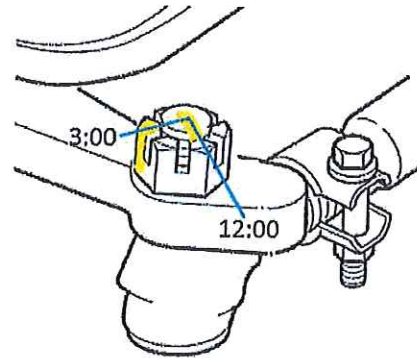
Record Rotation on Nut

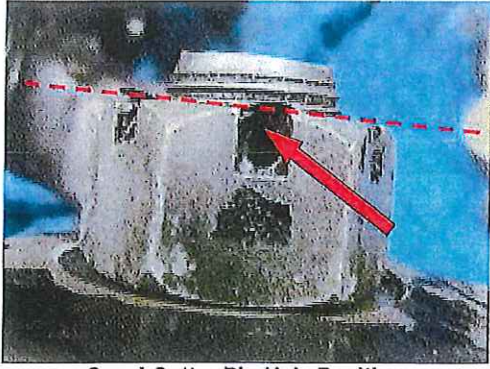
Good Cotter Pin Hole Position

- With the nut torque to 130 ft. lbs. advance the nut so that the cotter pin hole is aligned with a slot in the nut, reinstall the dial indicator and check for tie rod stud movement once again. Record results.
Note: Never back the nut off to align the cotter pin hole to the nut slot. Torque may reach 170 ft. lbs. to obtain proper alignment.
- Important:** Any tie rod stud with movement after proper nut torque and alignment will require the replacement of that knuckle and tie rod assembly.
- Important:** One last check. After the nut has been aligned with a slot in the nut, the cotter pin hole **CAN NOT** be above the top of the nut as shown below. Any cotter pin hole that is above the top of the nut surface will require the replacement of the knuckle and tie rod end assemblies.

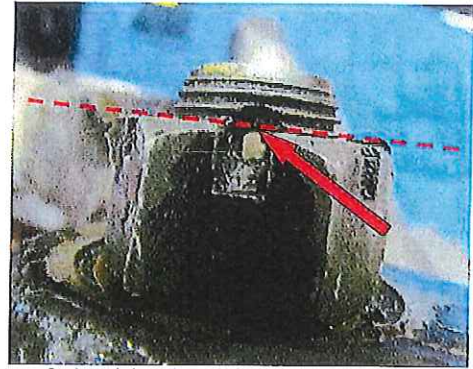
Cotter Pin Hole at *Maximum Height*

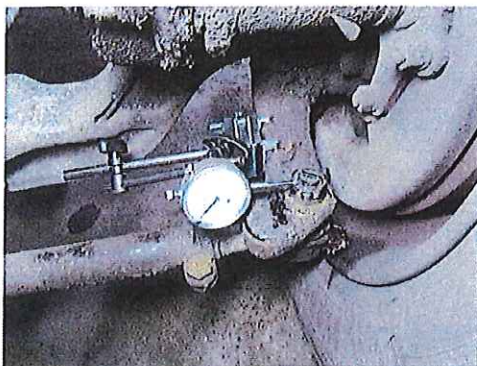
Dial Indicator Mounting Position

1. Block the forward and rear of at least one of the drive axle tires so the vehicle cannot move during this procedure.
2. With a flexible, magnetic base dial indicator, mount the base of the indicator on the tie rod arm so that the indicator tip can be centered on the threads of the stud just above the nut.

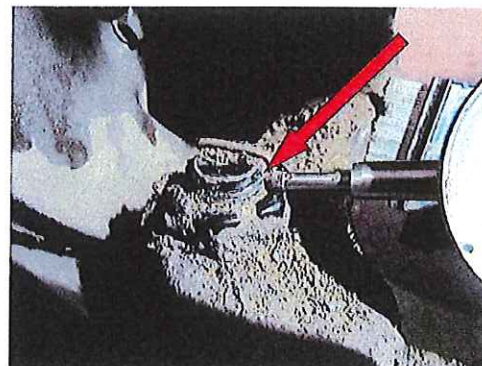
Dial Indicator Tip Must be Placed on The Stud

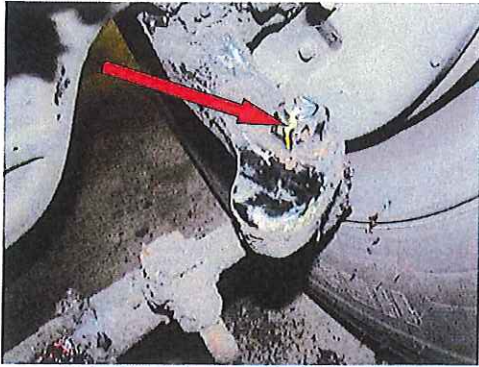
Paint Mark to Identify Nut Rotation

4. The next step is to remove the cotter pins and check for proper nut torque. Put a paint mark across one side of the nut and top of the stud. With a DIAL torque wrench and a 1 ¼" socket, torque the nut in a clockwise (tighten) direction until the nut just starts to rotate or you reach 130 ft. lbs. **Important: Do not exceed 170 ft. lbs.** Record your findings on the spreadsheet.

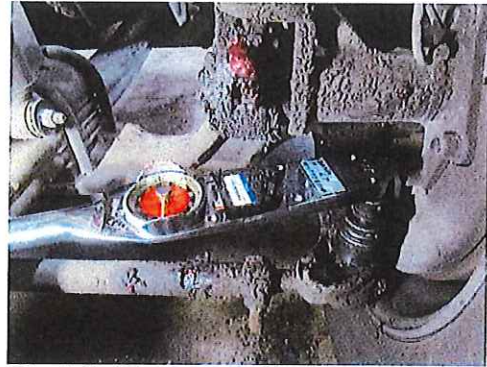
Check Nut Torque – Do Not Exceed 170 ft. lbs.

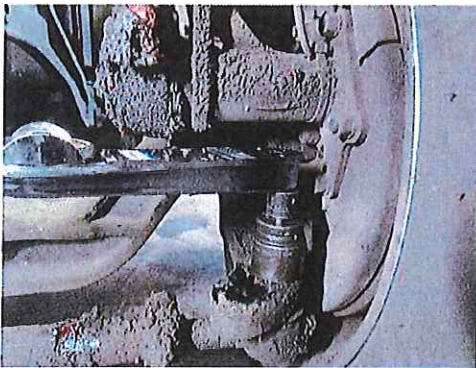
Retorque to 130 ft. lbs.

6. If you found rotation of the nut before you reached 130 ft. lbs., we can now torque the nut to 130 ft. lbs. Using the paint mark, record the amount of movement to the nut. Example: Use the paint mark as the 12:00 position, if the nut rotates ¼ turn to reach 130 ft. lbs., document the nut rotated as the 3:00 position.

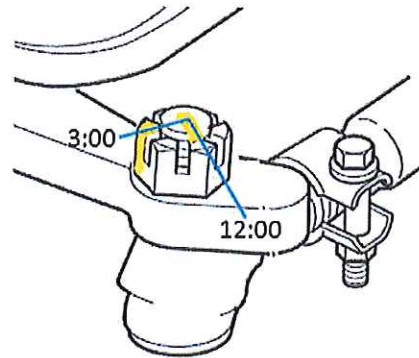
Record Rotation on Nut

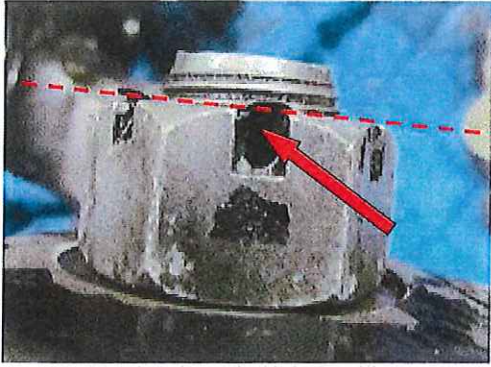
Good Cotter Pin Hole Position

7. With the nut torque to 130 ft. lbs. advance the nut so that the cotter pin hole is aligned with a slot in the nut, reinstall the dial indicator and check for tie rod stud movement once again. Record results.
Note: Never back the nut off to align the cotter pin hole to the nut slot. Torque may reach 170 ft. lbs. to obtain proper alignment.
8. **Important:** Any tie rod stud with movement after proper nut torque and alignment will require the replacement of that knuckle and tie rod assembly.
9. **Important:** One last check. After the nut has been aligned with a slot in the nut, the cotter pin hole **CAN NOT** be above the top of the nut as shown below. Any cotter pin hole that is above the top of the nut surface will require the replacement of the knuckle and tie rod end assemblies.

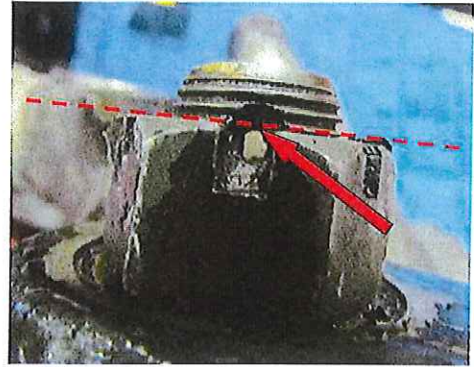
Cotter Pin Hole at Maximum Height
