DEFECT INFORMATION REPORT

Name of manufacturer: Honda Manufacturing of Alabama, LLC

Identification of potentially affected vehicles:

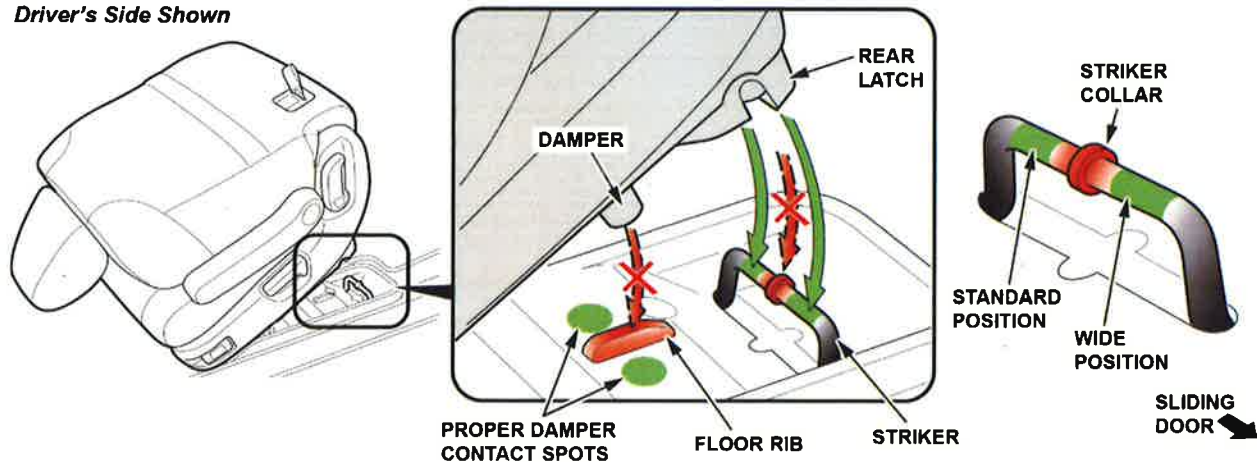
Driver's Side Shown

The second row outboard (outer) seats can be placed in two positions, standard and wide. The rear outboard seat strikers have a collar to define the two set positions. If an outboard seat is positioned over the collar while attaching the seat to the vehicle floor, the seat will not latch properly to the seat striker. An unlatched second row outboard seat could tip forward during moderate to heavy braking increasing the risk of injury to an occupant, including a child seated in a LATCH child seat.

Registered owners of affected vehicles will receive a notification letter in the mail that will contain detailed instructions for installing/positioning second row outer seats and confirming that they are securely latched. Similar information will be provided via online and social media channels prior to the notification. Once a final remedy is determined and the necessary parts are available, Honda will send a second letter to registered owners asking them to bring their vehicles to a dealership for a free repair.
