SUBJECT: Safety Recall 18S01 - Supplement # 1

Certain 2009-2010 and 2013 Mustang, 2009-2010 Ranger, Fusion, Milan, MKZ,

Edge and MKX Vehicles

Passenger Airbag Inflator Replacement

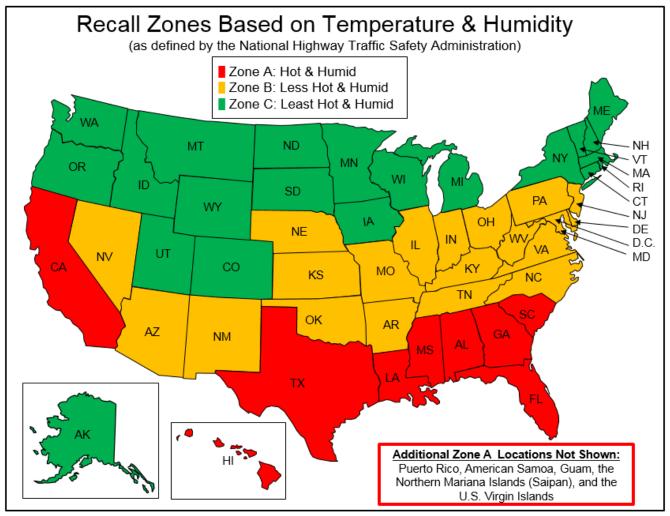
FIGURE 1

Due to owner relocations and vehicle resale activity, dealers located in other Zones may have some vehicles assigned to their FSA VIN list. All vehicles affected by this safety recall must be repaired, regardless of the vehicle's current location. Always use OASIS to identify affected vehicles. The Takata airbag recall zones have been defined by the NHTSA, based on temperature and humidity.
