David J. Johnson
 Director
 Service Engineering Operations
 Ford Customer Service Division

November 28, 2018

SUBJECT: Safety Recall 18S01 – Supplement #8
 Certain 2009-2010 and 2013 Mustang, 2009-2010 Ranger, 2009-2010 Fusion and Milan, 2009-2010 MKZ, and 2009-2010 Edge and MKX Vehicles
 Passenger Airbag Inflator Replacement

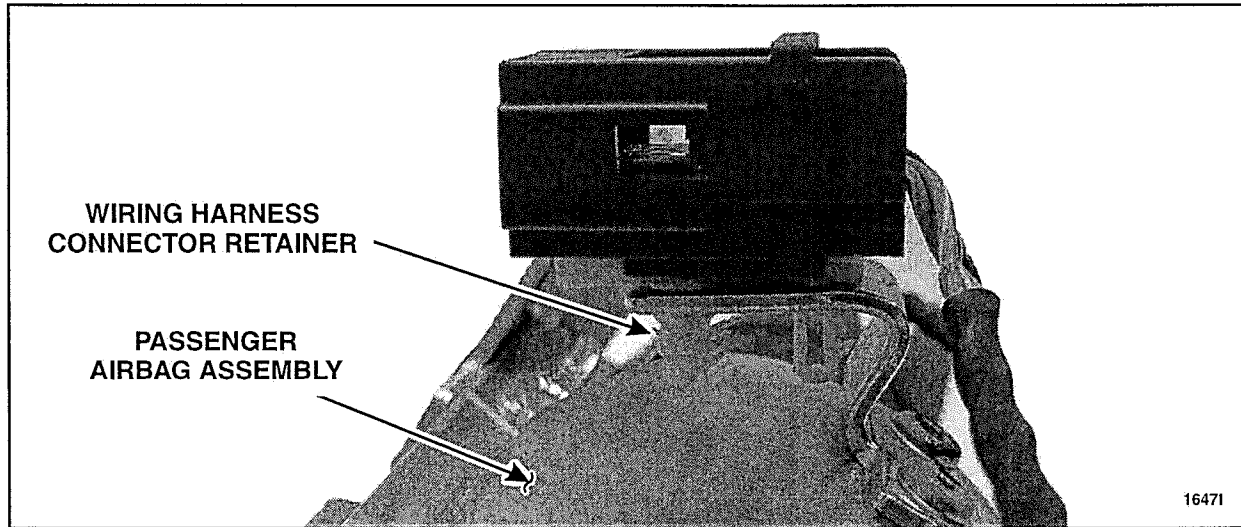
FIGURE 1

1. Remove the passenger airbag from the vehicle. Please follow the WSM procedures in Section 501-20B.
2. Set the airbag face down onto a surface that will not scratch or damage the airbag face.
3. Remove the wiring harness connector retainer from the passenger airbag assembly. See Figure 1.

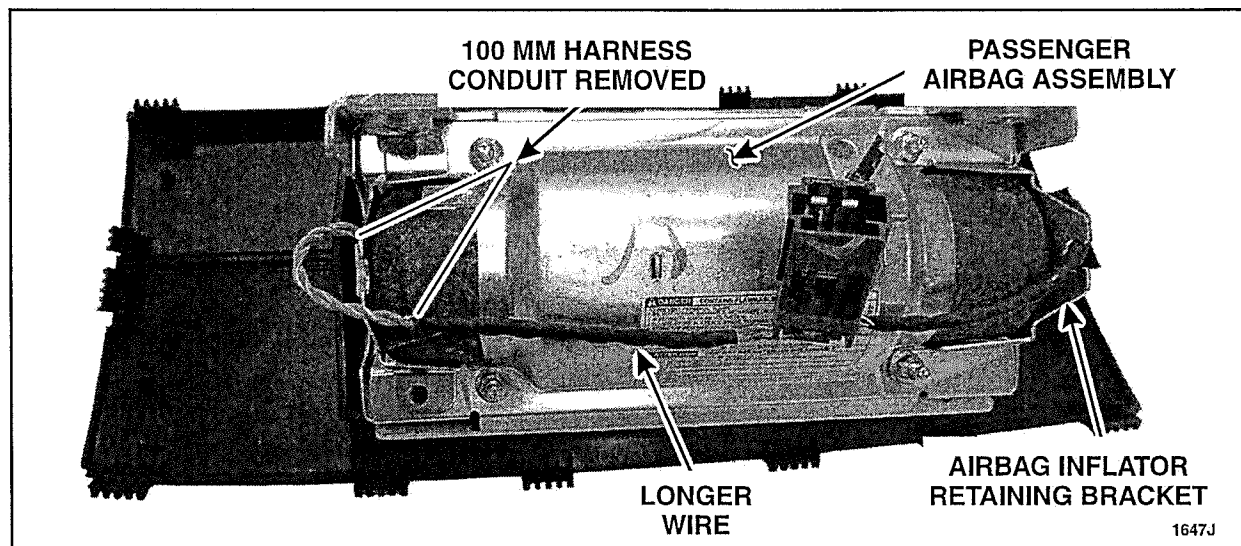
FIGURE 2

4. Remove approximately 100 mm (3.93 in) of the conduit from the passenger airbag assembly wire harness. See Figure 2.

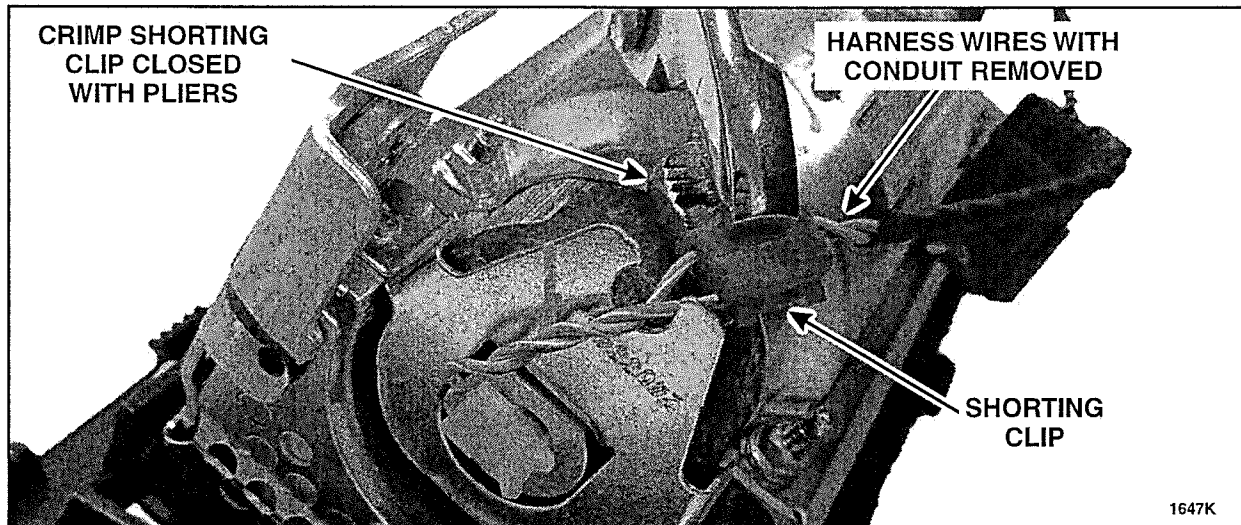
FIGURE 3

5. Position the shorting clip onto the harness wires, and crimp the shorting clip together one side at a time using pliers. See Figure 3.

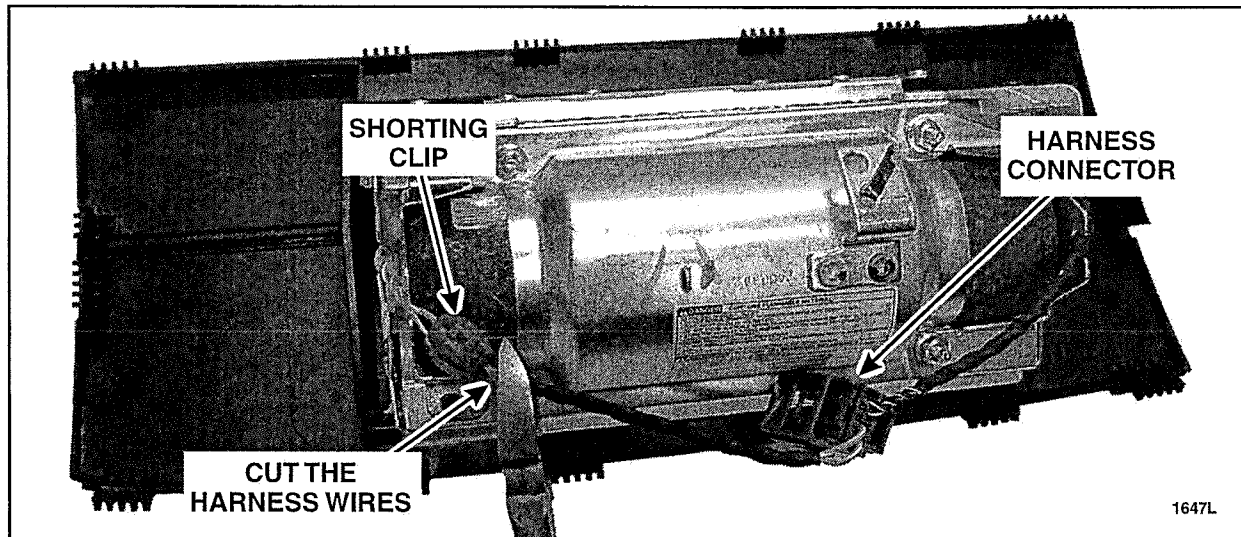
FIGURE 4

6. Cut the harness wires between the shorting clip and the harness connector. See Figure 4.

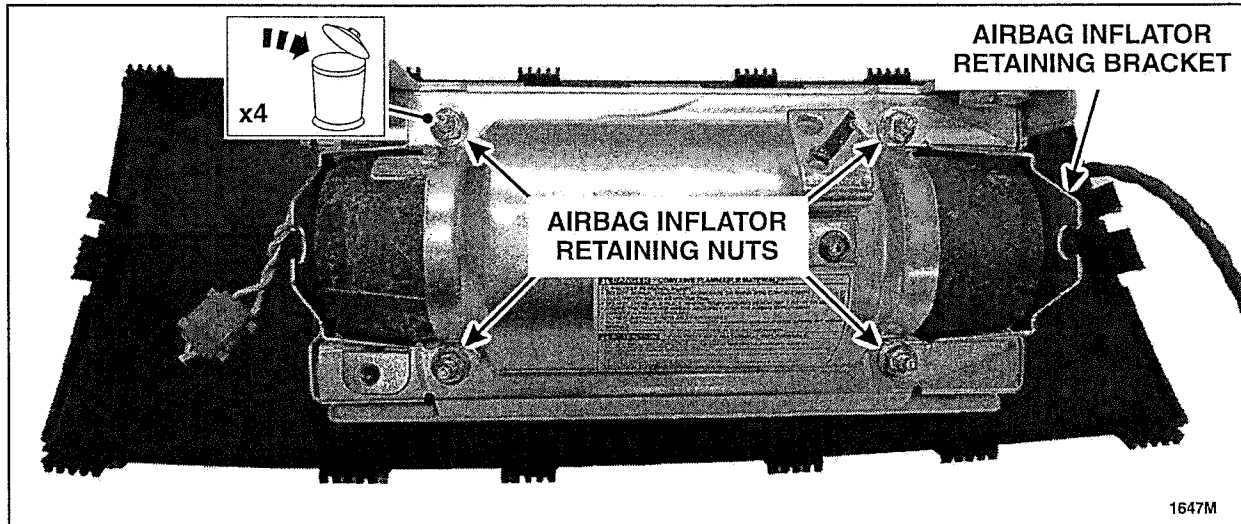
FIGURE 5

7. Remove and discard the four passenger airbag inflator retaining bracket nuts and the retaining bracket. See Figure 5.

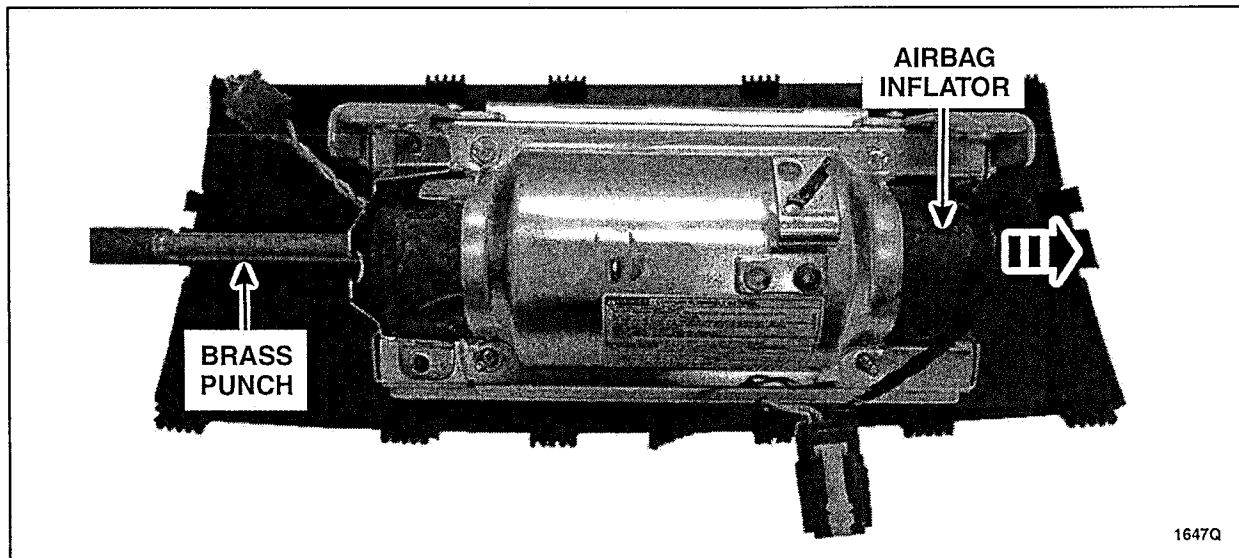
FIGURE 6

8. With an assistant holding the passenger airbag assembly, remove the inflator from the assembly by pushing outward on the inflator. Set the airbag inflator aside for return shipping. See Figure 6.

- If required, use of a brass punch is permitted (only at the location shown) to free the inflator from its mounted position.

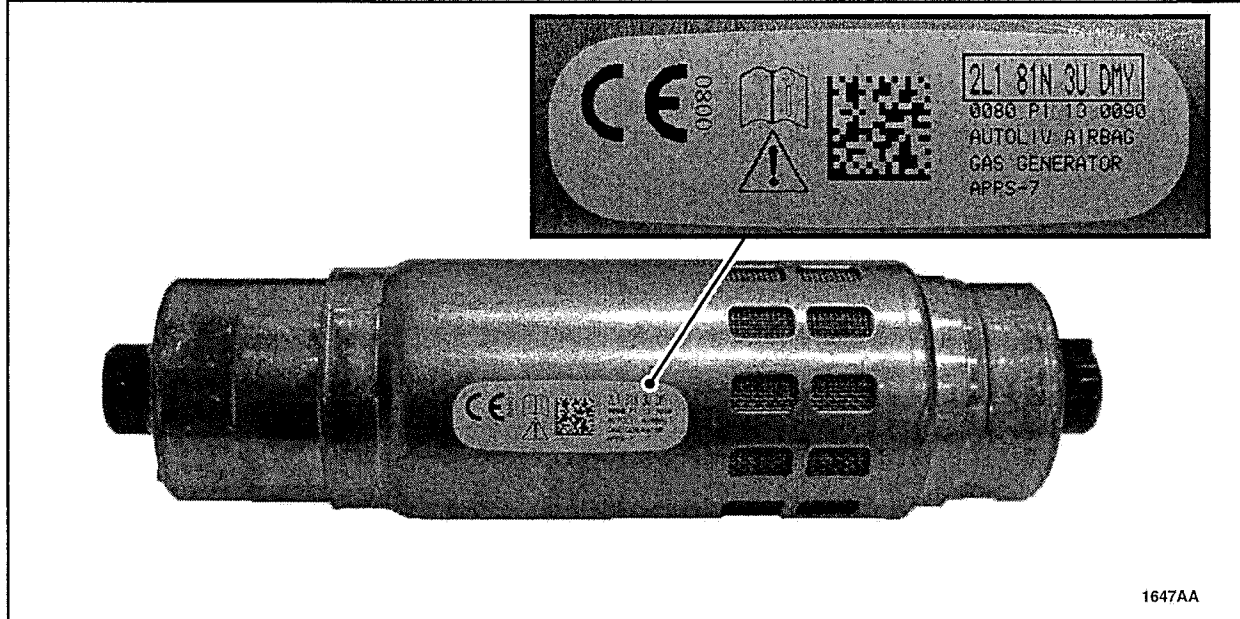
FIGURE 7

9. Record the 11 character serial number of the *new* airbag inflator on the repair order. See Figure 7.

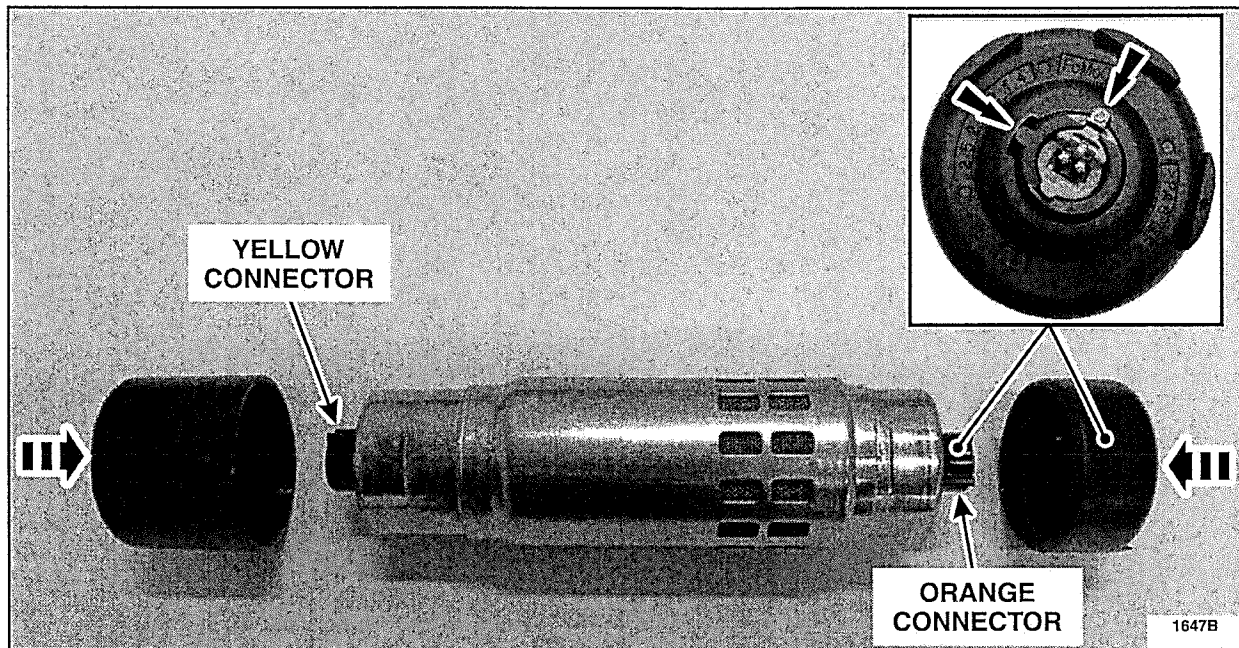
FIGURE 8

NOTE: The tail end cap does not have an alignment tab and may be installed in any orientation. Make sure the tail end cap is fully seated or you will not be able to install the inflator retaining bracket.

Install both *new* inflator end caps making sure the alignment feature on the cap nearest the inflator retaining bracket is properly oriented. See Figure 8.

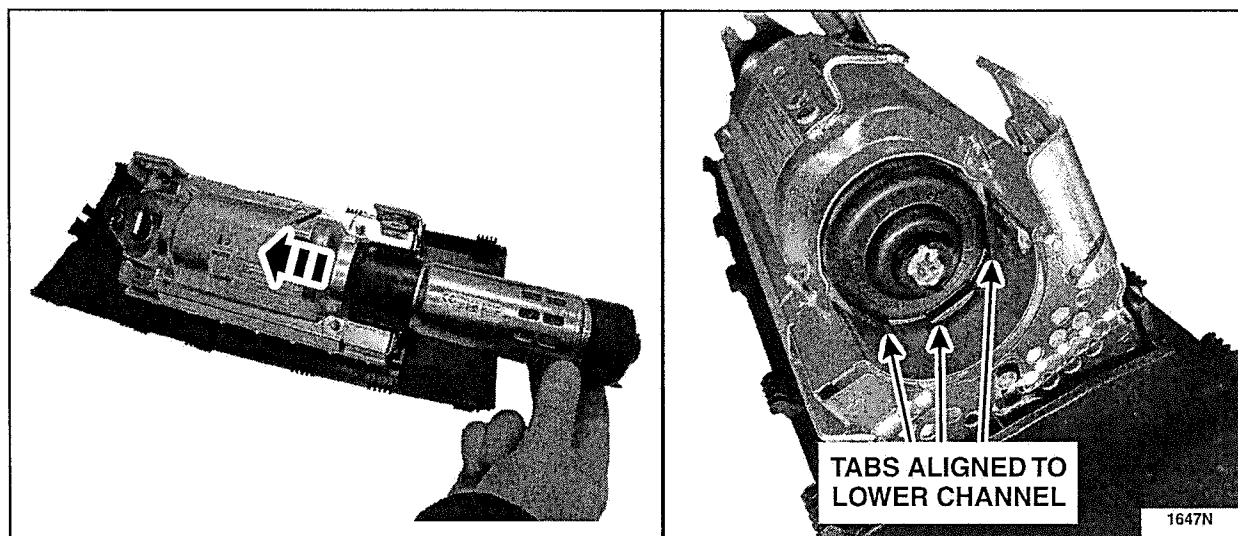
FIGURE 9

11. Install the inflator into the passenger airbag assembly with the orange connector end facing out. Align the three tabs on the cap nearest the inflator retaining bracket with the airbag module lower channel (facing down). See Figure 9.

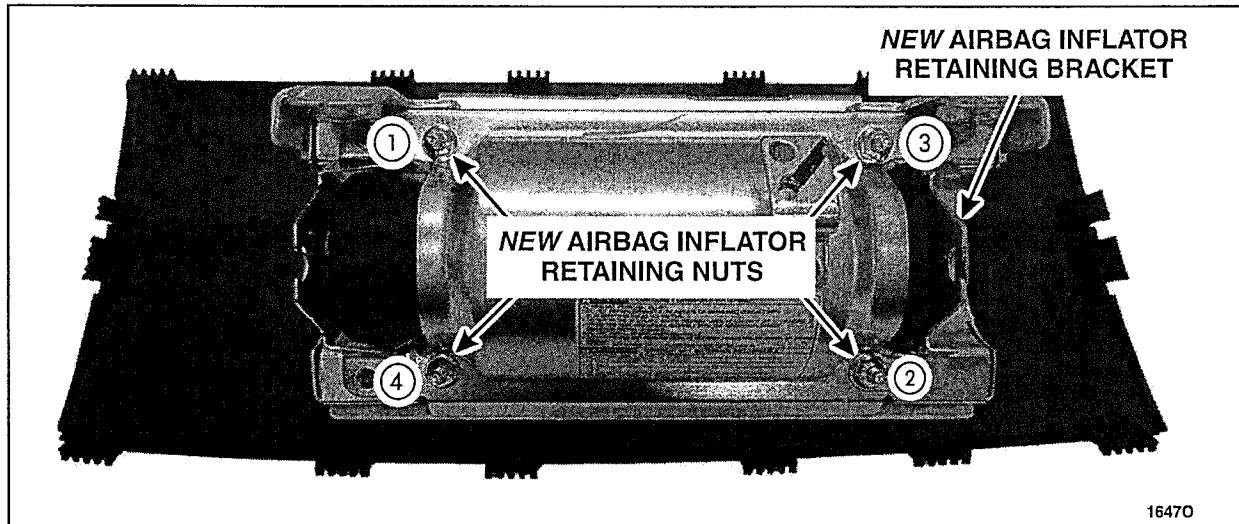
FIGURE 10

12. Install the *new* passenger airbag inflator retaining bracket and *new* nuts. See Figure 10.

- Torque the new retaining nuts in the sequence shown below to 4 Nm (35 lb-in).

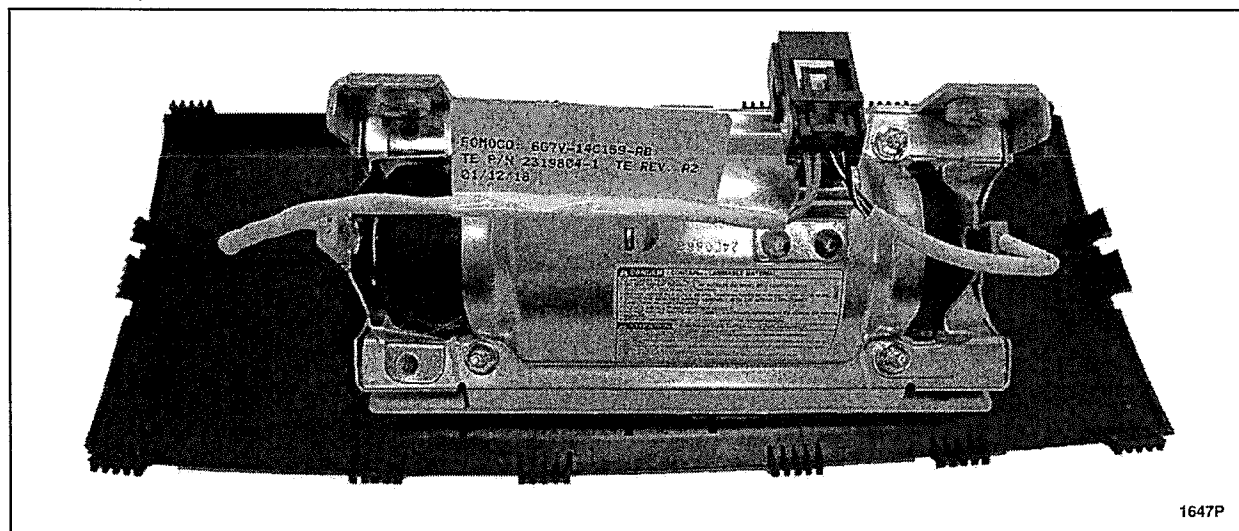
FIGURE 11

13. Align the T-shape index on both the wiring harness electrical connector and the airbag inflator. Install the new wiring harness onto the passenger airbag module and connect to both sides of the inflator. See Figure 11.

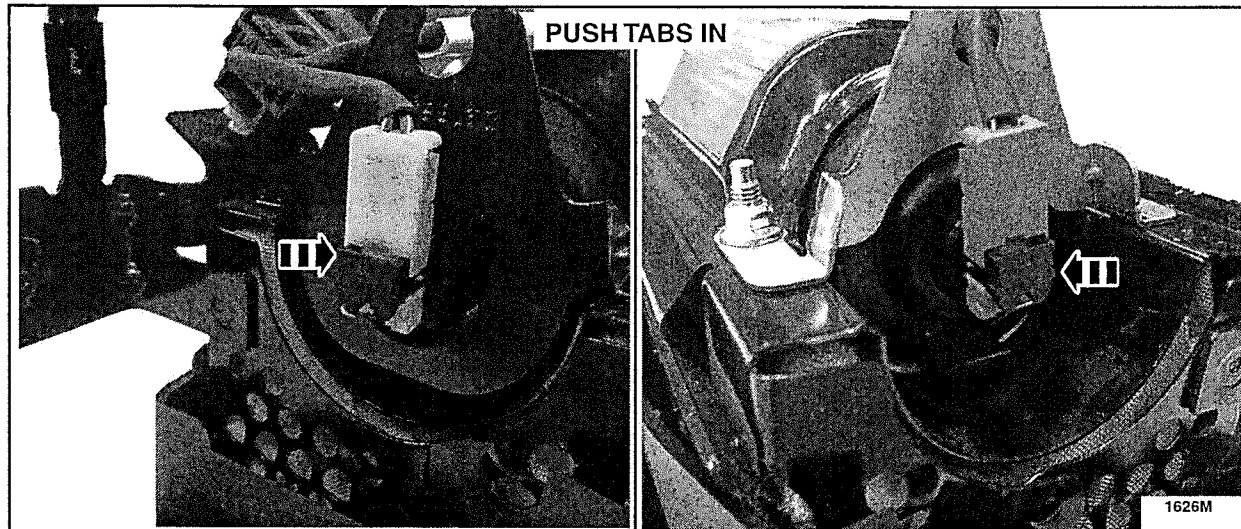
14. Insert the inflator wiring harness connector tabs. See Figure 12.

NOTE: Pull gently on the wiring harness to ensure it is properly seated.

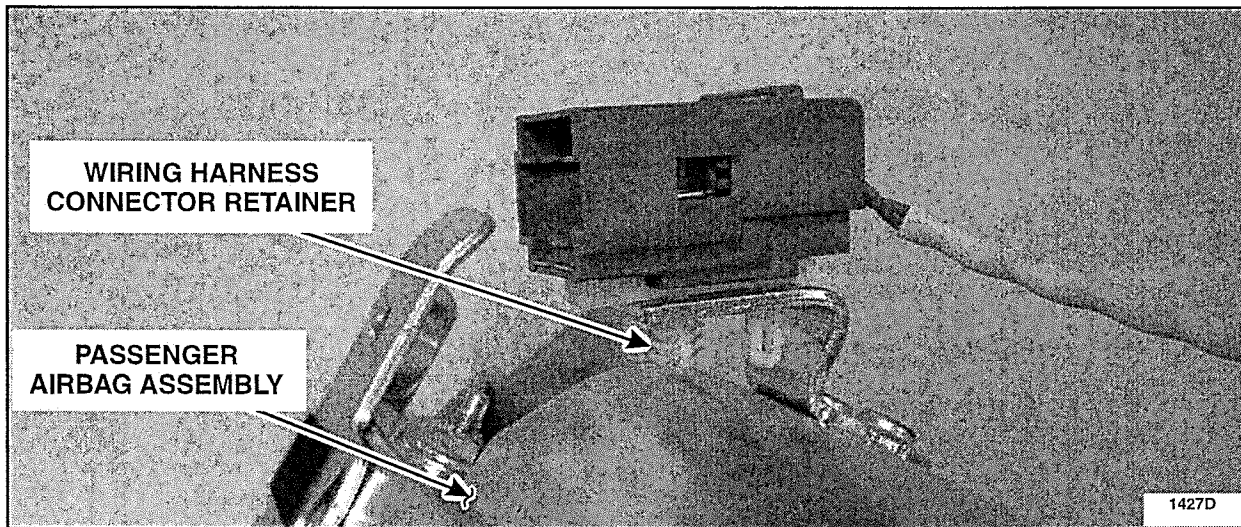
FIGURE 1

1. Remove the passenger airbag from the vehicle. Please follow the WSM procedures in Section 501-20B.
2. Set the airbag face down onto a surface that will not scratch or damage the airbag face.
3. Remove the wiring harness connector retainer from the passenger airbag assembly. See Figure 1.

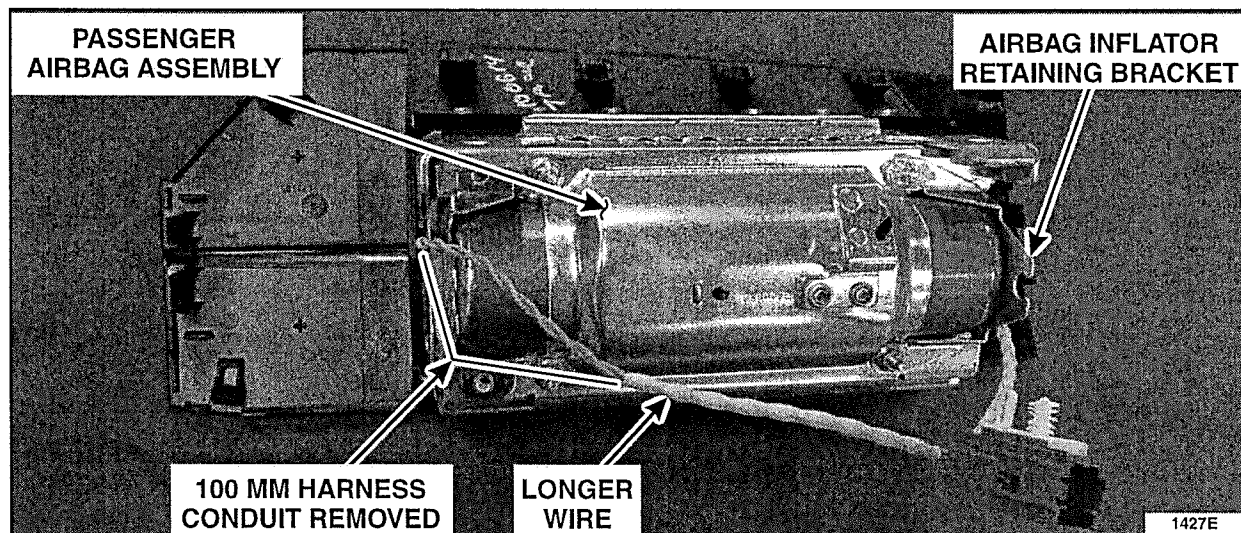
FIGURE 2

4. Remove approximately 100 mm (3.93 in) of the conduit from the passenger airbag assembly wire harness. See Figure 2.

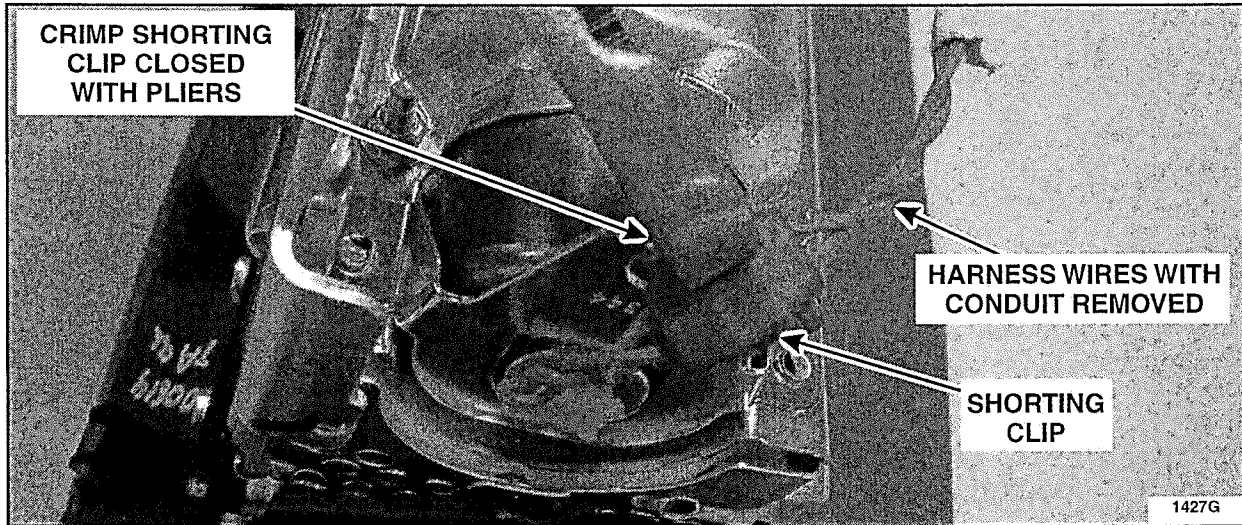
FIGURE 3

5. Position the shorting clip onto the harness wires, and crimp the shorting clip together one side at a time using pliers. See Figure 3.

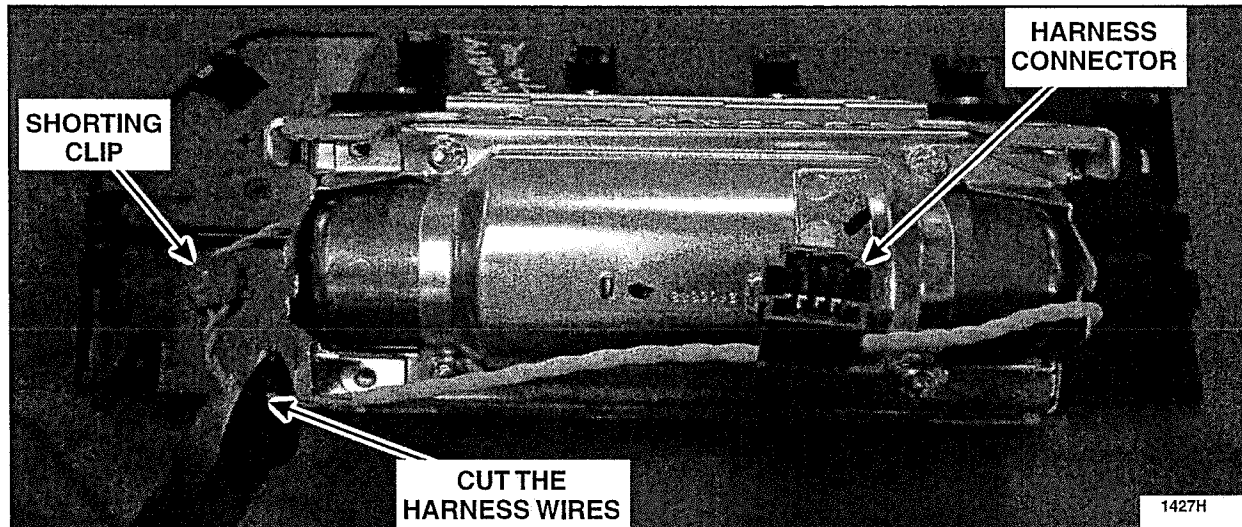
FIGURE 4

6. Cut the harness wires between the shorting clip and the harness connector. See Figure 4.

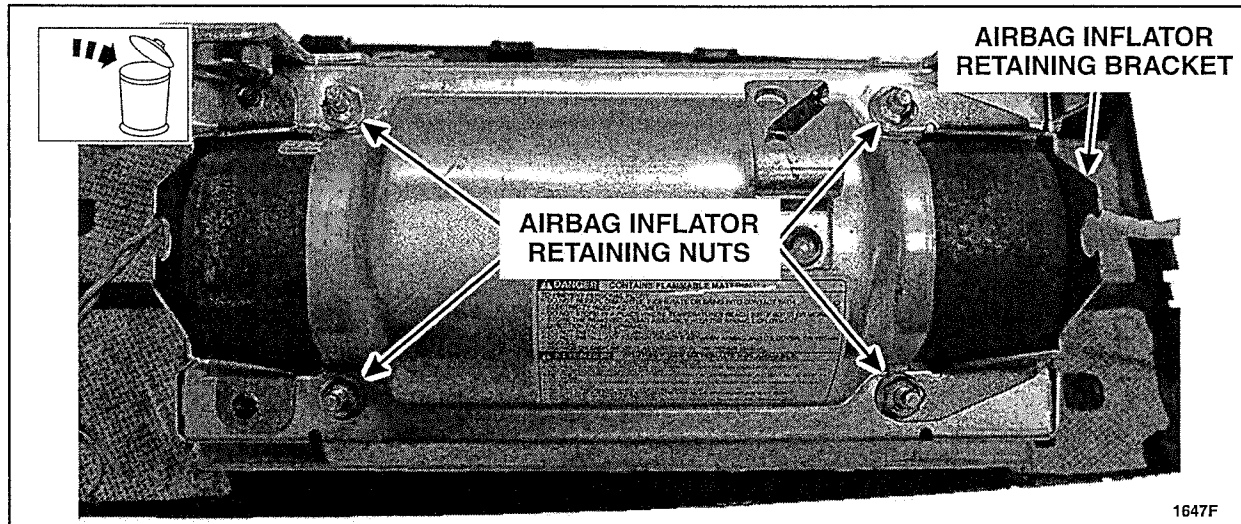
FIGURE 5

7. Remove and discard the four passenger airbag inflator retaining bracket nuts and the retaining bracket. See Figure 5.

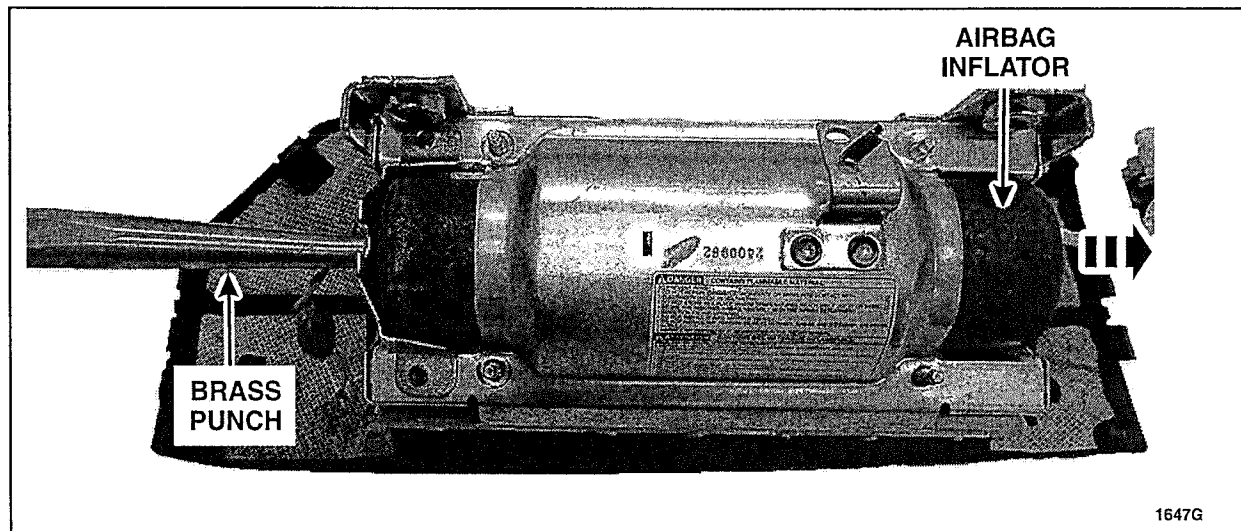
FIGURE 6

8. With an assistant holding the passenger airbag assembly, remove the inflator from the assembly by pushing outward on the inflator. Set the airbag inflator aside for return shipping. See Figure 6.

- If required, use of a brass punch is permitted (only at the location shown) to free the inflator from its mounted position.

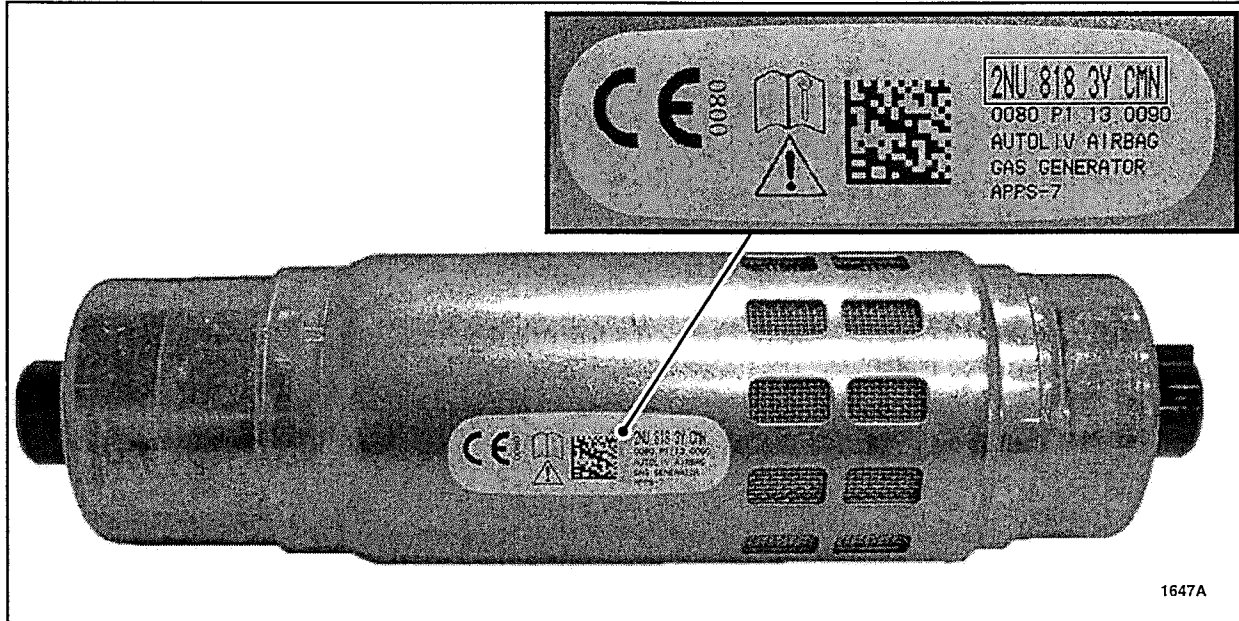
FIGURE 7

9. Record the 11 character serial number of the *new* airbag inflator on the repair order. See Figure 7.

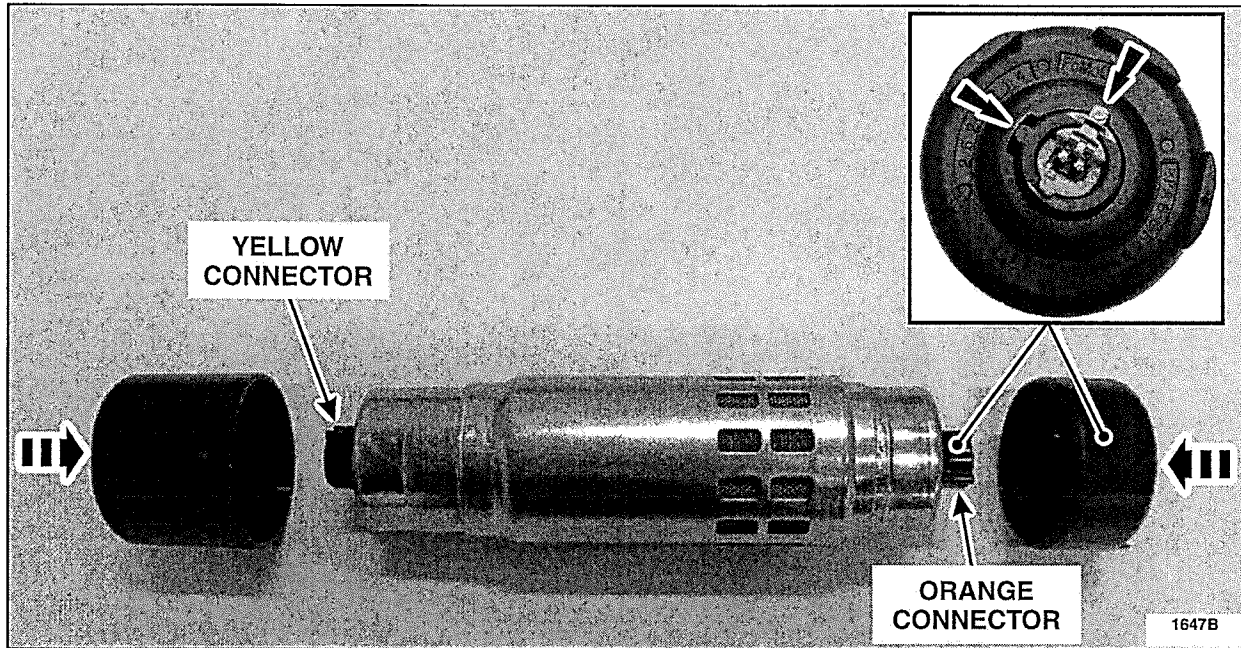
FIGURE 8

Install both *new* inflator end caps making sure the alignment feature on the cap nearest the inflator retaining bracket is properly oriented. See Figure 8.

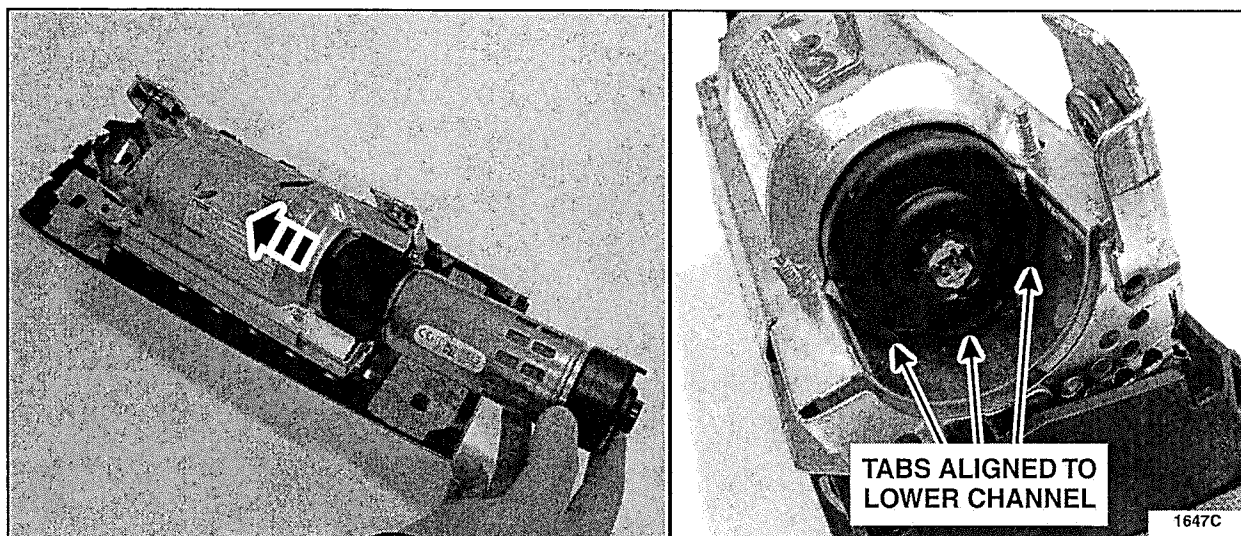
FIGURE 9

11. Install the inflator into the passenger airbag assembly with the orange connector end facing out. Align the three tabs on the cap nearest the inflator retaining bracket with the airbag module lower channel (facing down). See Figure 9.

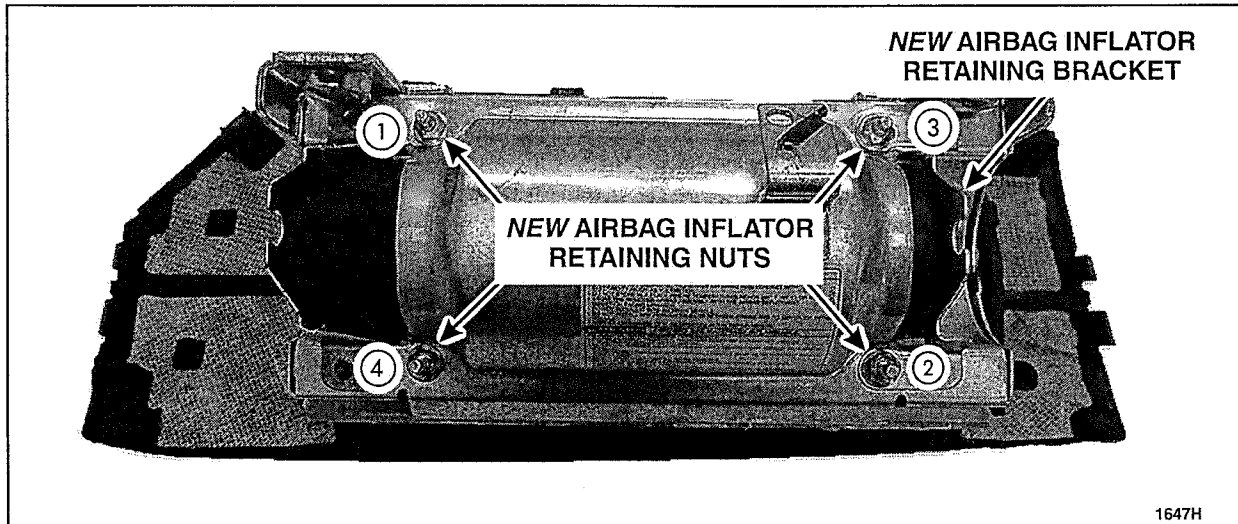
FIGURE 10

- Torque the new retaining nuts in the sequence shown below to 4 Nm (35 lb-in).

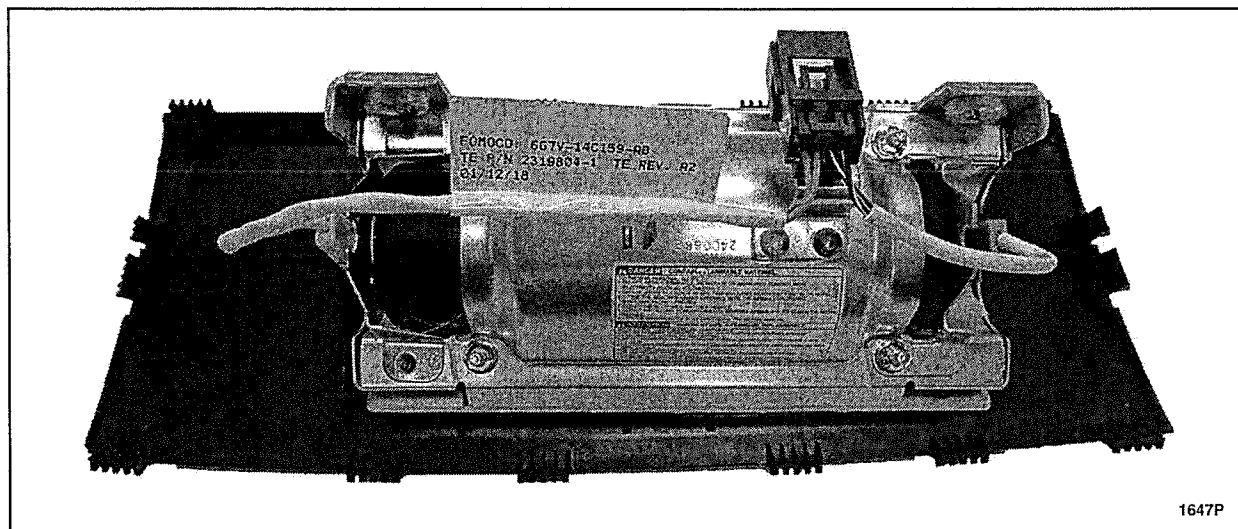
FIGURE 11

13. Align the T-shape index on both the wiring harness electrical connector and the airbag inflator. Install the new wiring harness onto the passenger airbag module and connect to both sides of the inflator. See Figure 11.

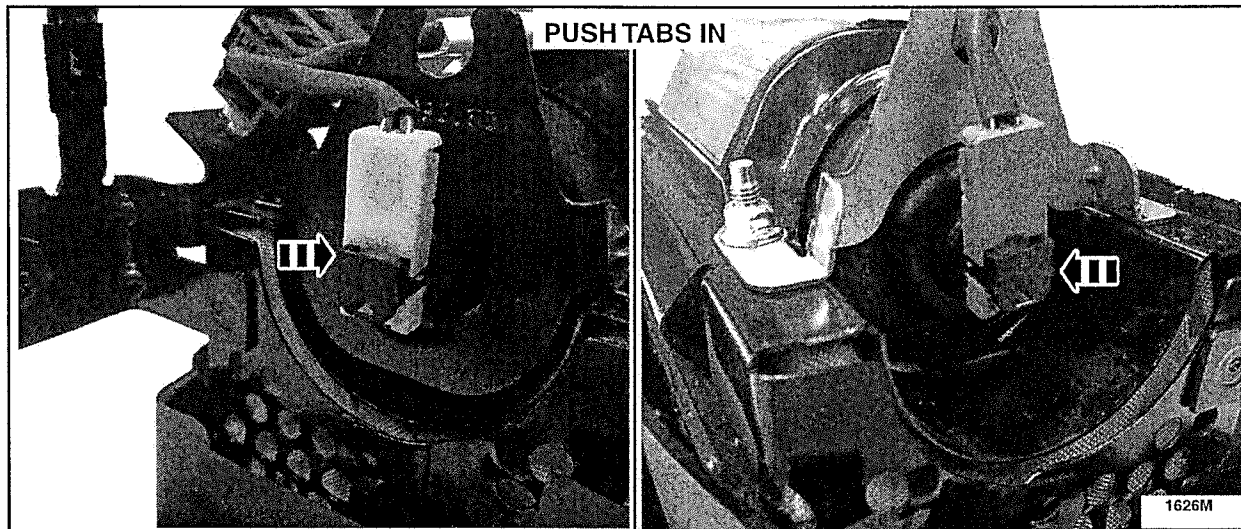
FIGURE 12

NOTE: Pull gently on the wiring harness to ensure it is properly seated.

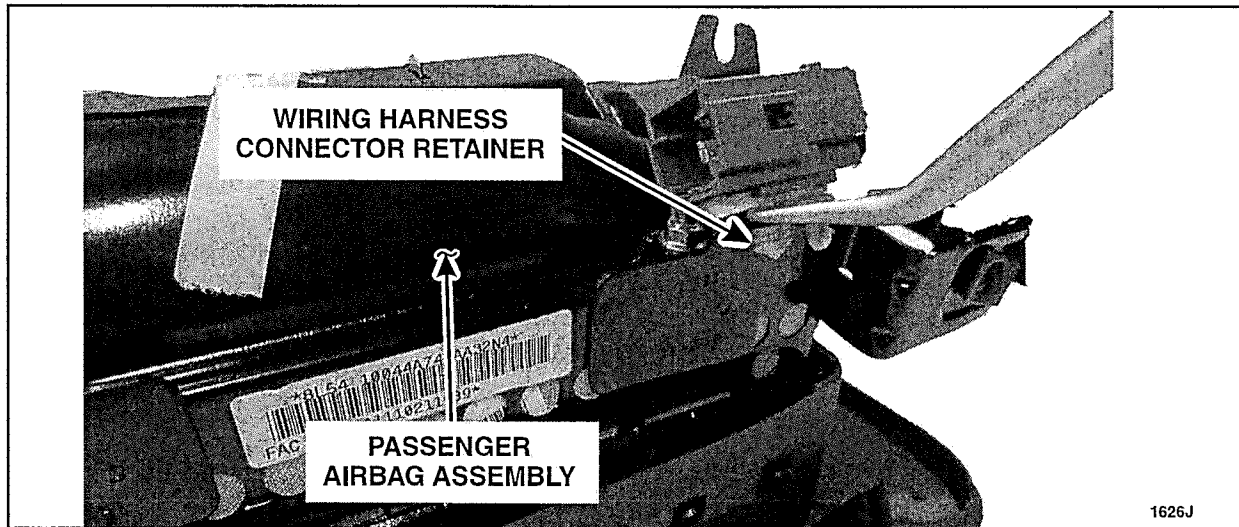
FIGURE 1

1. Remove the passenger airbag from the vehicle. Please follow the WSM procedures in Section 501-20B.
2. Set the airbag face down onto a surface that will not scratch or damage the airbag face.
3. Remove the wiring harness connector retainer from the passenger airbag assembly. See Figure 1.

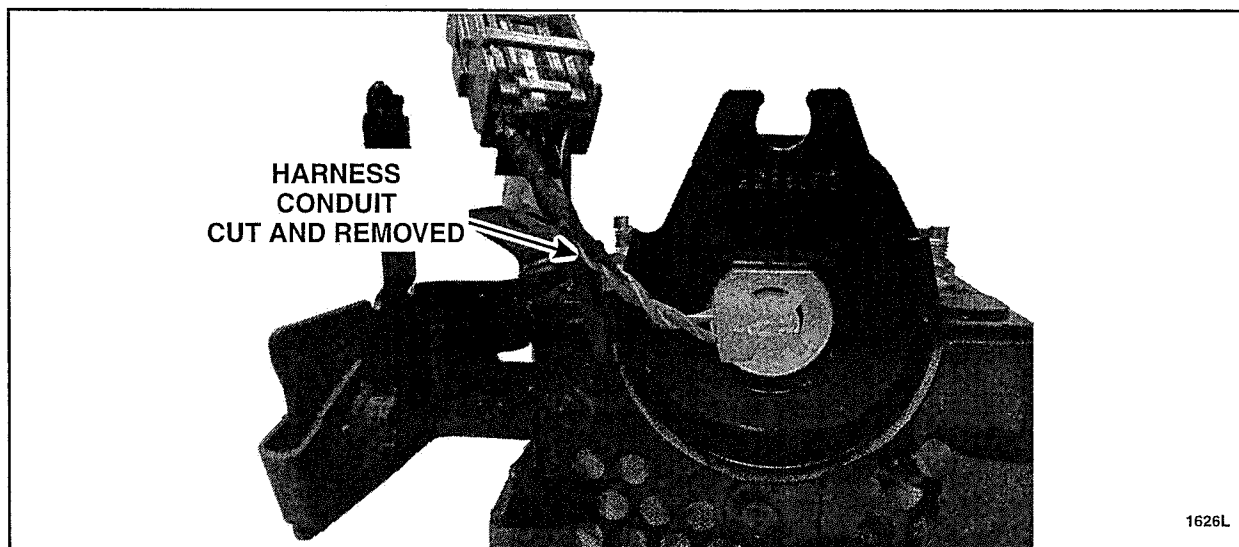
FIGURE 2

4. Remove the black conduit from the passenger airbag assembly wire harness in the area shown. See Figure 2.

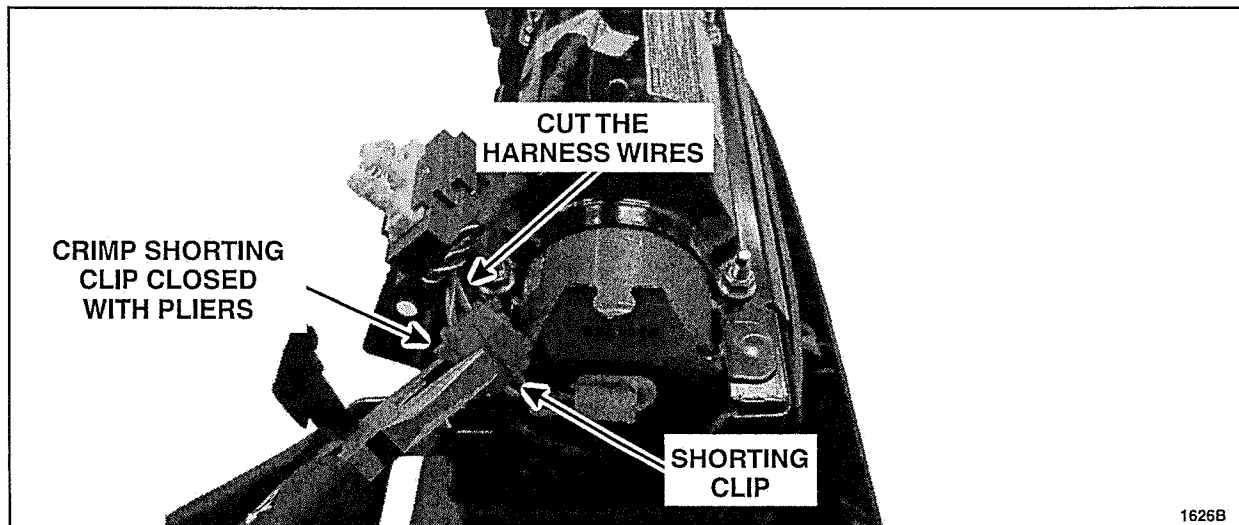
FIGURE 3

5. Position the shorting clip onto the harness wires, and crimp the shorting clip together one side at a time using pliers. See Figure 3.
6. Cut the harness wires between the shorting clip and the harness connector. See Figure 3.

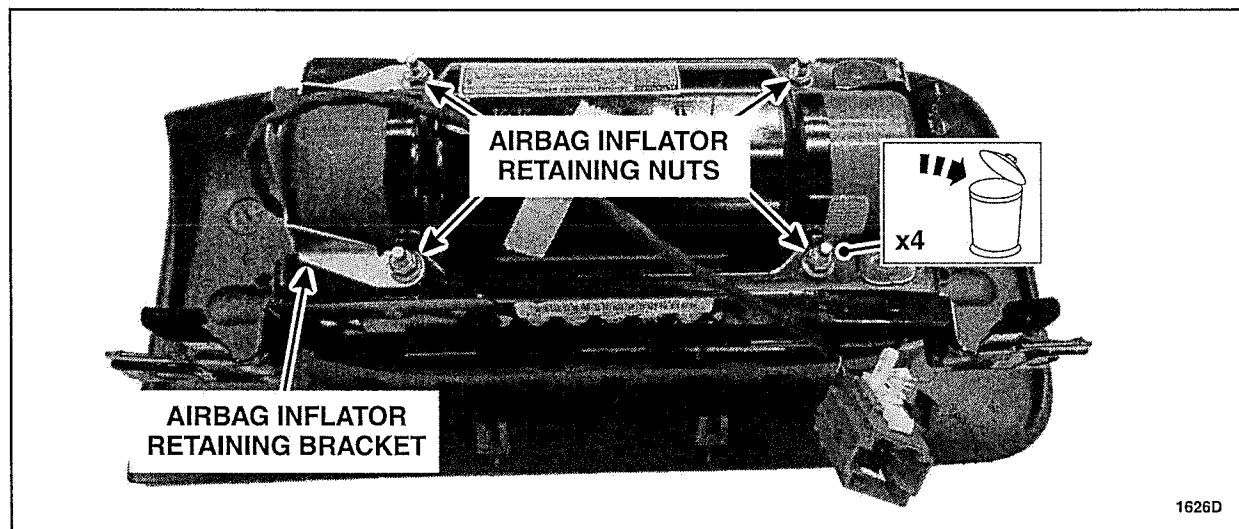
FIGURE 4

7. Remove and discard the four passenger airbag inflator retaining bracket nuts and the retaining bracket. See Figure 4.

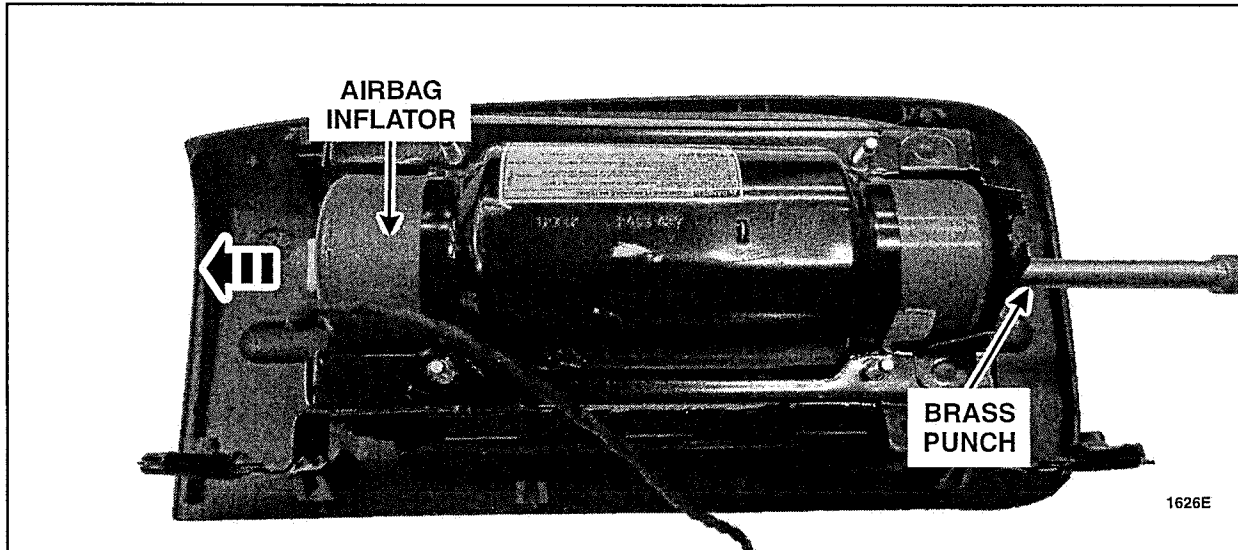
FIGURE 5

- If required, use of a brass punch is permitted (only at the location shown) to free the inflator from its mounted position.

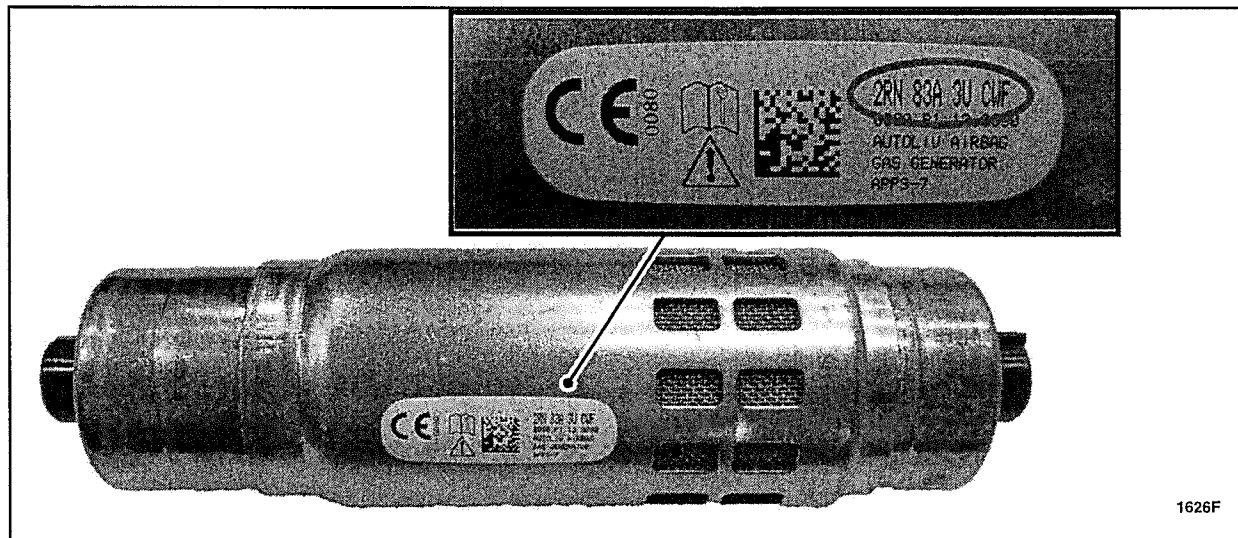
FIGURE 6

9. Record the 11 character serial number of the *new* airbag inflator on the repair order. See Figure 6.

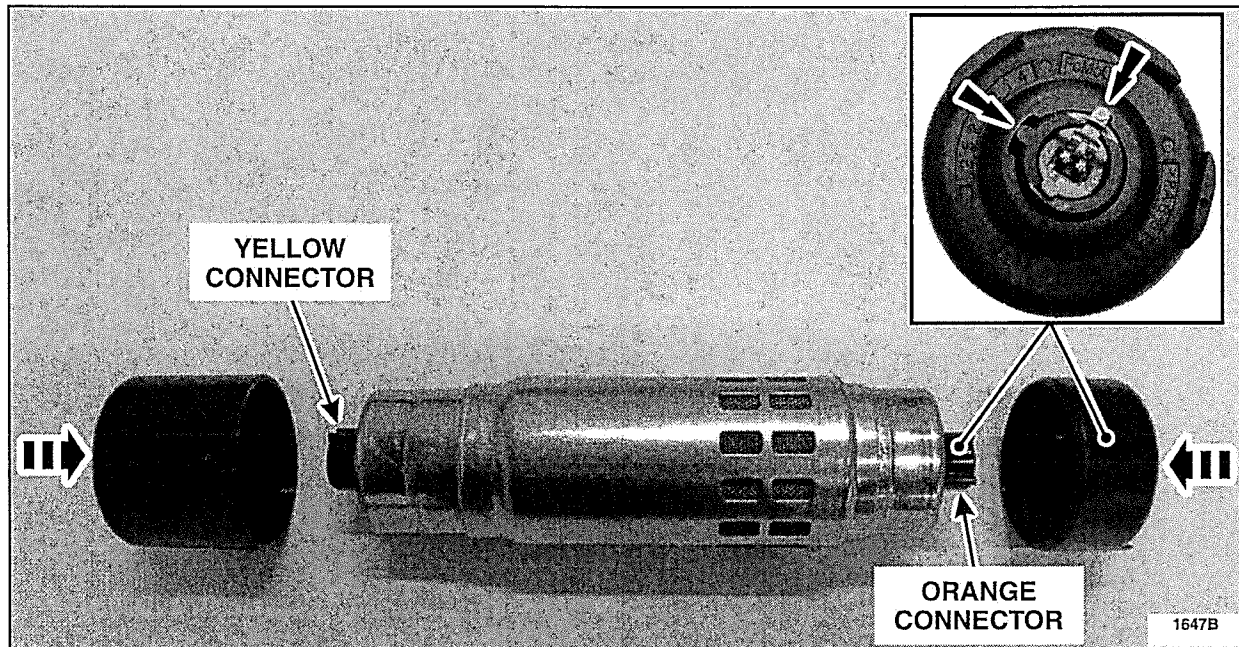
FIGURE 7

Install both *new* inflator end caps making sure the alignment feature on the cap nearest the inflator retaining bracket is properly oriented. See Figure 7.
