David J. Johnson
 Director
 Service Engineering Operations
 Ford Customer Service Division

November 28, 2018

SUBJECT: Safety Recall 18S01 – Supplement #8
 Certain 2009-2010 and 2013 Mustang, 2009-2010 Ranger, 2009-2010 Fusion and Milan, 2009-2010 MKZ, and 2009-2010 Edge and MKX Vehicles
 Passenger Airbag Inflator Replacement

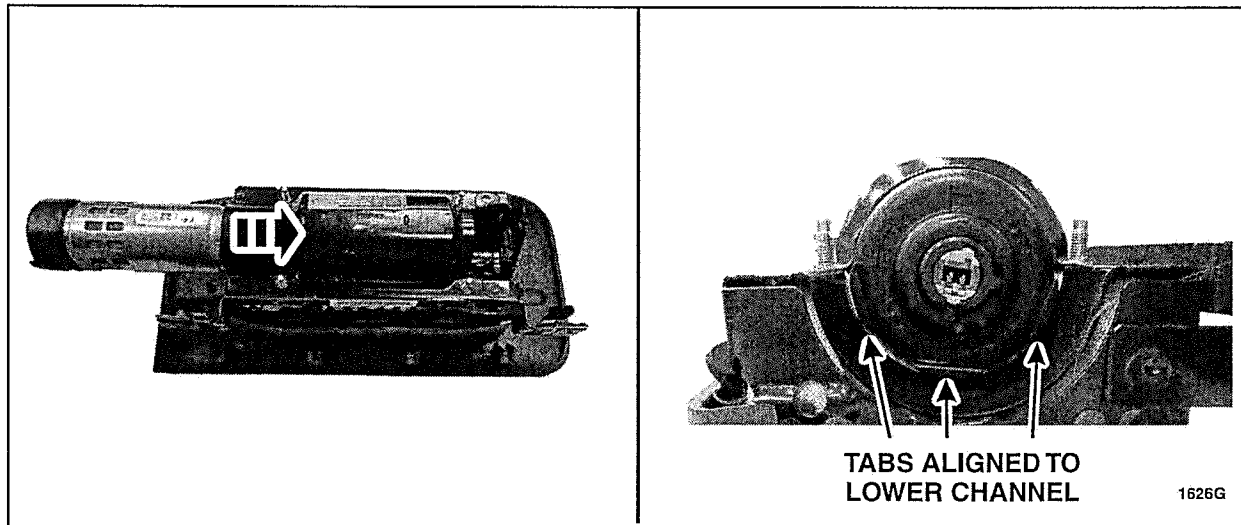
FIGURE 8

11. Install the inflator into the passenger airbag assembly with the orange connector end facing out. Align the three tabs on the cap nearest the inflator retaining bracket with the airbag module lower channel (facing down). See Figure 8.

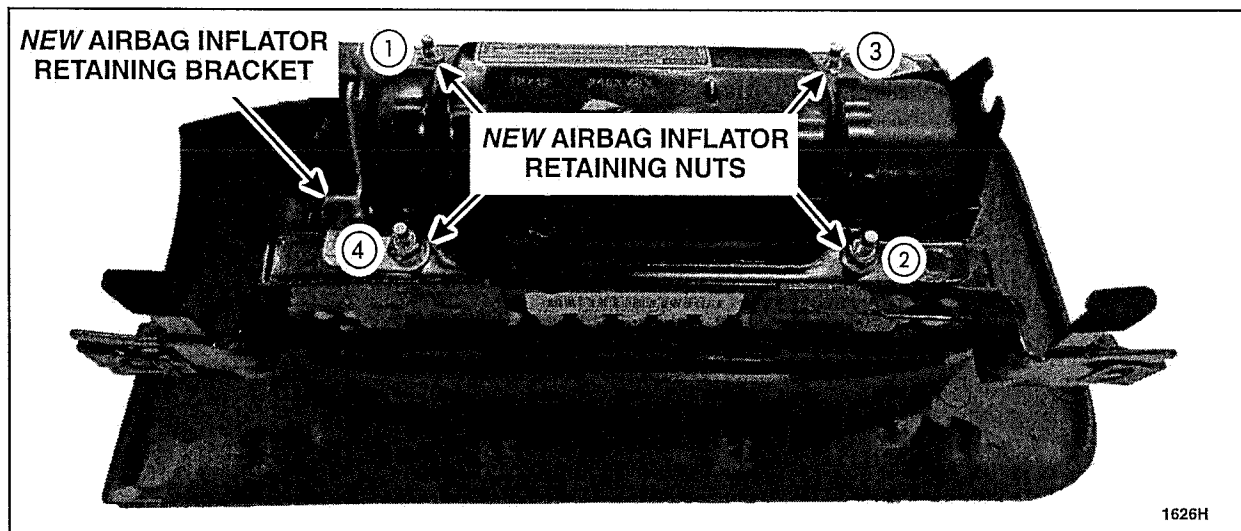
FIGURE 9

- Torque the new retaining nuts in the sequence shown below. Tighten to 4 Nm (35 lb in).

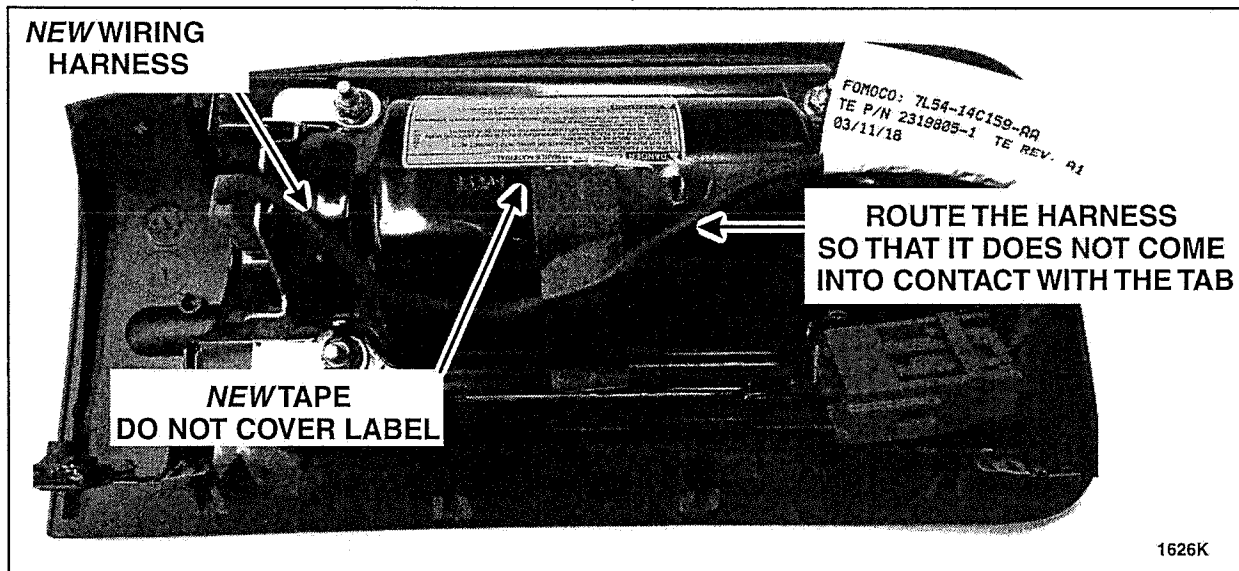
FIGURE 11

- Install the *new* tape to the wiring harness and airbag assembly, do not cover the airbag warning label with the new tape. For correct placement See Figure 11.

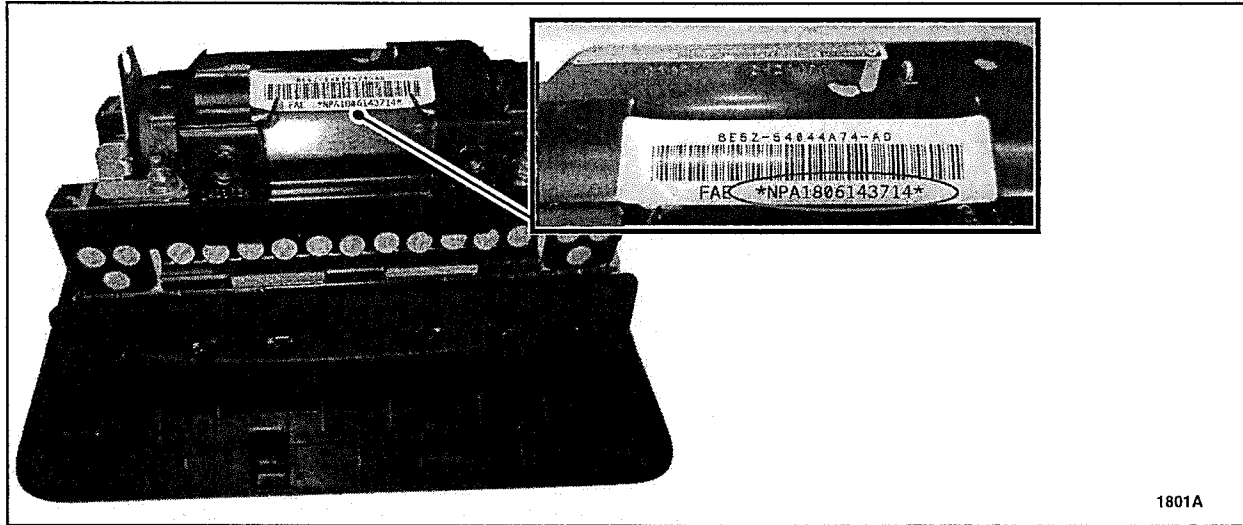
FIGURE 1

1. Record the 13 character serial number of the new airbag module on the repair order. See Figure 1.
2. Replace the passenger airbag module. Refer to section 501-20B of the workshop manual.
3. Package the replaced airbag module in the new part box and provide to the appropriate dealership personnel for part returns.

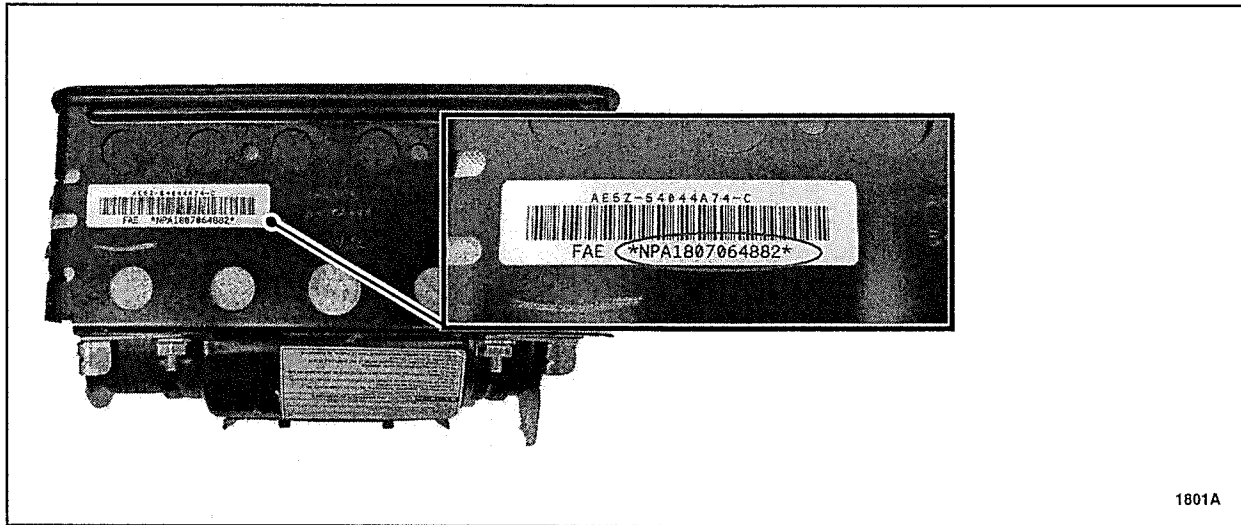
FIGURE 1

1. Record the 13 character serial number of the new airbag module on the repair order. See Figure 1.

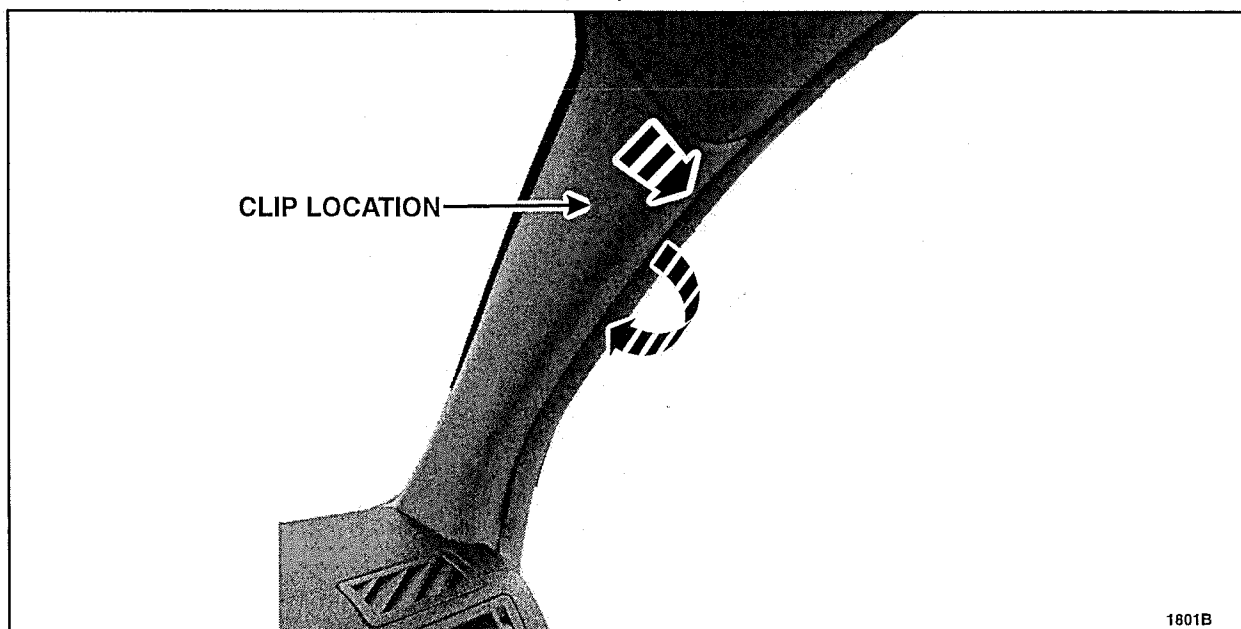
FIGURE 2

2. Remove the left hand and right hand A-Pillar trim panels. Reuse the LH and RH trim panels for this repair. See Figure 2.

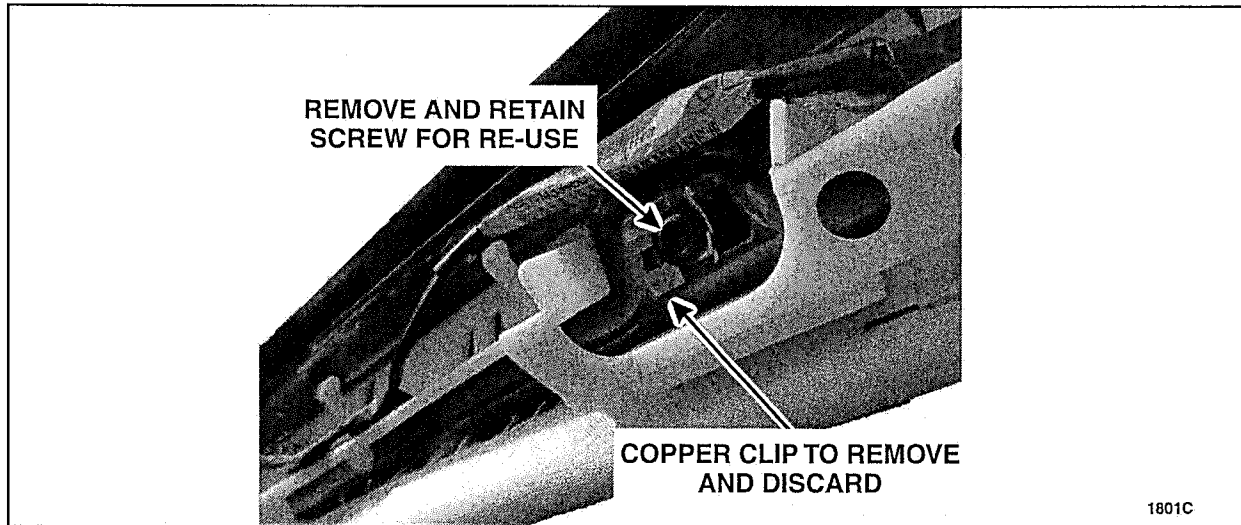
FIGURE 3

3. Remove and discard the top A-Pillar clip from the body. Retain the screw for re-use. See Figure 3.

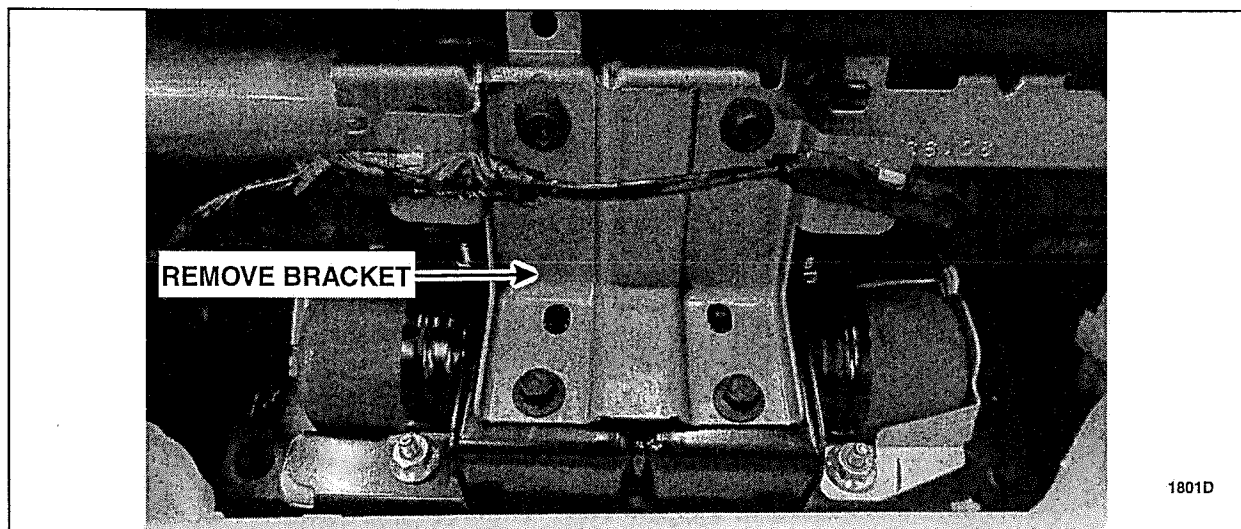
FIGURE 4

- Remove the instrument panel crossmember-to-airbag module bracket. See Figure 4.
- Torque to 80 lb. in (9 Nm).

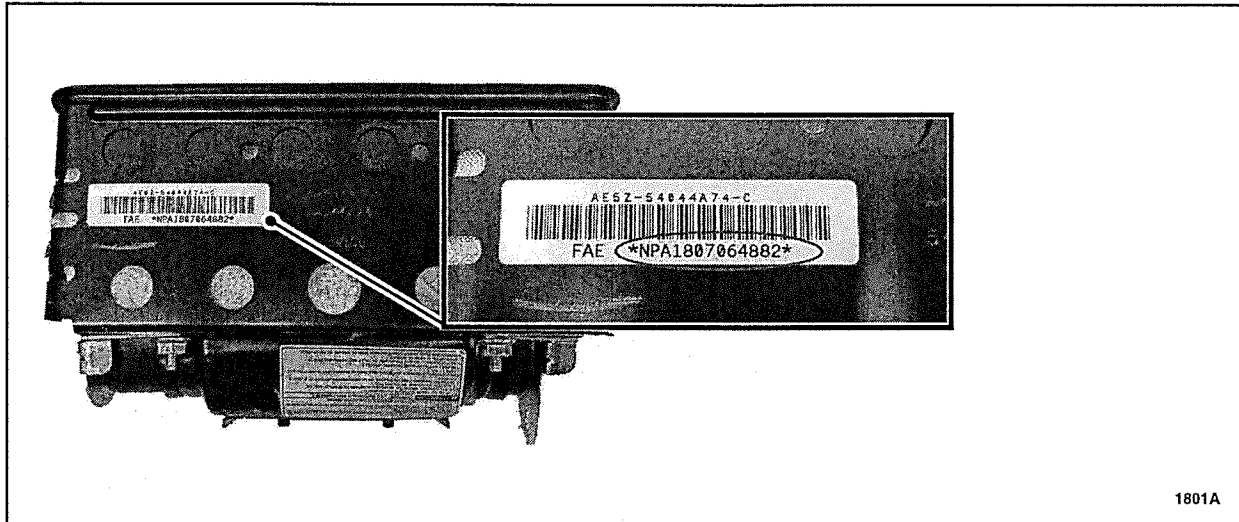
FIGURE 1

1. Record the 13 character serial number of the new airbag module on the repair order. See Figure 1.

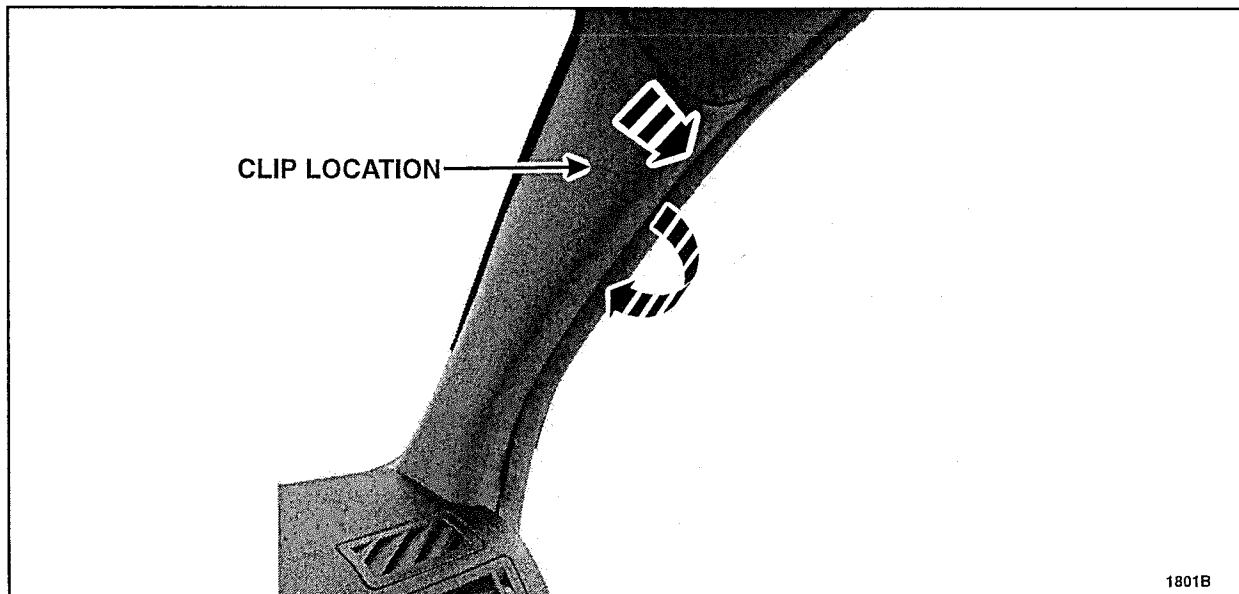
FIGURE 2

2. Remove the left hand and right hand A-Pillar trim panels. Reuse the LH and RH trim panels for this repair. See Figure 2.

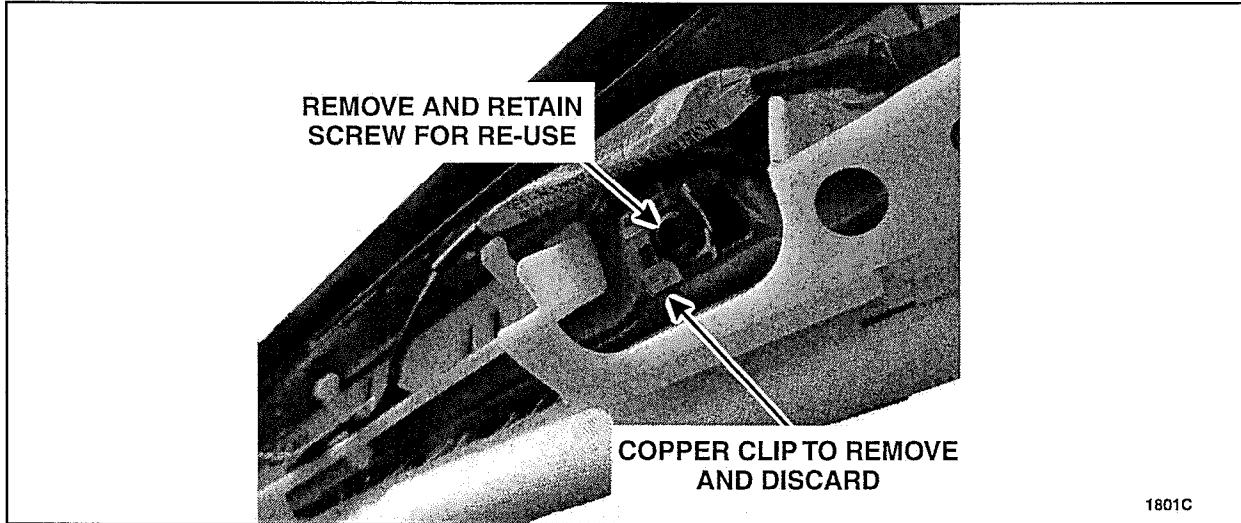
FIGURE 3

3. Remove and discard the top A-Pillar clip from the body. Retain the screw for re-use. See Figure 3.

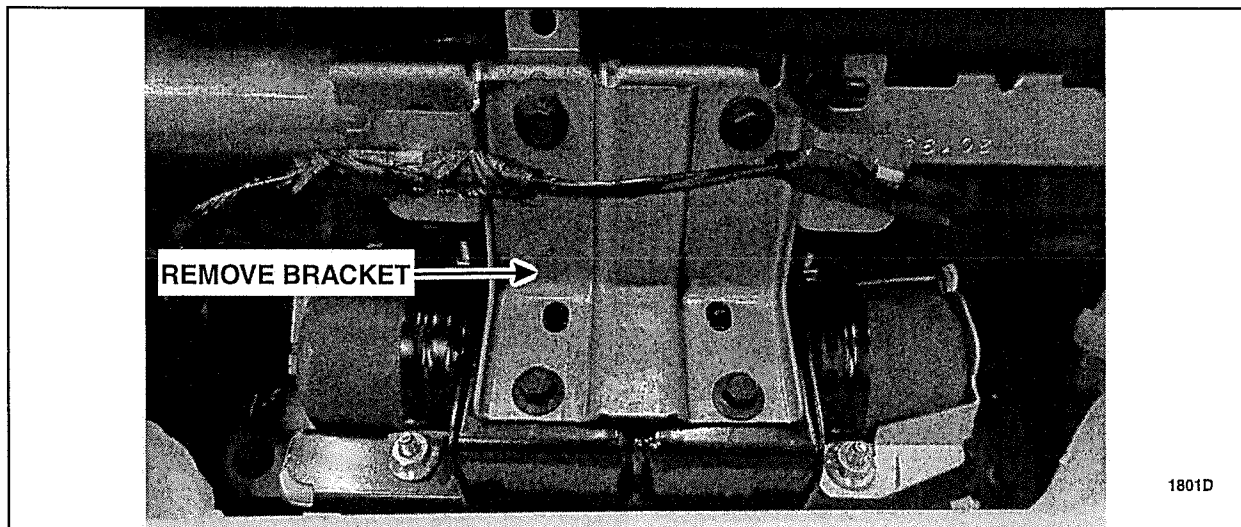
FIGURE 4

- Remove the instrument panel crossmember-to-airbag module bracket. See Figure 4.
- Torque to 80 lb. in (9 Nm).

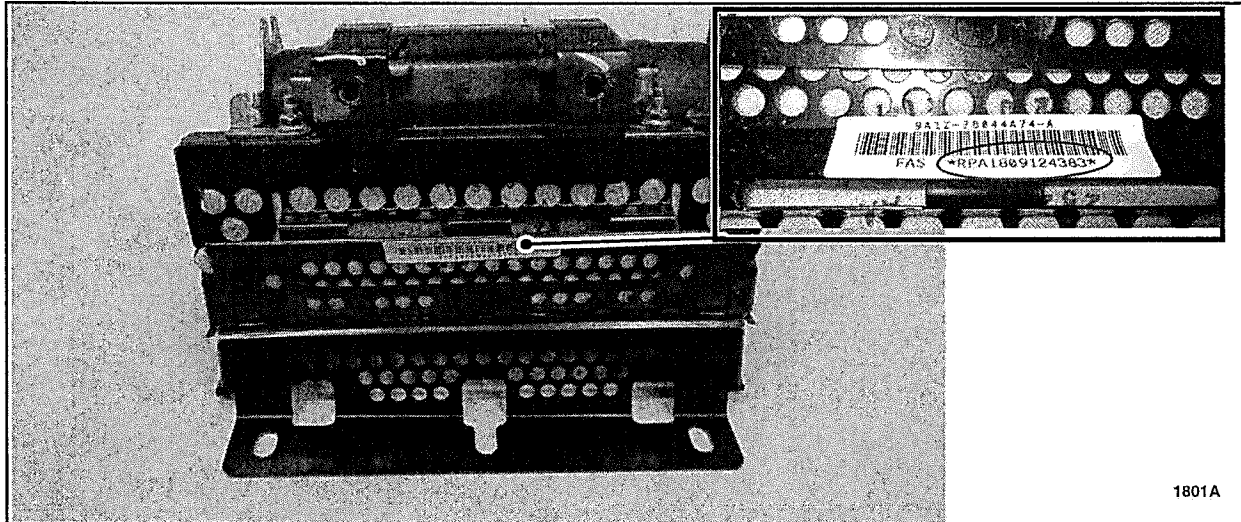
FIGURE 1

1. Record the 13 character serial number of the new airbag module on the repair order. See Figure 1.
2. Replace the passenger airbag module. Refer to section 501-20B of the Workshop Manual.
3. Package the replaced airbag module in the new part box and provide to the appropriate dealership personnel for part returns.
