RECALL BULLETIN:
180322REV

YEAR(S) AFFECTED:
2017-2018

Correction of
Satellite Dish
Mounting

May 2018

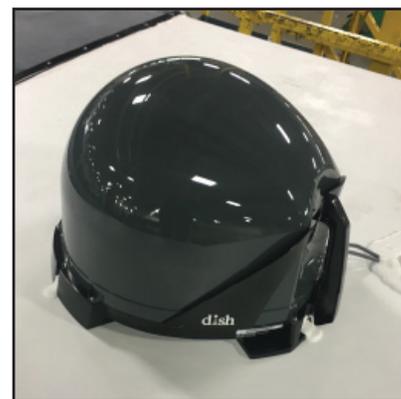
On motorhomes affected by this recall, the Tailgater satellite dish was not properly secured to the roof and may come loose or detach. If the satellite dish detaches from the roof, it could present a road hazard, which may result in personal injury and/or property damage.

2. Block wheels to prevent movement.
3. Use a ladder to access the roof. Bring along 1 tube of white Dicor 502-LSW Self-Leveling sealant, one recall parts kit, and tools. See TOOLS and PARTS lists on Page 4 for detailed specifications.
4. Locate the King Tailgater satellite dish on the roof. See Figure 1 for reference.
