SUBJECT: **NEW VEHICLE DEMONSTRATION / DELIVERY HOLD – Safety Recall 18S09**
 Certain 2017-2018 Model Year F-150 and 2018 Expedition, Navigator and Mustang
 Vehicles Equipped with a 10R80 Transmission
 Park Pawl Guide Cup Roll Pin Inspection

CERTAIN 2017- 2018 F-150 AND 2018 EXPEDITION, NAVIGATOR AND MUSTANG VEHICLES WITH A 10R80 TRANSMISSION – PARK PAWL GUIDE ROLL PIN INSPECTION

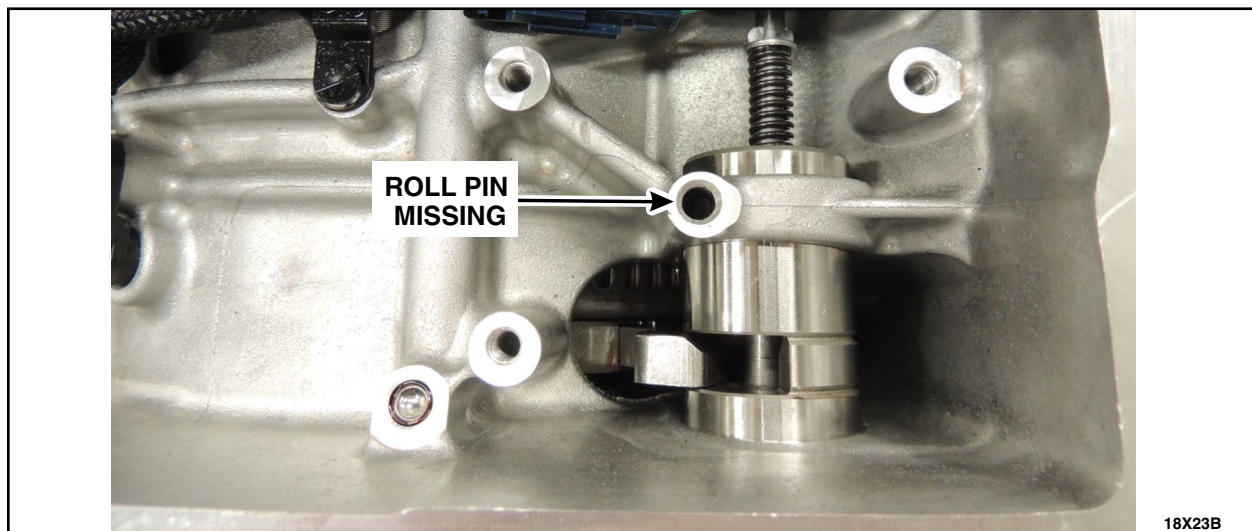
FIGURE 6

8. Inspect for the missing park pawl actuator rod sleeve roll pin. See Figure 6.

- If the park pawl actuator rod sleeve roll pin is missing proceed to Step 9.
- If the park pawl actuator rod sleeve roll pin is present, the vehicle can be reassembled by reversing the removal procedure.
