April 5, 2018

SUBJECT: NEW VEHICLE DEMONSTRATION / DELIVERY HOLD - Safety Recall 18S10
Certain 2018 Model Year Expedition, F-150, F-650 and F-750 Vehicles
Transmission Selector Lever Cable Inspection

CERTAIN 2018 MODEL YEAR EXPEDITION, F-150, F-650 AND F-750 VEHICLES — TRANSMISSION SELECTOR LEVER CABLE INSPECTION

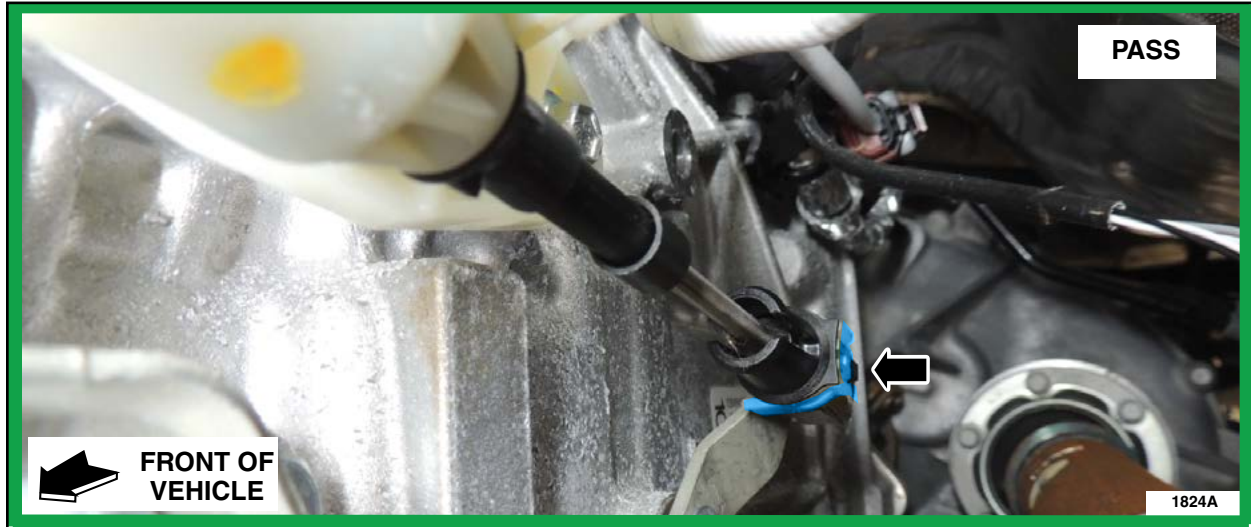
FIGURE 2

4. Inspect the selector lever cable adjuster lock to ensure it is fully seated. See Figures 2 and 3.
- If the cable adjuster lock is fully seated as shown in Figure 2, proceed to Step 5.
 - If the cable adjuster lock is not fully seated as shown in Figure 3, proceed to Step 6.

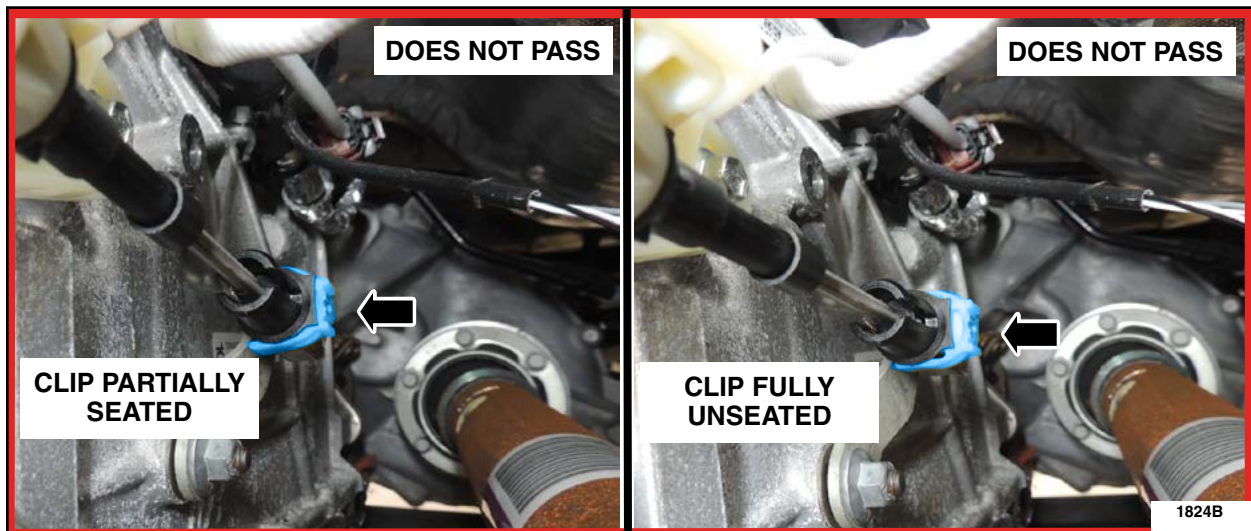
FIGURE 3

In some of the affected vehicles, the transmission selector lever cable adjuster lock clip (located at the transmission end of the selector lever cable) may not be seated properly. This may allow the transmission to be in a state different than the shift lever position selected by the driver.

6. Adjust the selector lever cable. Please follow the Workshop Manual (WSM) procedures in Section 307-05 Automatic Transmission External Controls.
 - The vehicle was previously placed on a hoist with the selector lever in D, during the inspection procedure.
7. Grip the selector lever cable adjuster lock as shown above in Figure 4. Pull on the lock to ensure it is fully seated after the adjustment is completed.
8. If equipped, install the splash shield. See Figure 1.
 - Torque to 71 lb.in (8 Nm).
9. Place the transmission selector lever in the P (Park) position.
