Campaign Service

BULLETIN NUMBER:
CB18-H-001

SAFETY RECALL V1801

BRAKE SWITCH INSPECTION

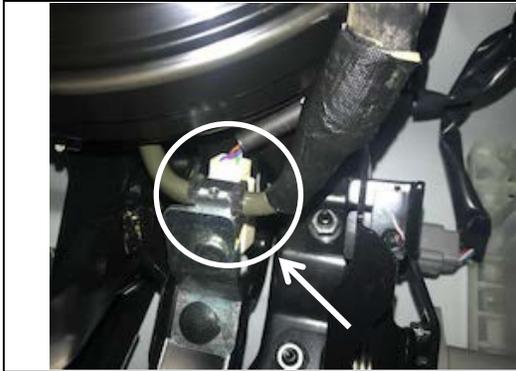
Figure 1

1. Locate the brake switch on the front of the brake pedal bracket. (See Figure 1) The brake switch is installed into the retainer clip (See Figure 2) which is installed onto a flat metal plate on the brake pedal bracket. Ensure to properly illuminate the area with a drop light.

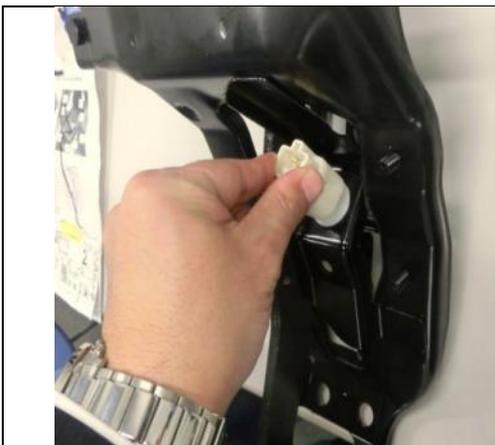
Figure 3

2. Push the brake switch towards the passenger side and then towards the driver side (See Figure 3) to determine if the retainer clip lifts up and forms a gap on either side from the flat metal plate (See Figure 4).
 - a. If the retainer clip **does not** lift up and form a gap, then the clip is fully seated and the campaign **is complete**. Proceed to the “Applying the Campaign Label” section.
 - b. If the retainer clip **does** lift up and form a gap on either side, proceed to Step 3.

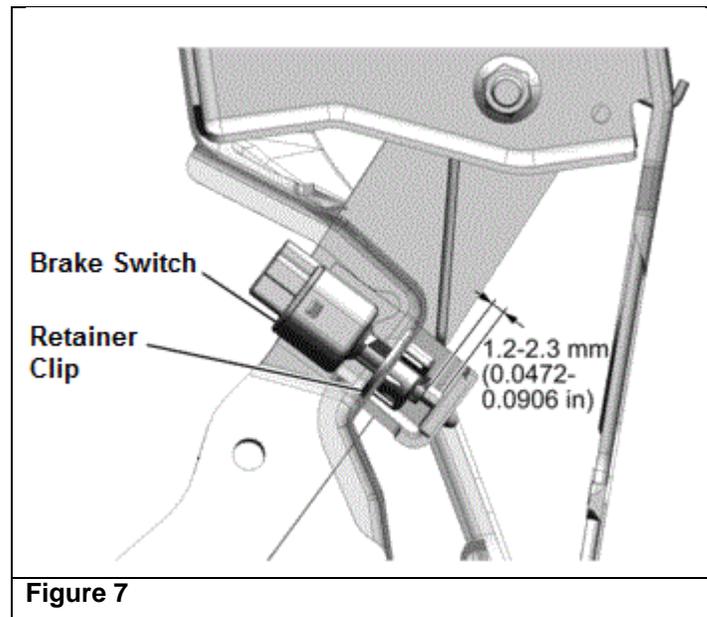
A gap (1.2 to 2.3 mm) between the tip of the threaded portion of the switch and the pedal side bracket will be made automatically when the switch is locked into place by turning. (See Figure 7) This gap is the correct brake switch adjustment.

4. Push inward on the retainer clip with a fingertip – an audible click may be heard.
5. Reinstall the brake switch by inserting the switch into the retainer clip opening, then push inward until the tip of the threaded portion of the switch makes contact with the pedal side bracket. This will depress the brake switch, but not the brake pedal. Rotate the switch clockwise approximately 45° while contact is being made.
