TO: Mercedes-Benz Dealer Principals, General Managers, Sales Managers, Service Managers, Parts Managers	FROM: Gregory Gunther, Department Manager, Vehicle Compliance and Analysis, Engineering Services
RE: <b>Recall Campaign Launch Notification</b> <b>20180500 12 Retrofit Headlamp Sealing Caps</b> <b>MY17 213 (E-Class)</b>	DATE: June 1, 2018

Campaign No. 2018050012, June 2018

SUBJECT: **Model 213 Model Year 2017**  
**Retrofit cover for headlamp adjustment screws at left and right**

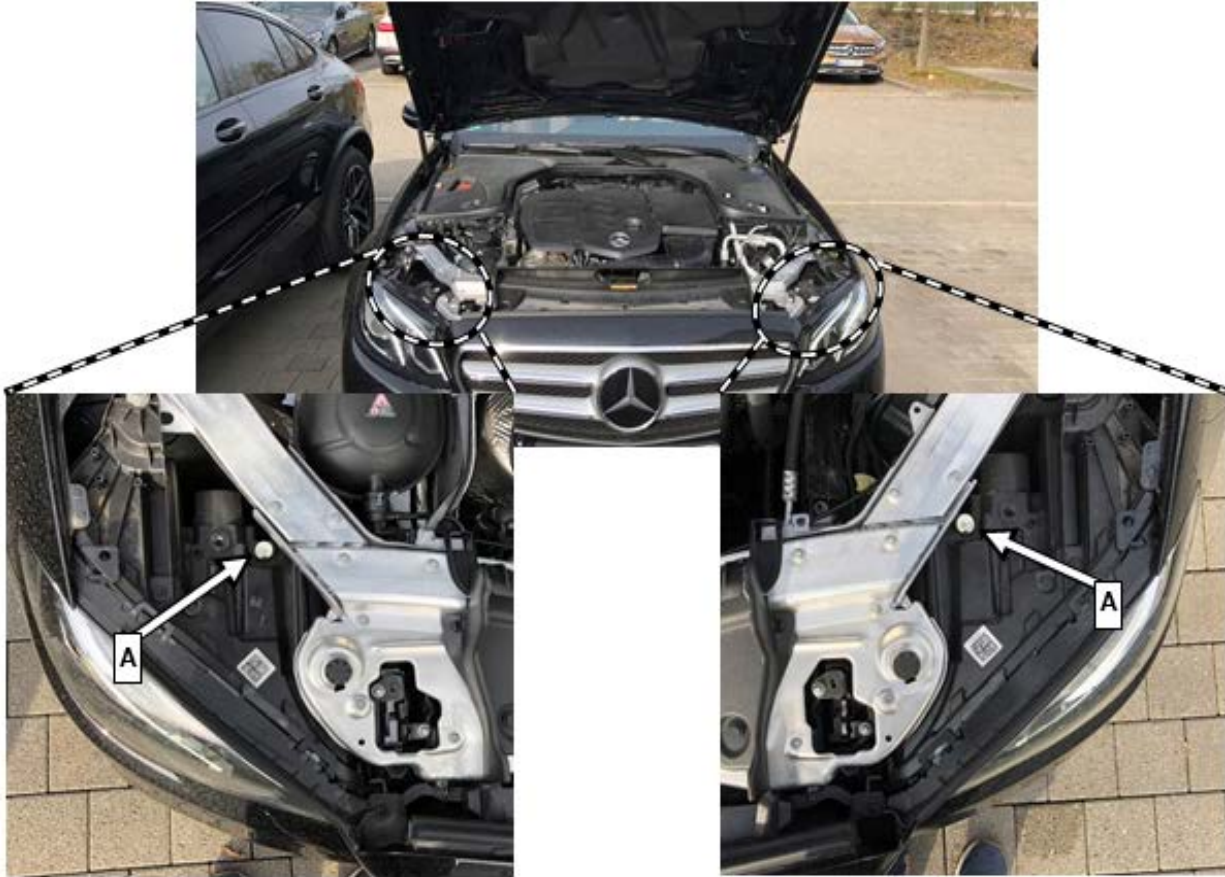
Daimler AG ("DAG"), the manufacturer of Mercedes-Benz vehicles, has determined that on certain E-Class vehicles (213 platform) the horizontal adjustment mechanism might be accessible and therefore not meet the requirement of Federal Motor Vehicle Safety Standards (FMVSS). An authorized Mercedes-Benz dealership will retrofit headlamp sealing caps on the affected vehicles.

1. Open engine hood.
2. Retrofit cover (A) for headlamp adjustment screws at left and right.
