| RE: <b>Recall Campaign 20180600 10</b><br><b>Launch Notification</b><br><b>Replace Rear Insulation Mat</b><br><b>MY08-09 45 1</b><br><b>(smart fortwo)</b> | DATE: July 20, 2018 |

Campaign No. 2018060010, July 2018

SUBJECT: **Smart Fortwo Model 451 Model years 2008-2009**  
**Replace damping in rear engine compartment**

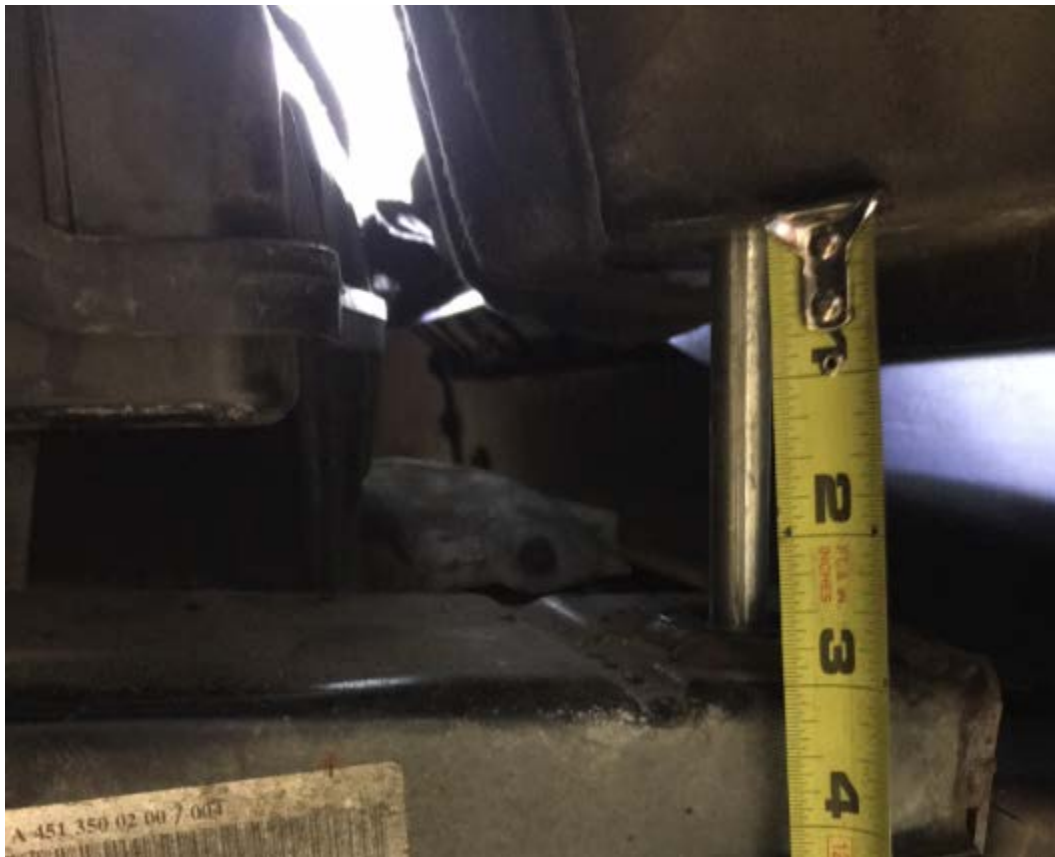
**Figure 1**

**i** The damping can be replaced with the rear drive module lowered only 3 inches (Figure 1).  
Please note: Certain steps in the WIS document AR01.00-P-3050MCU may be omitted: (page 5).

**Procedure****1. Lower rear drive module.**

- Omit lowering the fuel tank (step 11)
- Omit removing the air filter housing (step 3)
- Omit disconnecting the park paw cable (step 4)

**i** Make sure the A/C lines are not making contact with the fuel tank when lowering the rear drive module.
