TO: Freightliner and Mercedes-Benz Dealer Principals, General Managers, Sales Managers, Service Managers, Parts Managers	FROM: Michael Scott, Vans Regulations and Certifications
RE: <b>Recall Campaign Launch Notification MY17 906 (Sprinter) Spot Welds</b>	DATE: June 21, 2018

Campaign No. 2018060009, June 2018

SUBJECT: **Model 906 (Sprinter), Model Year 2017**  
**Spot Welds on Front Side Wall Paneling**

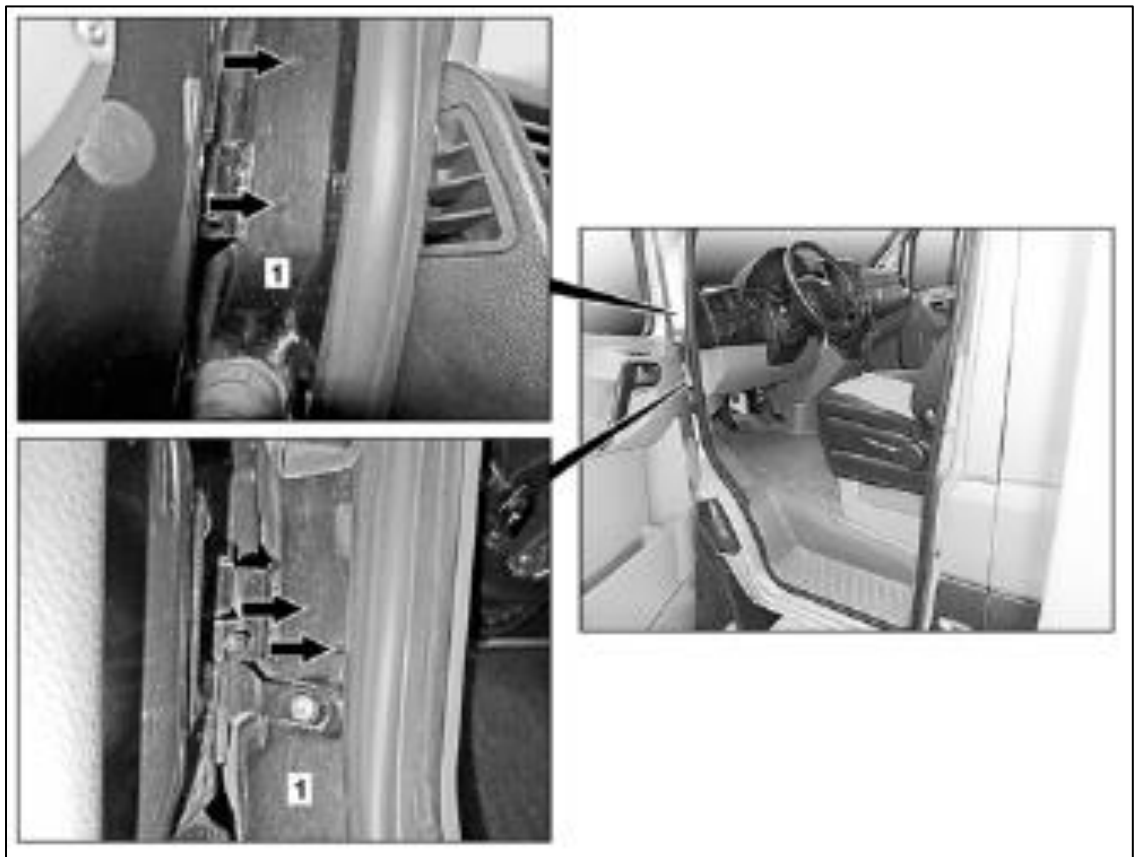
1 A-pillar

Daimler AG (DAG), the manufacturer of Mercedes-Benz Vans, has determined that on certain Mercedes-Benz and Freightliner Sprinter vehicles, spot welds might be missing on the front side wall on the driver and/or the passenger side. The affected spot welds connect the door portal with the underlying hinge reinforcements behind. If the missing welds affect body strength, there may be an increased risk of injury in the event of a crash. An authorized Mercedes-Benz or Freightliner Sprinter dealer will check if any of the welds on the A-pillar are missing. If necessary, the affected vehicles will be reworked by setting the missing weld spots at the front side wall panelling.

Check		
1	Check whether vehicle is affected by measure	<p><b>i</b></p> <p>For authorized Mercedes-Benz service partners, only the entry in the "Extended VEGA Application" (EVA) system, in the "Current" tab is decisive. An additional test of the affected vehicles in the workshop information system (WIS) or vehicle list is thereby not necessary.</p>
2	Check whether spot welds (arrows) are present on A-pillar (1).	<p><b>i</b></p> <p>Check A-pillars (1) on driver and front passenger side.</p> <p><b>i</b></p> <p>Clean A-pillars (1) before visual check with a rag.</p> <p>If spot welds (arrows) are present,</p> <p style="text-align: center;">↓</p> <p>end the measure.</p> <p>If no spot welds (arrows) are present,</p> <p style="text-align: center;">↓</p> <p>continue with operation step 3.</p>
Remove		
3	Remove respective front door.	
4	Remove respective fender.	
5	Cover all detachable parts remaining in vehicle with welding protection blankets.

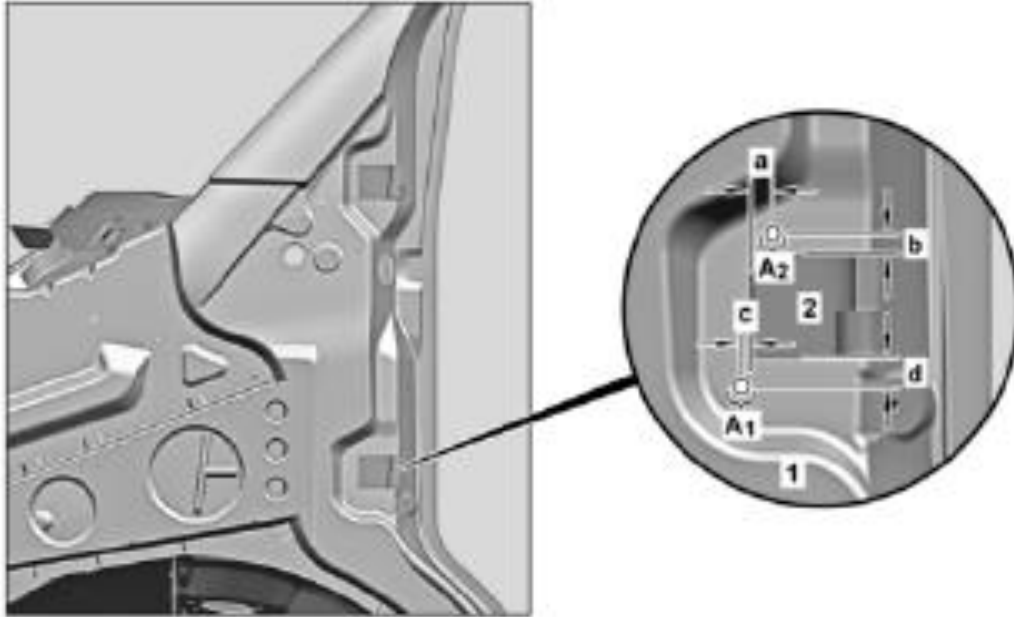
a Dimension (9 mm) b Dimension (12 mm) c Dimension (9 mm) d Dimension (15 mm)

Observe dimensions (a, b, c, d). The edges of the hinge holder (2) act here as reference edges.

1 Use spot-weld cutter to cut holes on A-pillar outer section (1) next to lower hinge holder (2) of front door (areas A<sub>1</sub> and A<sub>2</sub>).

Never cut through 2 panel thicknesses. Otherwise, inert gas plug welding will no longer be possible.

2 Grind A-pillar outer section (1) down to bare metal around the holes (areas A<sub>1</sub> and A<sub>2</sub>).

3 Remove shavings and milling chips.
