TO: Mercedes-Benz Dealer Principals, General Managers, Sales Managers, Service Managers, Parts Managers	FROM: Michael Scott, DM Regulatory Management and Campaigns
RE: Recall Campaign Launch Notification MY15 - MY17 447 (Metris) Mercedes-Benz Transmission Carrier Attachment	DATE: June 21, 2018

Campaign No. 2018060012, June 2018

SUBJECT: **Model 447 (Metris), Model Year 2015 - 2017
Transmission Carrier Attachment**

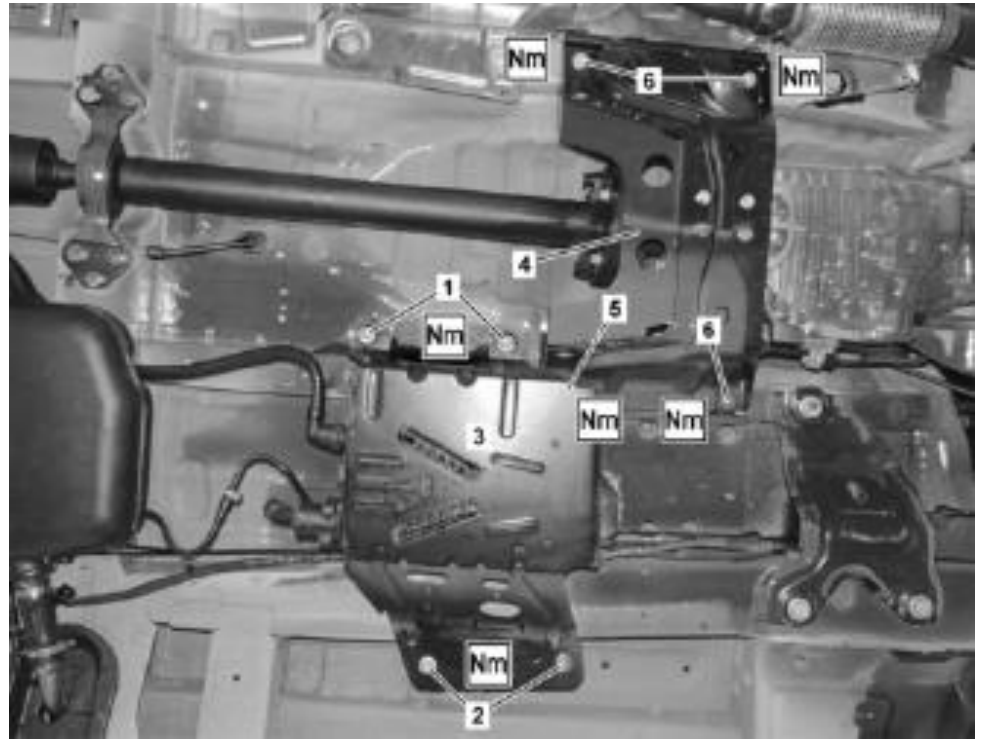
Daimler AG, the manufacturer of Mercedes-Benz Metris vehicles, has determined that in certain vehicles (Platform 447), the screw connection of the transmission carrier to the vehicle body may not be tightened with the specified torque. If the screw connection of the transmission carrier is not sufficiently torqued, the bolts could loosen and subsequently lose connection with the vehicle. In that event, the position of the transmission carrier and the angle of the propeller shaft to the transmission could change. If this angle exceeds a certain degree, the joint disc could be damaged and lead to its complete failure. The customer will be alerted to clear warning signs of vibrations and rattling noises during operation of the vehicle prior to such loss of power. In this case, the vehicle would remain controllable (steering and braking would not be affected). However, an increased risk of a crash cannot be ruled out. An authorized Mercedes-Benz dealer will perform a check of the bolts on all potentially affected Metris vehicles and replace the bolts if necessary.

- 1 Bolts
- 2 Bolts
- 3 Activated charcoal canister bracket
- 4 Transmission carrier
- 5 Screw
- 6 Bolts

Check		
1	Check whether vehicle is affected by measure.	i For authorized Mercedes-Benz service partners, only the entry in the "Extended VEGA Application" (EVA) system, in the "Current" tab is decisive. An additional test of the affected vehicles in the workshop information system (WIS) or in the vehicle list is thereby not necessary.
Remove		
2	Raise vehicle.	
3	Remove bolts (1) of activated charcoal canister holder (3).

4	Unfasten bolts (2) of activated charcoal canister holder (3) by a few turns.	Do not stretch electric lines as well as hoses and lines of activated charcoal canister. Damage may occur otherwise. i To gain access to the bolt (5), release bolts (2) only. The bracket for the activated charcoal canister (3) remains mounted to the vehicle.
Check		
5	Check torque of bolts (5, 6) of transmission carrier (4).	When checking the torque none of the bolts (5, 6) may turn before the torque value is reached. If one of the bolts (5, 6) turns replace it. Otherwise, the correct tightening torque for the respective bolts (5, 6) cannot be assured. Nm Bolt, transmission carrier to longitudinal member If bolts (5, 6) turn before the torque value is reached. ↓ Replace relevant bolts (5, 6).
Install		
6	Screw bolt (1, 2) into activated charcoal canister holder (3).	Nm M8
7	Lower vehicle.

Number	Designation		Model 447 with engine 274, 651 Model 448 with engine 274
BA22.10- N-1002-01EE	Bolt, transmission carrier to longitudinal member	Nm	58
