Subject: Delivery Stop & Recall 18V-XXX: Check & Replace Steering Wheel

SI B32 06 18
Steering and Wheel Alignment

DELIVERY STOP & RECALL 18V-XXX: CHECK AND REPLACE STEERING WHEEL

G01 (X3 SAV)

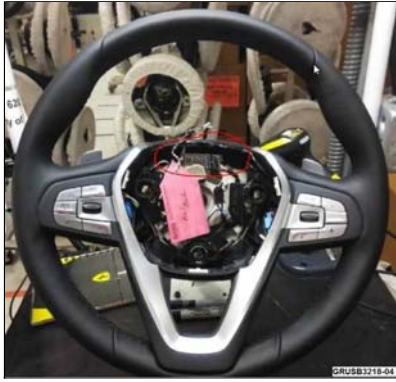
The bar code label for the steering wheel can be found in the circled area as shown on left.

Check the serial number on the bar code label as shown and compare it to the list below.

Only the middle series of numbers in the serial number will change between vehicles.

If the serial number matches the list to the left, then the steering wheel should be replaced as described in repair manual 32 33 015.
