TO: Mercedes-Benz Dealer Principals, General Managers, Sales Managers, Service Managers, Parts Managers	FROM: Gregory Gunther, Department Manager, Vehicle Compliance and Analysis, Engineering Services
RE: <b>Recall Campaign Launch Notification</b> <b>2018080001</b> <b>Replace Prefuse Box</b> <b>MY18 217 222 (S-Class Coupe, S-Class)</b>	DATE: August 17, 2018

Campaign No. 2018080001, August 2018

SUBJECT: **Models S-Class and S-Class Coupe vehicles (222, 217 platform)  
Model Year 2018  
Check Nuts of Prefuse Box, Replace if Necessary**

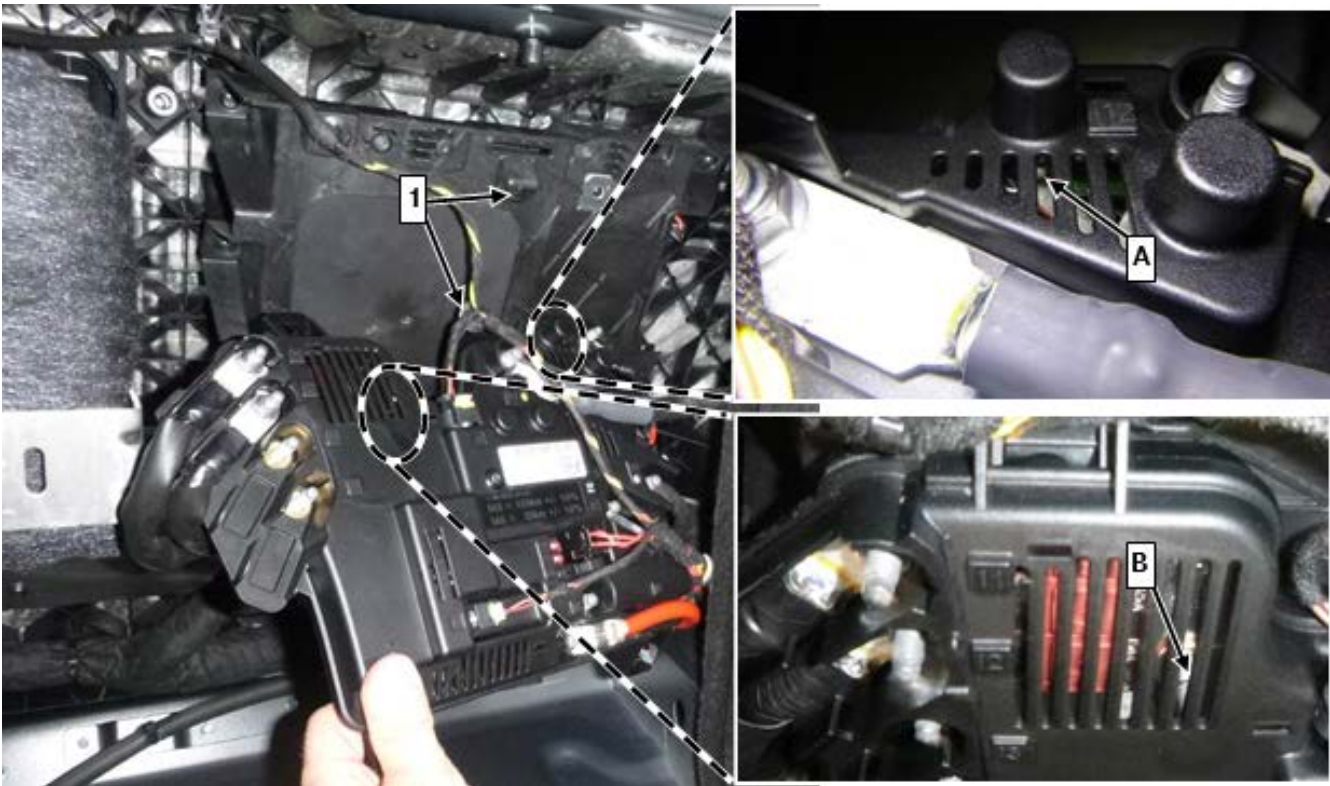
Figure 1

1. Disconnect ground line of battery (**AR54.10-P-0003LF**).
2. Expose rear prefuse box.  
Basic data model 217: **AR54.15-P-1340LC**  
Basic data model 222: **AR54.15-P-1340LF**
3. Loosen clip and four screws for the prefuse box (**1, figure 1**). Together with the connected lines, tilt the prefuse box slightly downward.
4. Check to see if the nuts (**A and B, figure 1**) are present.  
**i** It is **essential** that **both** nuts (**A and B, figure 2**) be present.

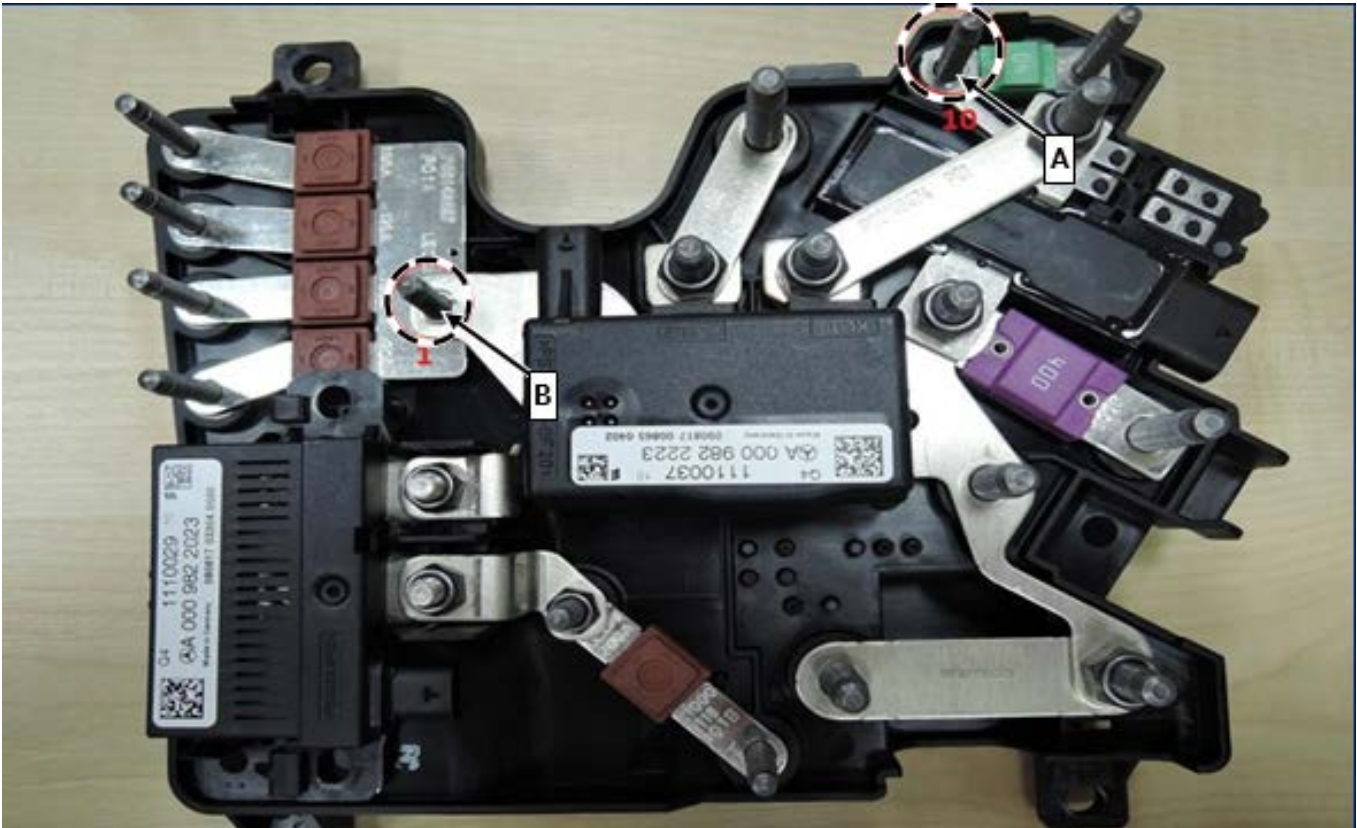
**Figure 2**

Daimler AG, (“DAG”) the manufacturer of Mercedes-Benz vehicles, has determined that on certain S-Class and S-Class Coupe vehicles (222, 217 platform), two nuts which secure the power bars inside the pre-fuse-box in the trunk might not have been installed during the production process. Power bars that are not secure inside the pre-fuse box could result in higher electrical resistance between them increasing the risk of fire. Additionally, intermittent contact between the power bars could lead to loss of certain vehicle functions. Such loss could lead to impairment of engine operation, the seat belt functions and the instrument cluster, increasing the risk of a crash. As a precautionary measure an authorized Mercedes-Benz dealer will check the pre-fuse-box on the affected vehicles and install the two nuts, if necessary.

- a. If the nuts (**A or B**) are not present: **perform work procedure.**
- b. If the nuts (**A and B**) are present: **end measure.**

1. Replace prefuse box.  
Model 217: **AR54.15-P-1340LC**  
Model 222: **AR54.15-P-1340LF**
2. Assemble in reverse order.
