TO: Mercedes-Benz Dealer Principals, General Managers, Sales Managers, Service Managers, Parts Managers	FROM: Gregory Gunther, Department Manager, Vehicle Compliance and Analysis, Engineering Services
RE: <b>Recall Campaign Launch Notification</b> <b>2018070012</b> <b>Check Rear Beltline Trim – Phase 2</b> <b>MY17-18 A205 (C-Class Cabriolet)</b>	DATE: September 14, 2018

Campaign No. 2018070012, September 2018

SUBJECT: **Model: C-Class Cabriolet (A205 platform) Model Years: 2017-2018**  
**Check Rear Beltline Trim**

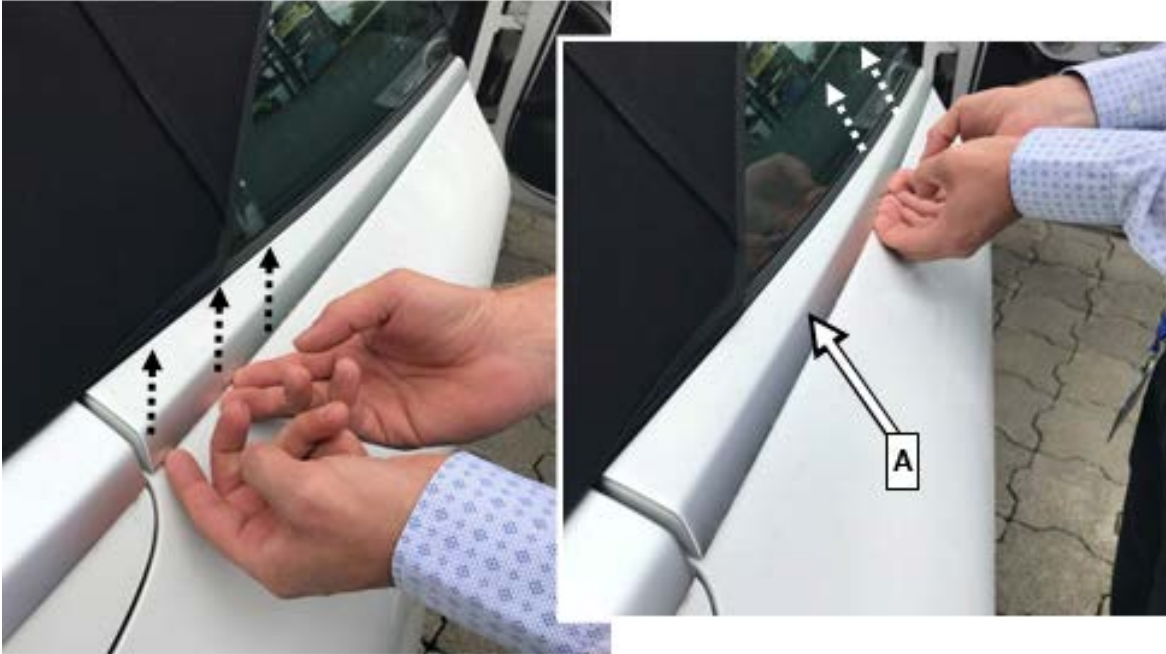
Figure 1

**i** To do so, pull trim element (**A, Figure 1**) upwards.

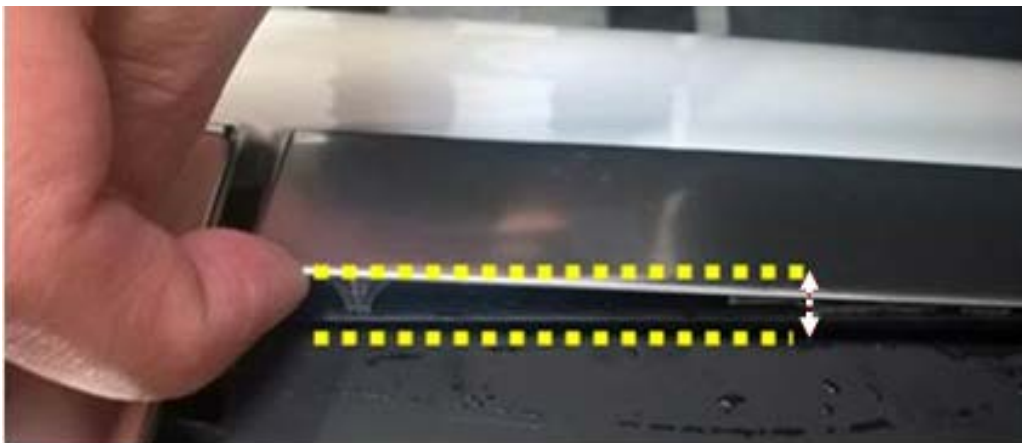
Figure 2

**i** The bonding between the trim element and plastic basic carrier rail may become detached (**Figure 2**).

- a. Trim element can be detached from the plastic basic carrier rail: Perform **work procedure**.
- b. Trim element **cannot** be detached from plastic basic carrier rail: **End measure**.
