**SUBJECT: NEW VEHICLE DEMONSTRATION / DELIVERY HOLD - Safety Recall 18S21**  
Certain 2018 Model Year F-53 Motorhome Chassis  
Front Wheel Studs

## CERTAIN 2018 MODEL YEAR F-53 MOTORHOME CHASSIS - FRONT WHEEL STUDS

### OVERVIEW

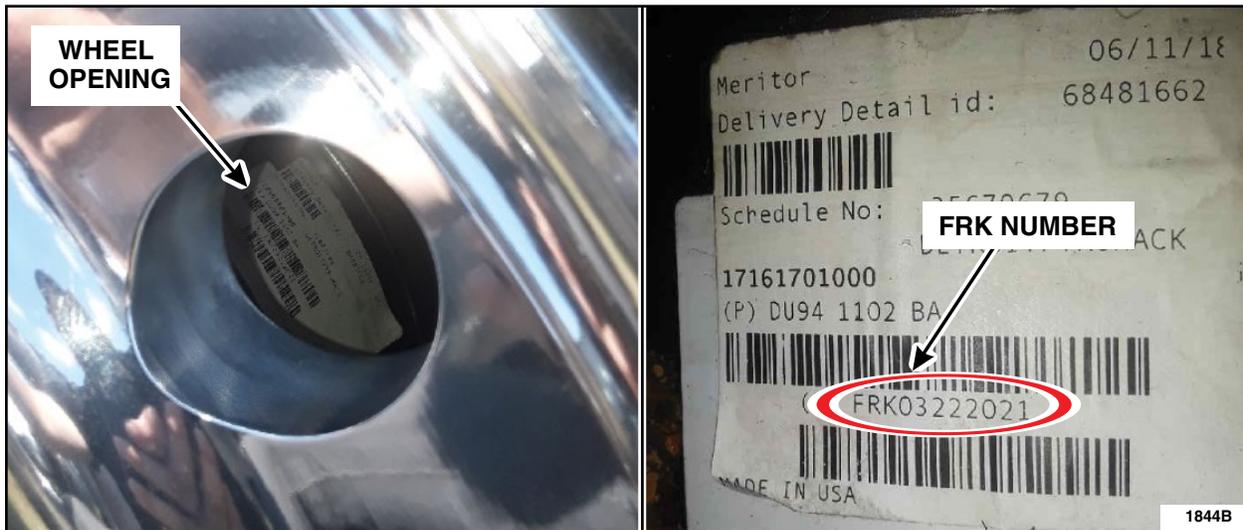
FIGURE 1

1. Locate the printed label on each front wheel hub and rotor assembly by viewing it through the wheel openings. See Figure 1.
2. Record the serial numbers printed on the labels starting with the letters "FRK". See Figure 1.
  - If left hand or right hand wheel hub assembly serial numbers fall between the ranges in the table below, the wheel studs are suspect and need to be individually inspected, proceed to Step 3.

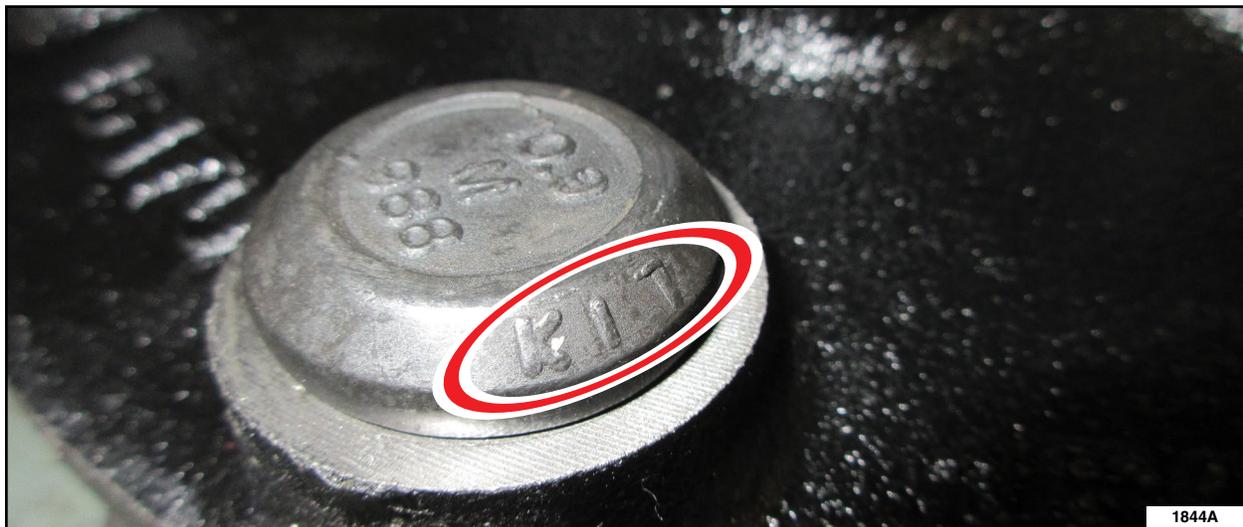
FIGURE 2

- If the hub assembly label is missing or illegible, the wheel studs are suspect and need to be individually inspected, proceed to Step 3.
  - If neither hub assembly serial number falls within the range listed, the inspection is complete.
3. Remove the wheel from the affected hub assembly (or assemblies).
  4. Inspect the head of each wheel stud. Studs marked with K17 must be replaced. See Figure 2. Proceed to the proper repair based on the vehicle's GVW as listed below.
    - If no wheel studs are marked with K17 then the inspection is complete.

5. Remove the wheel hub. Please refer to Workshop Manual (WSM) procedures in section 204-01.
6. Remove the brake disc. Please refer to WSM procedures in section 206-03.
7. Replace the affected wheel studs. Please refer to WSM procedures in section 204-01.

8. Replace the affected wheel studs. Please refer to WSM procedures in section 204-01.
