David J. Johnson
 Director
 Service Engineering Operations
 Ford Customer Service Division

October 8, 2019

SUBJECT: NEW VEHICLE DEMONSTRATION / DELIVERY HOLD
Safety Recall 18S20 – Supplement 1
 Certain 2013-2016 Fusion and 2013-2014 Escape with a 6F35 Transmission
 Shift Cable Bushing Replacement and Protective Service Cap

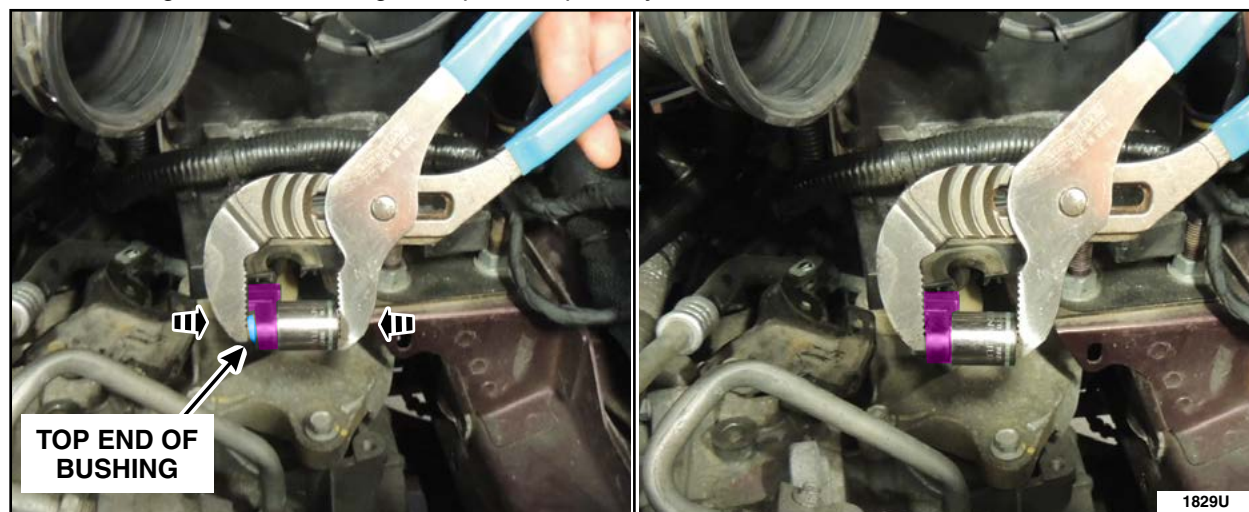
FIGURE 4

NOTE: For all 2013 Fusion and Escape vehicles equipped with original shift cable, the bushing is taller than the replacement bushing.

6. Using a pair of Straight Jaw Adjustable pliers and a 15mm shallow socket push the bushing partially out of the selector lever cable end. See Figure 4.

- Use caution not to damage the shifter cable during this procedure.
- Inspect for damage before installing the new shifter cable bushing.

NOTE: The 15mm socket will rest against the hard plastic bottom end of shift cable, and will be large enough to allow bushing to be pressed partially out.
