July 2019  
FL780AB  
NHTSA #18V-491  
Transport Canada #2018-387  
SECOND REVISED NOTICE

## Subject: Cascadia ICUC Bulb Check Function

**Models Affected:** Specific Freightliner Cascadia vehicles manufactured May 3, 2016, through July 11, 2018, and equipped with a certain ICUC.

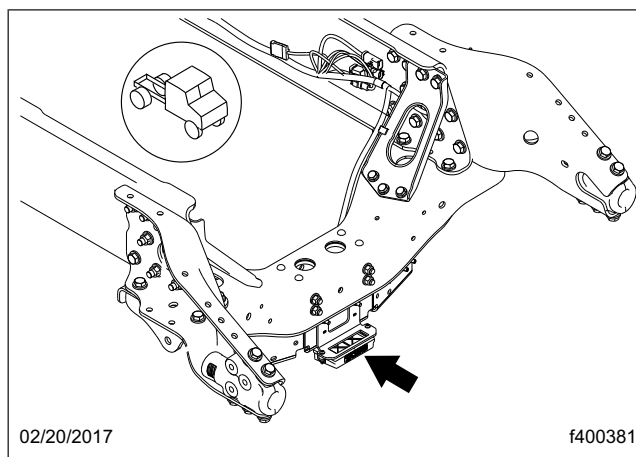
**Fig. 5, TPMS Receiver**

28. Disconnect the wiring harness and antenna cable from the TPMS ECU Receiver. See [Fig. 5](#).

29. Remove the two M6 x 1 flange-head capscrews and remove the TPMS ECU Receiver.
30. Use the existing bolt holes and the two M6 x 1 flange-head capscrews to attach the new TPMS ECU Receiver to the vehicle. Tighten the capscrews 7 to 10 lbf·in (79 to 158 N·cm).
31. With the ignition off, connect the wiring harness and antenna cable to the TPMS ECU Receiver.
32. Install the front bumper. Refer to Section 31.02, Subject 100 in the *New Cascadia Workshop Manual* for instructions.
33. Connect batteries and turn ignition on. Wait 10 seconds, then follow the DTNA\_ECUSwap prompts and press OK. Continue to follow the prompts to transfer the configuration to the new TPMS ECU. When complete, the following message will display: "ECU Configuration has been successfully transferred."

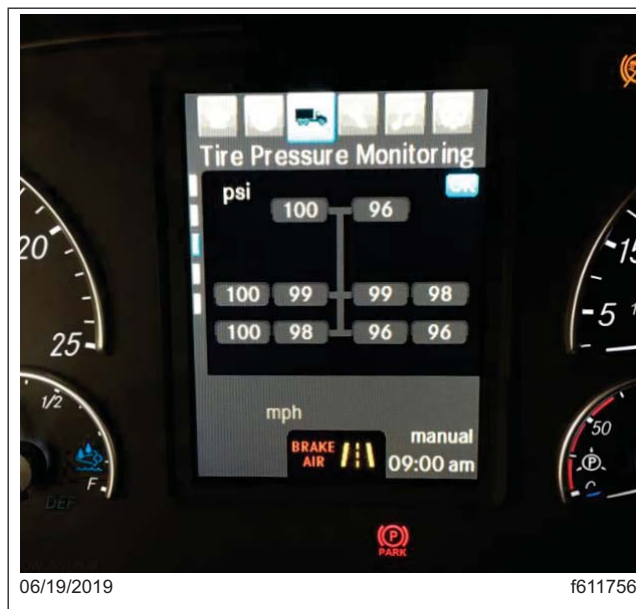
**Fig. 6, ICUC Tire Pressure Monitoring Screen**

34. Turn the ignition to the ON position, and verify that the TPMS sensor readings are present. Use the left-hand steering wheel buttons to scroll to the ICUC Tire Pressure Monitoring screen. See [Fig. 6](#) . Tire pressures should be present for each configured axle.
