TO: Mercedes-Benz Dealer Principals, General Managers, Sales Managers, Service Managers, Parts Managers	FROM: Heike Scheuble, General Manager, Aftersales
RE: Recall Campaign Notification MY17 - MY18 447 Mercedes-Benz Metris Transmission Flange	DATE: September 4, 2018

Campaign No. :	Campaign Desc. :	Transmission Flange
2018080018	VS2FLANGE	
<p>This is to notify you of the upcoming Recall Campaign to replace the transmission flange and the affected bolts on approximately 6 MY17-MY18 Mercedes-Benz Metris (447) vehicles. The recall campaign will be visible on the www.safercar.gov website and may generate questions from customers. All affected VINs are flagged as "OPEN" on September 17, 2018.</p>		
Background		
Issue	<p>Daimler AG, the manufacturer of Mercedes-Benz vans, has determined that in certain Mercedes-Benz Metris vehicles (VS20 - platform 447) for the US-market, automatic transmissions with high levels of corrosion on the transmission flange may have been incorrectly installed. Therefore, the screw connections to the transmission flanges may not be correct on the affected vehicles. If the screw connection to the transmission flange is not sufficient, the bolts could loosen and

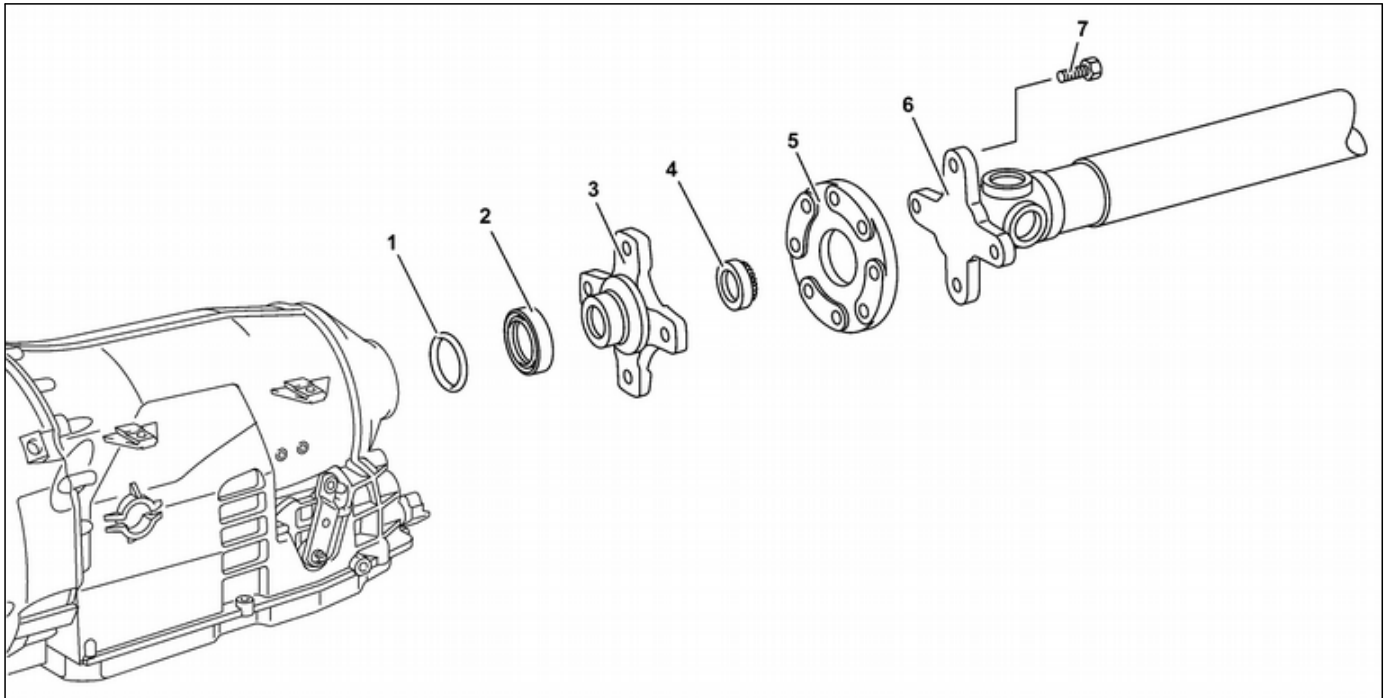
Daimler AG, the manufacturer of Mercedes-Benz vans, has determined that in certain Mercedes-Benz Metris vehicles (VS20 - platform 447) for the US-market, automatic transmissions with high levels of corrosion on the transmission flange may have been incorrectly installed. Therefore, the screw connections to the transmission flanges may not be correct on the affected vehicles. If the screw connection to the transmission flange is not sufficient, the bolts could loosen and subsequently lose connection with the vehicle. Should a customer ignore the clear warning signs and continue to operate the vehicle, the propeller shaft could fall onto the transmission cross member and result in an abrupt loss of motive power. If this occurs while driving, the drive shaft would continue to turn in an uncontrolled manner and further consequential damage to adjacent components could occur. This may increase the risk of a crash. An authorized Mercedes-Benz dealer will replace the transmission flange and the affected bolts, and clean the shaft seal on all potentially affected vehicles.

2 Radial shaft sealing ring

3 Output flange

5	Replace radial shaft sealing ring (2) and output flange (3).	Thoroughly clean area of radial shaft sealing ring (2). Otherwise, the smallest dirt particles in the hydraulic components can lead to malfunctions and a total failure of the transmission.
	Install	
6	Install engine cross member at rear.	
7	Disconnect diagnostic unit.
