David J. Johnson
Director
Service Engineering Operations
Ford Customer Service Division

August 30, 2018

SUBJECT: NEW VEHICLE DEMONSTRATION / DELIVERY HOLD - Safety Recall 18S25
Certain 2018 Edge and MKX, and 2019 Flex and MKT Vehicles
Generator and Starter Motor Cable Nuts

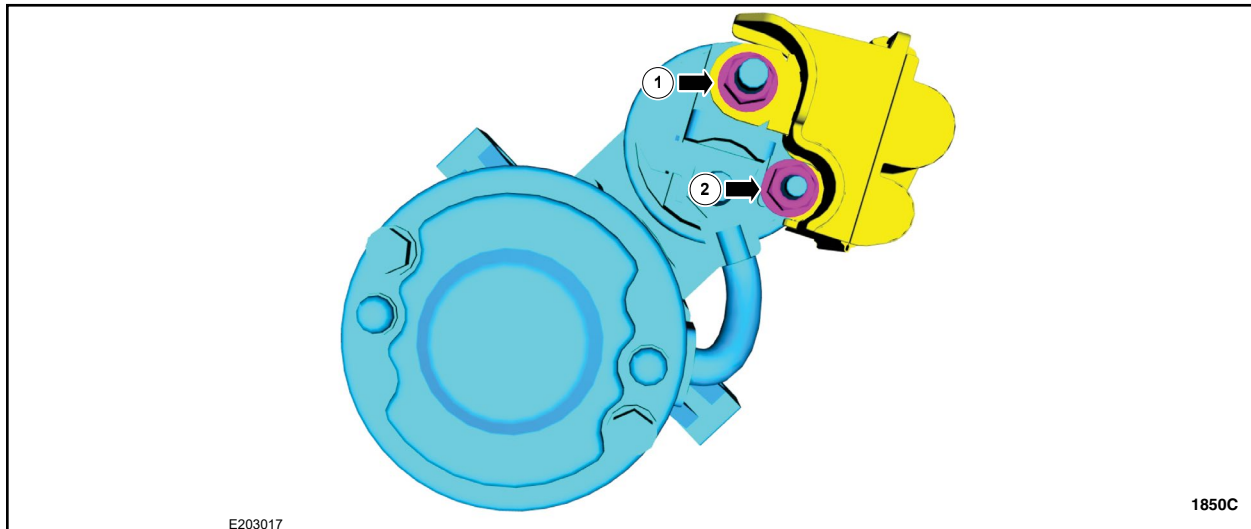
FIGURE 4

5. Inspect the starter motor battery positive cable nut and stud and the starter control wire nut and stud for cross threading or damage and torque both nuts. See Figure 4.

- Battery positive cable: Torque to 106 lb.in (12 Nm).
- Starter motor control wire: Torque to 53 lb.in (6 Nm).

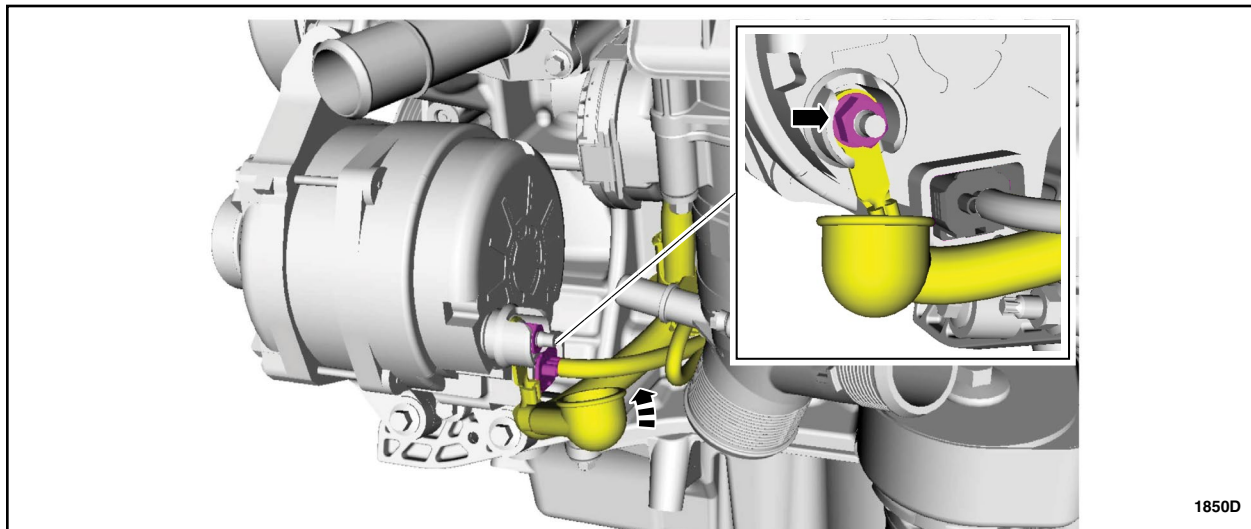
FIGURE 5

6. Inspect the generator battery positive cable nut and stud for cross threading and torque the nut. See Figure 5.

- Torque to 150 lb.in (17 Nm).

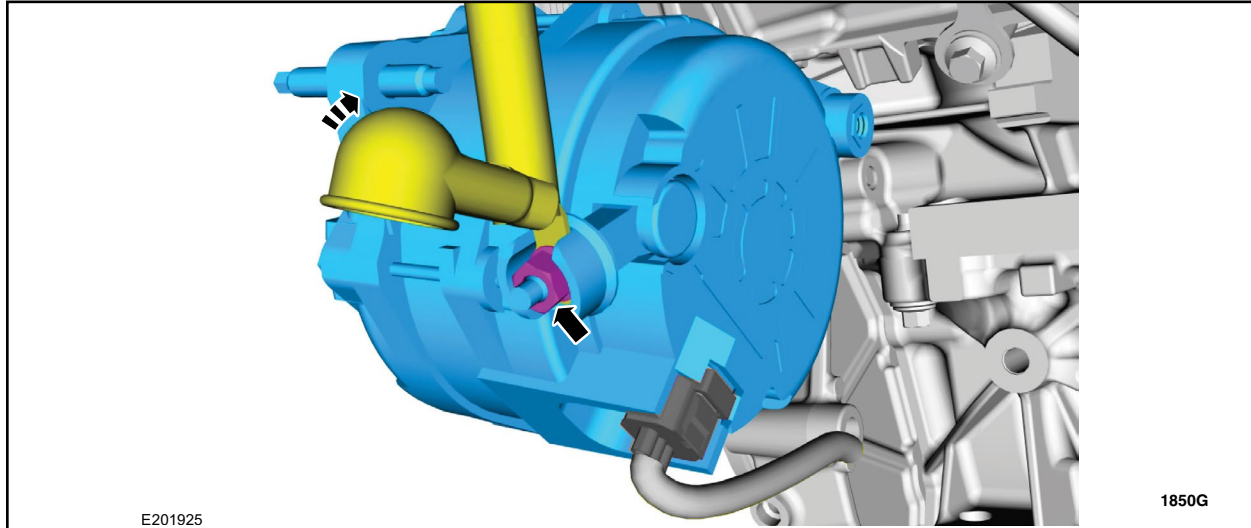
FIGURE 8

5. Inspect the generator battery positive cable nut and stud for cross threading and torque the nut.
See Figure 8.

- Torque to 150 lb.in (17 Nm).

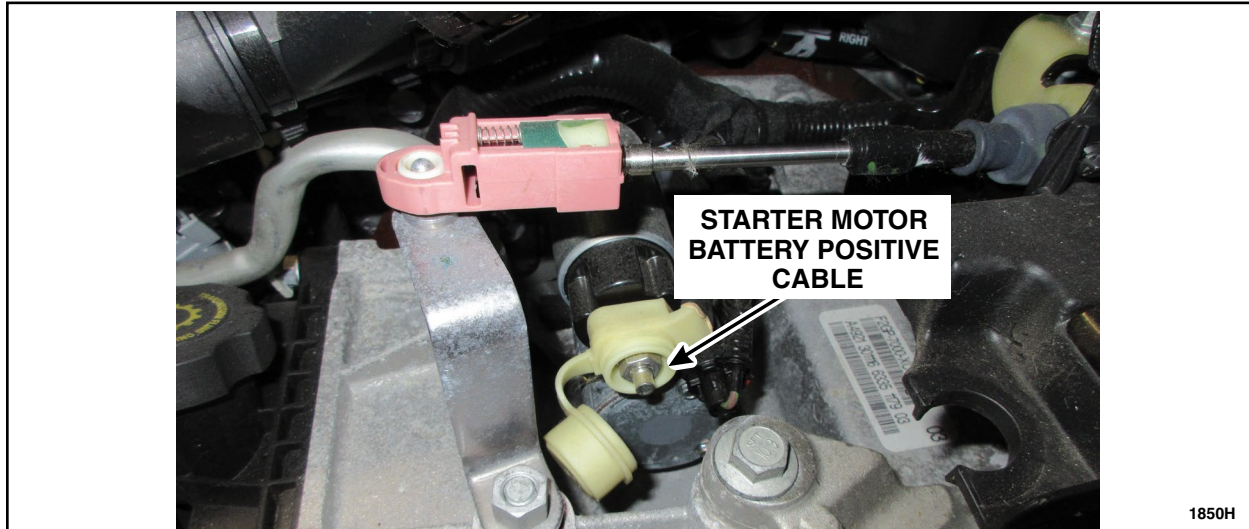
FIGURE 9

6. Remove the air cleaner. Please refer to WSM procedures in section 303-12B.
7. Inspect the starter motor battery positive cable nut and stud for cross threading or damage and torque the nut. See Figure 9.
 - Torque to 106 lb.in (12 Nm).

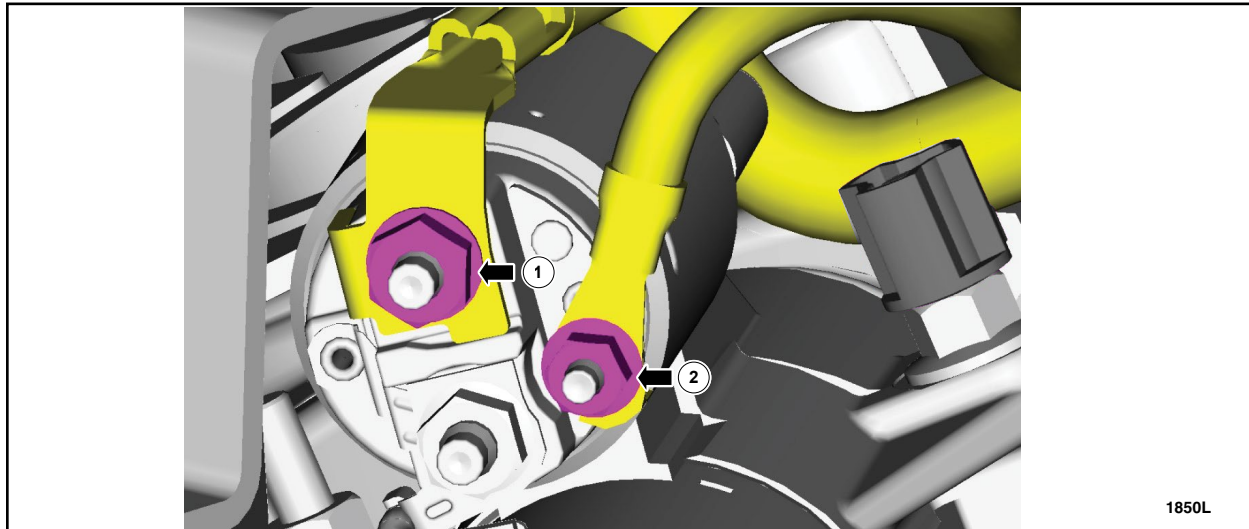
FIGURE 12

4. Inspect the starter motor battery positive cable nut and stud and the starter control wire nut and stud for cross threading or damage and torque both nuts. See Figure 12.

- Battery positive cable: Torque to 106 lb.in (12 Nm).
- Starter motor control wire: Torque to 53 lb.in (6 Nm).

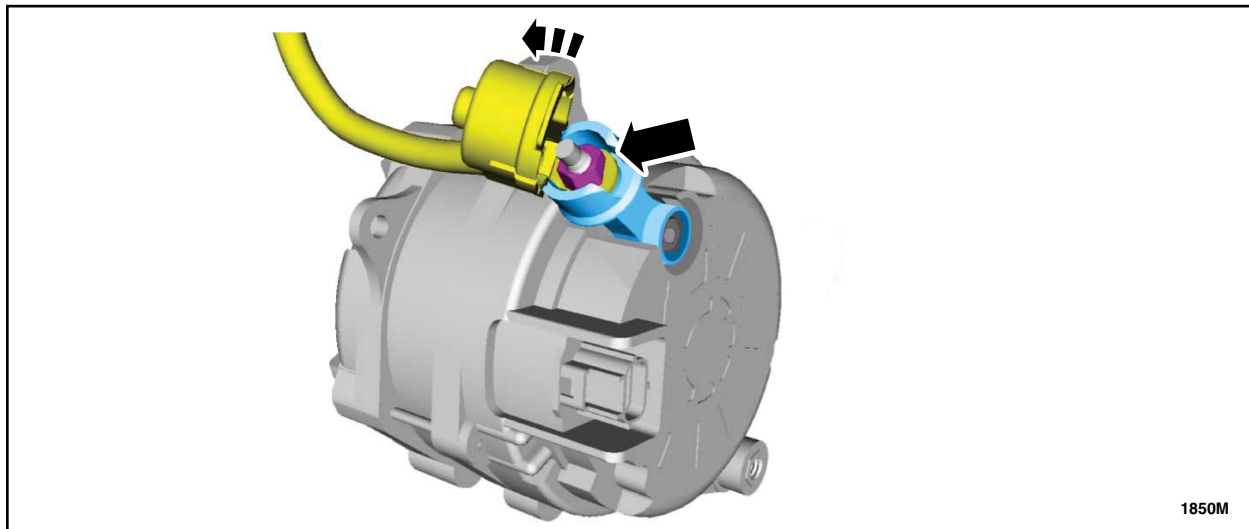
FIGURE 13

5. Inspect the generator battery positive cable nut and stud for cross threading and torque the nut. See Figure 13.

- Torque to 150 lb.in (17 Nm).

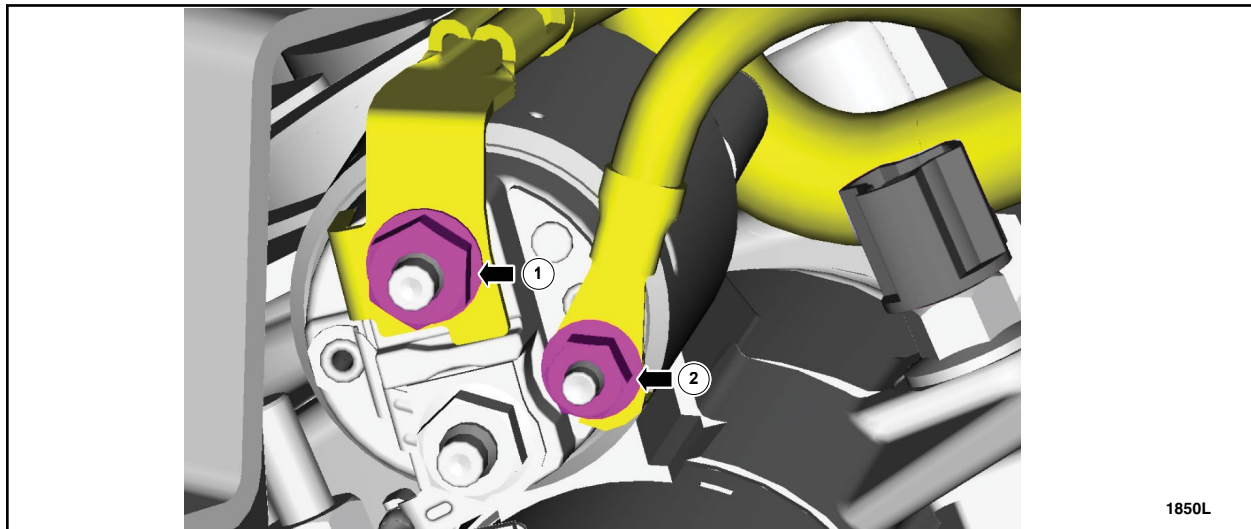
FIGURE 15

3. Inspect the starter motor battery positive cable nut and stud and the starter control wire nut and stud for cross threading or damage and torque both nuts. See Figure 15.
 - Battery positive cable: Torque to 106 lb.in (12 Nm).
 - Starter motor control wire: Torque to 53 lb.in (6 Nm).

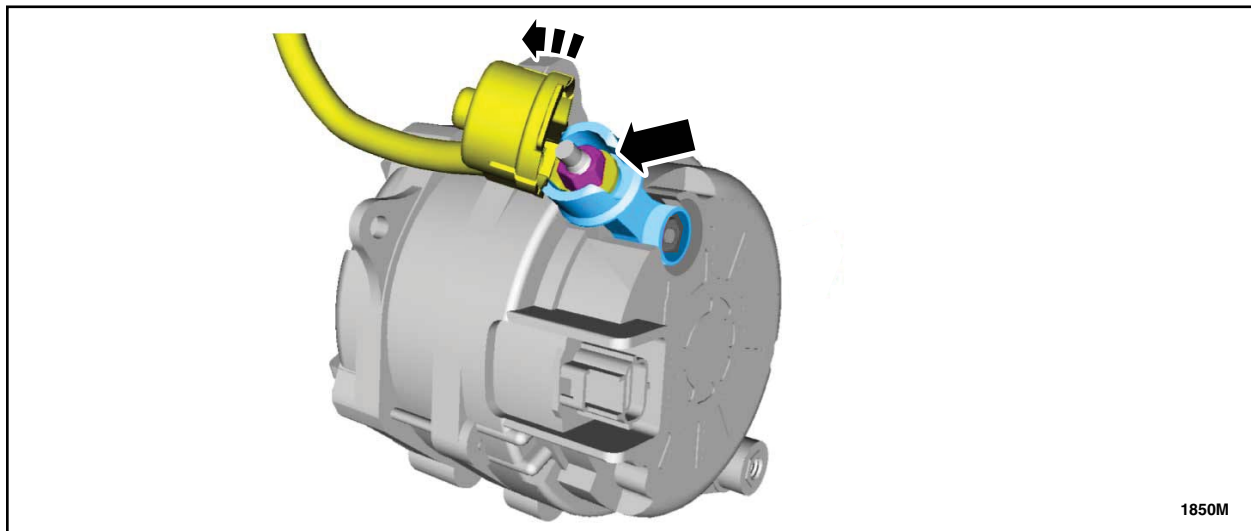
FIGURE 17

5. Inspect the generator battery positive cable nut and stud for cross threading and torque the nut.
See Figure 17.

- Torque to 150 lb.in (17 Nm).

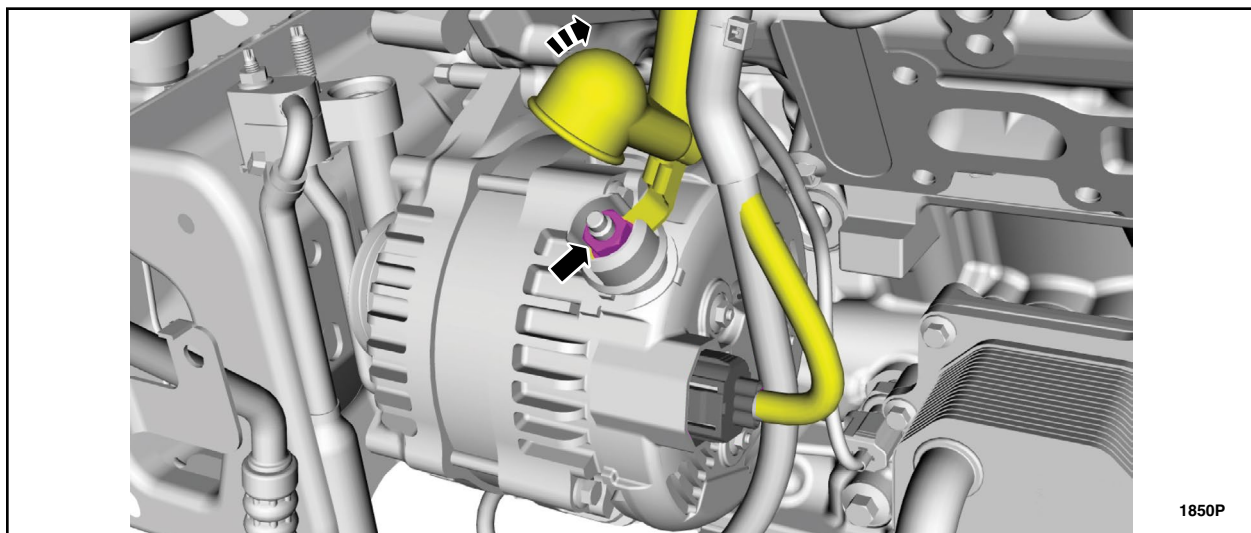
FIGURE 19

3. Inspect the generator battery positive cable nut and stud for cross threading and torque the nut. See Figure 19.

- Torque to 150 lb.in (17 Nm).

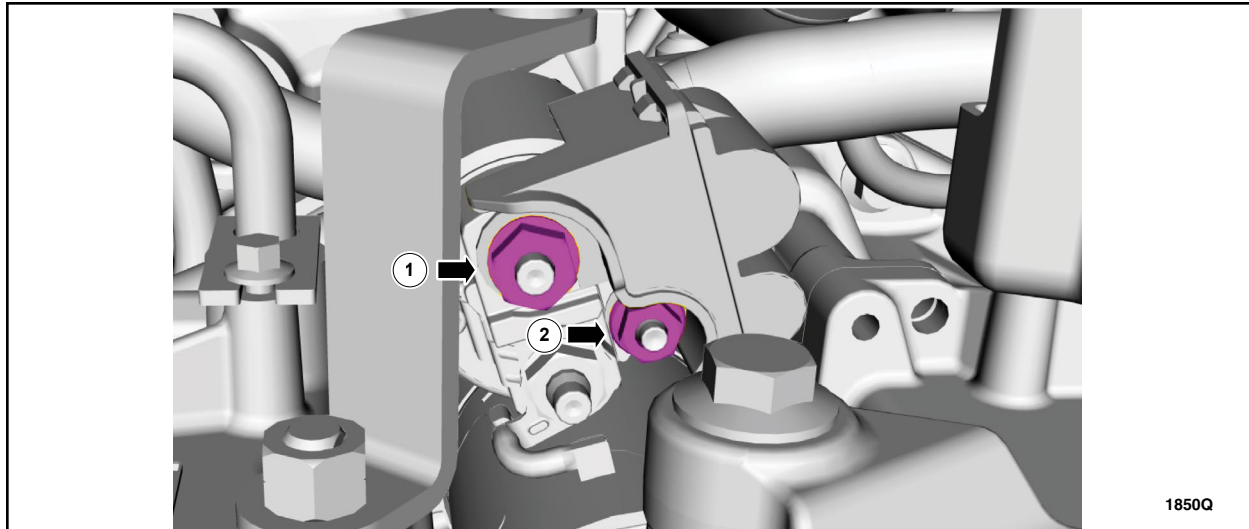
FIGURE 20

4. Inspect the starter motor battery positive cable nut and stud and the starter control wire nut and stud for cross threading or damage and torque both nuts. See Figure 20.

- Torque to 106 lb.in (12 Nm).
- Torque to 55 lb.in (6.2 Nm).
